Planning, Transport, Regeneration Overview and Scrutiny Committee

Page
1. Apologies for Absence	
2. Minutes	5 - 20
To approve as a correct record the minutes of the Planning, Transport, Regeneration Overview and Scrutiny Committee meeting held on 4 July 2023, 30 August 2023 (Extraordinary) and 28 September 2023 (Extraordinary).	
3. Items of Urgent Business	
To receive additional items that the Chair is of the opinion should be considered as a matter of urgency, in accordance with Section 100B (4) (b) of the Local Government Act 1972. To agree any relevant briefing notes submitted to the Committee.	
4. Declaration of Interests	
5. Thurrock Scheduled Ancient Monuments: Assessment of	21 - 176

The Thurrock Scheduled Ancient Monuments: Assessment of Settings is a technical baseline document that provides a detailed assessment of the significance and setting of these Scheduled Ancient Monuments (SAMs), as well as initial recommendations as to how the setting and significance of each SAM can be preserved and enhanced. It has been prepared to support the plan-making process as well as to better enable evidence-led decision making within Development Management.

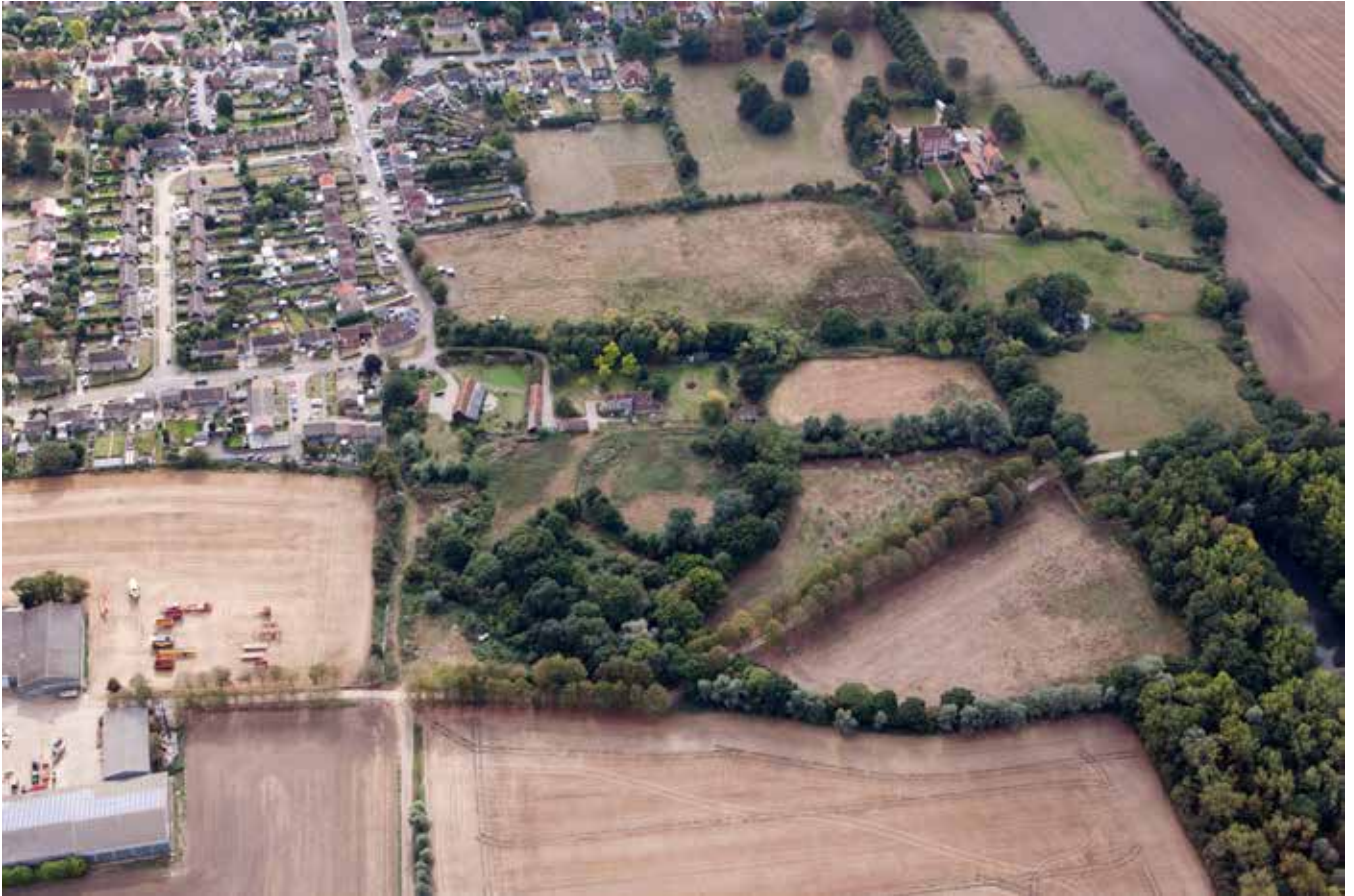
(Left) Figure 3 Aerial view of Bishop Bonner's Palace looking southwards, the ringwork is clearly visible, with the bailey located under the trees beside it. In the top-left of the photo is Orsett Church, Old Hall Farm is located immediately above the earthwork and The Decoy in the bottom-right of the photo.

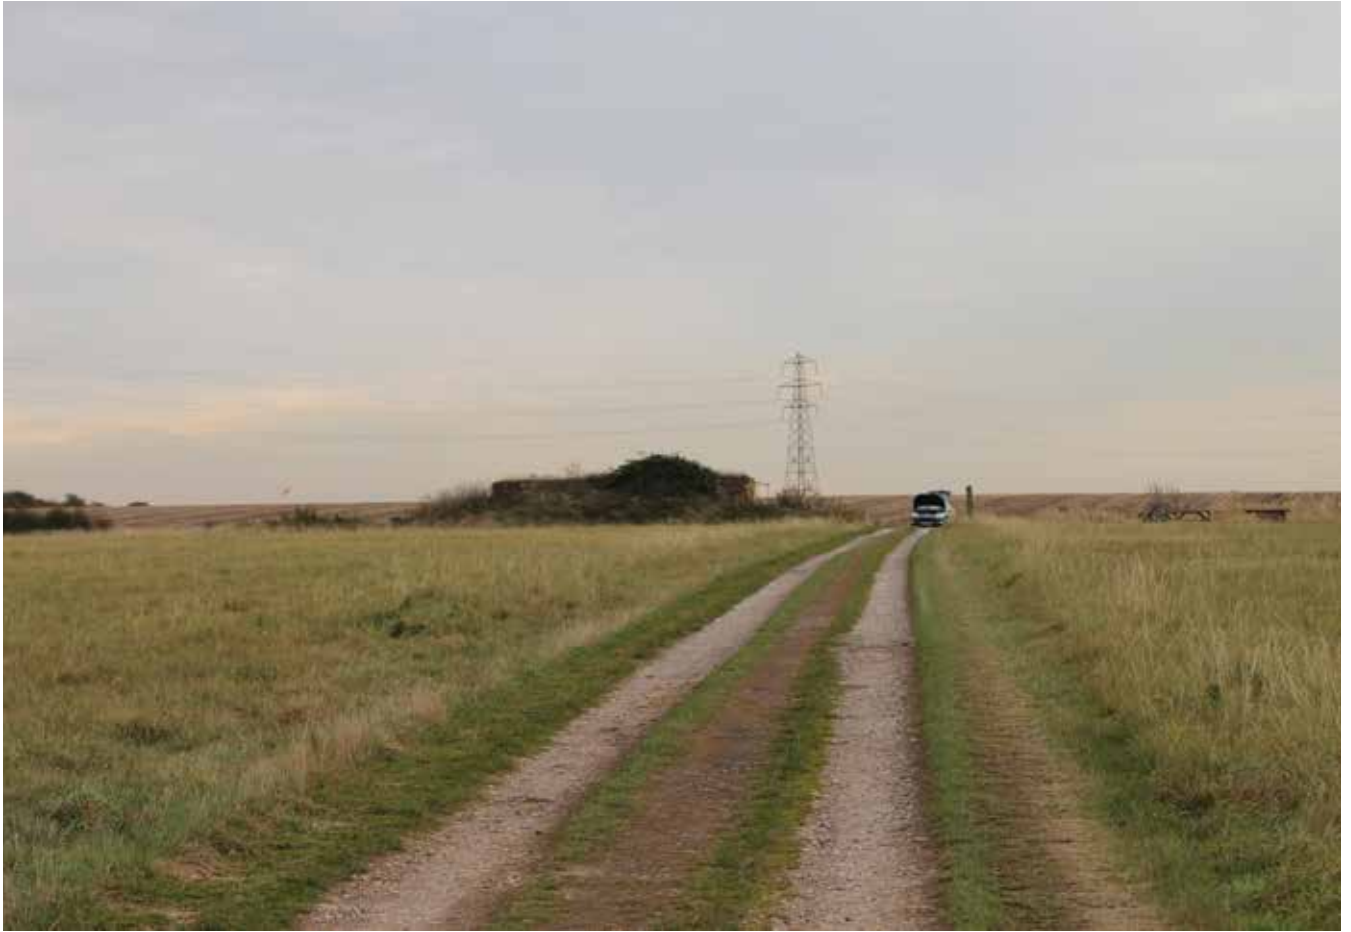
(Left) Figure 4: Location plan showing the principal views to and from the monument

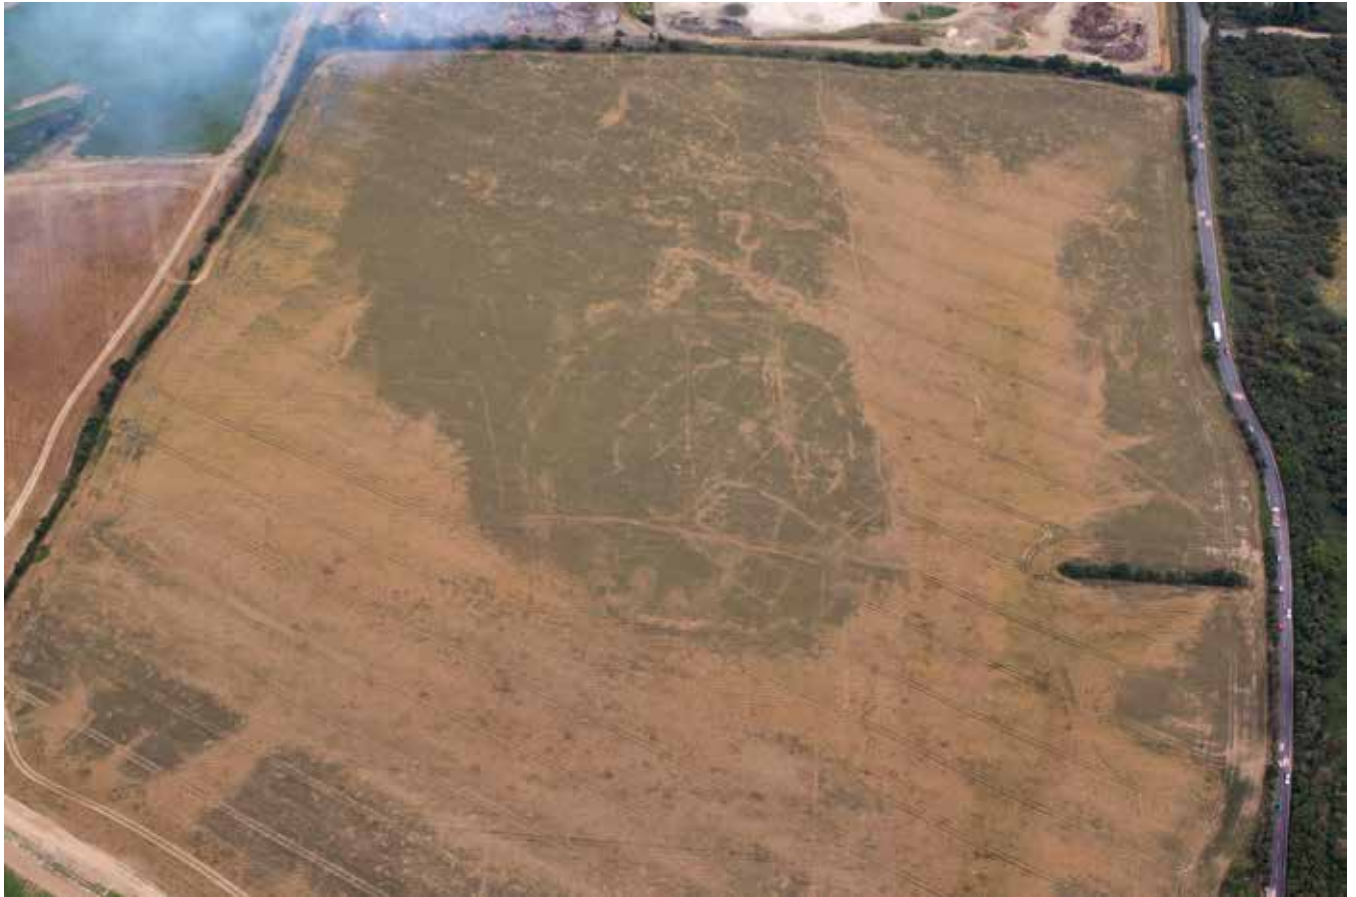
Figure 6 Aerial view of the cropmarks, looking north, the causewayed enclosure is visible in the centre of the photographs as the lighter dashed lines forming two concentric circles. (EX11_04_048 ©ECC)

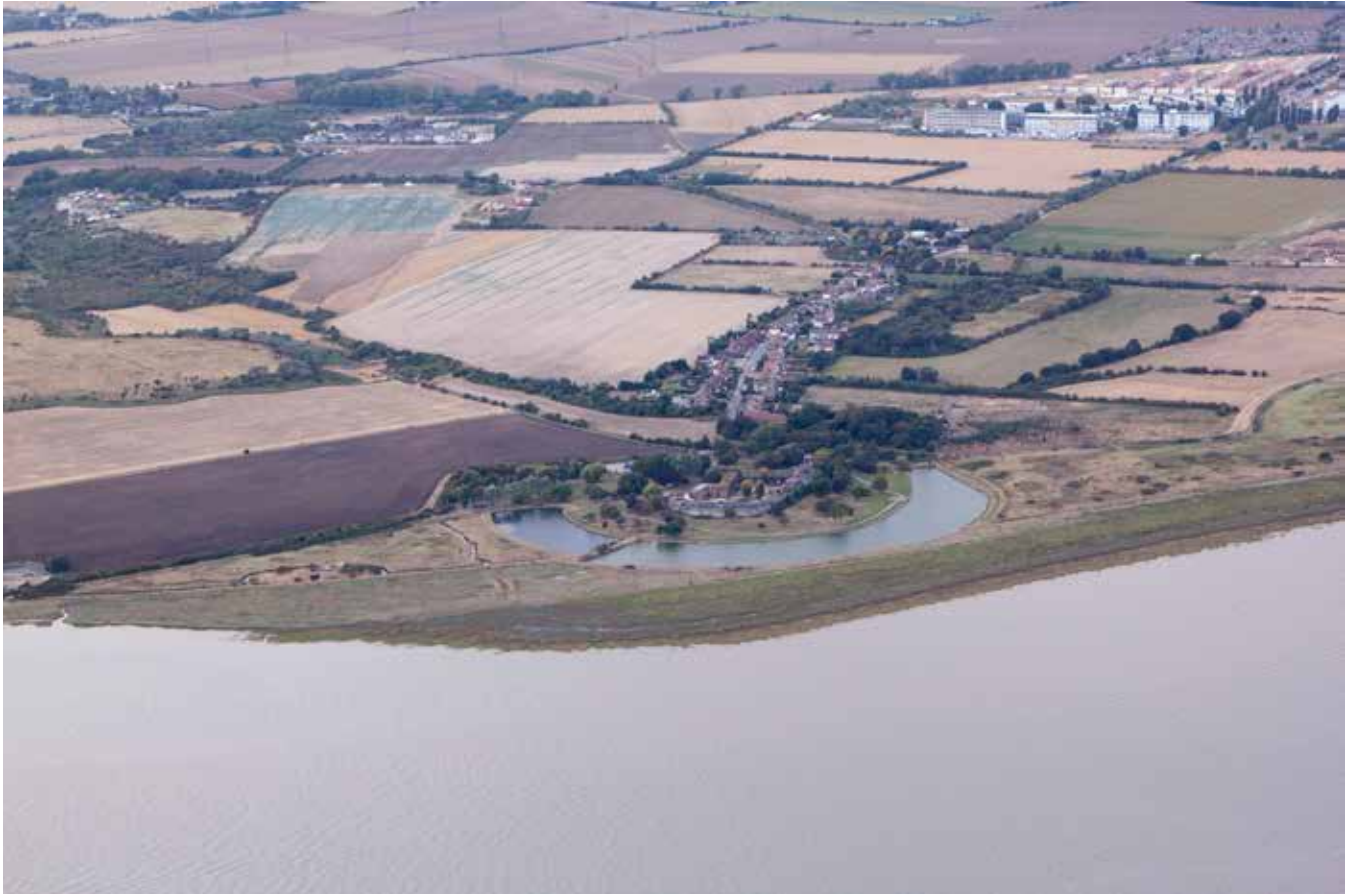
(Left) Figure 7 Location plan showing the principal views to and from the monument (other significant views are indicated by the smaller view-point symbols)

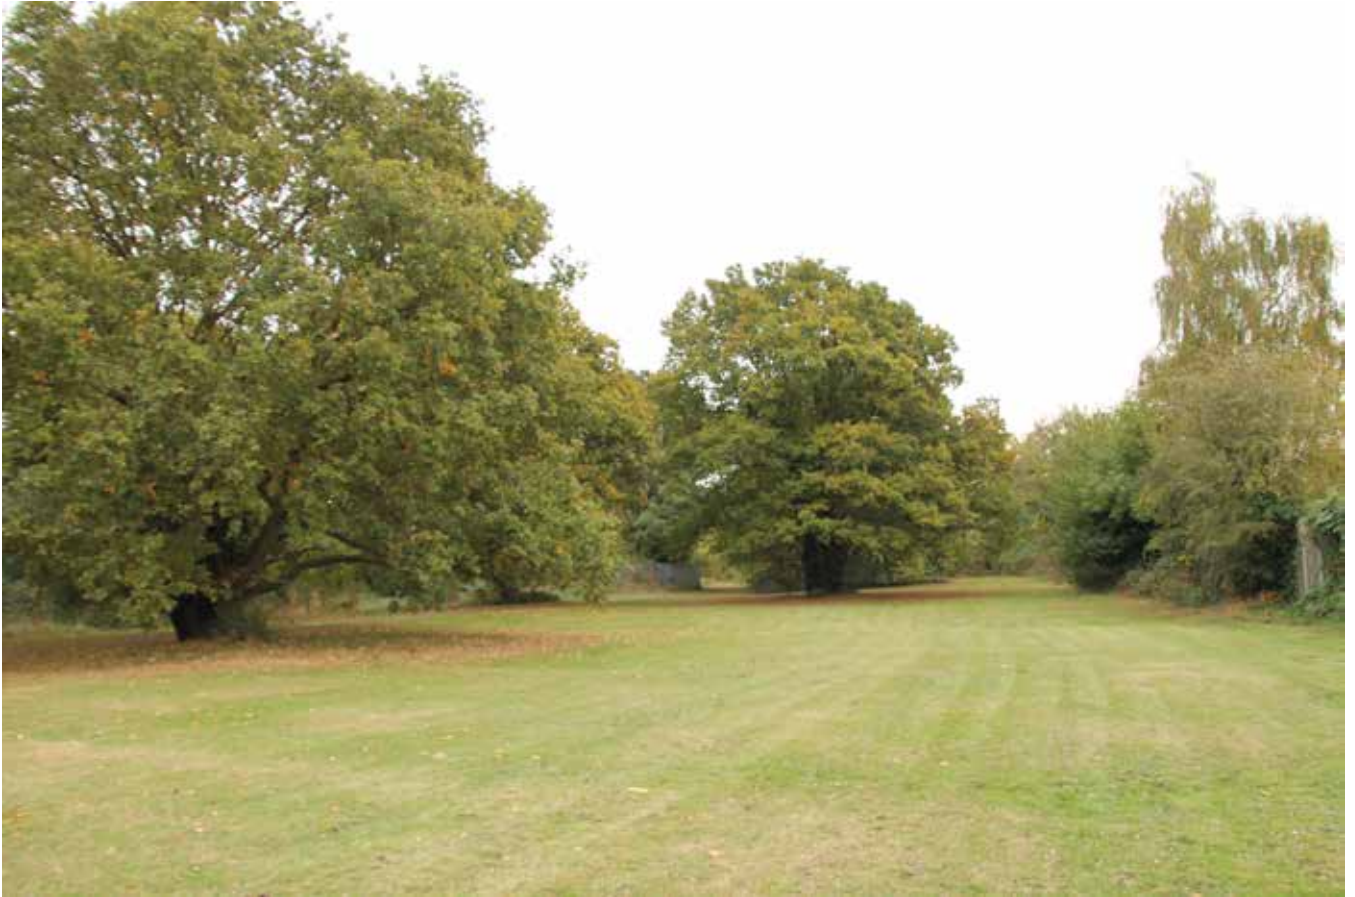
View 2: View looking east to the open dene holes (behind grey security fencing), partially hidden behind the mature trees in the foreground. The rear boundary of the properties fronting Parkside is on the right and The wooded areas of Hangman's Wood to the left.

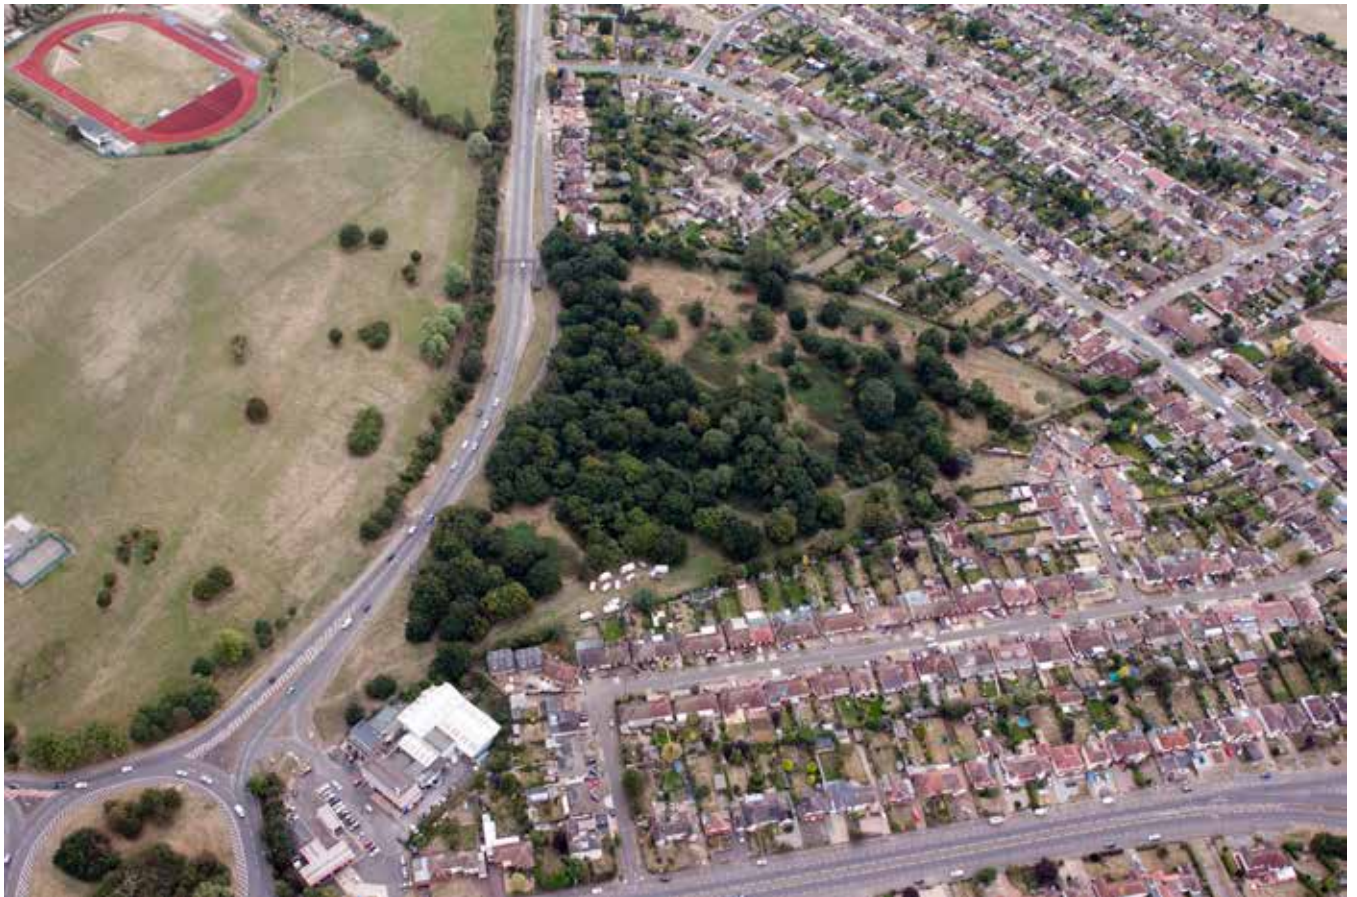
Figure 13 Hangman's Wood in its immediate setting. Some of the darker vegetation in the mown grass may indicate other dene hole sites.

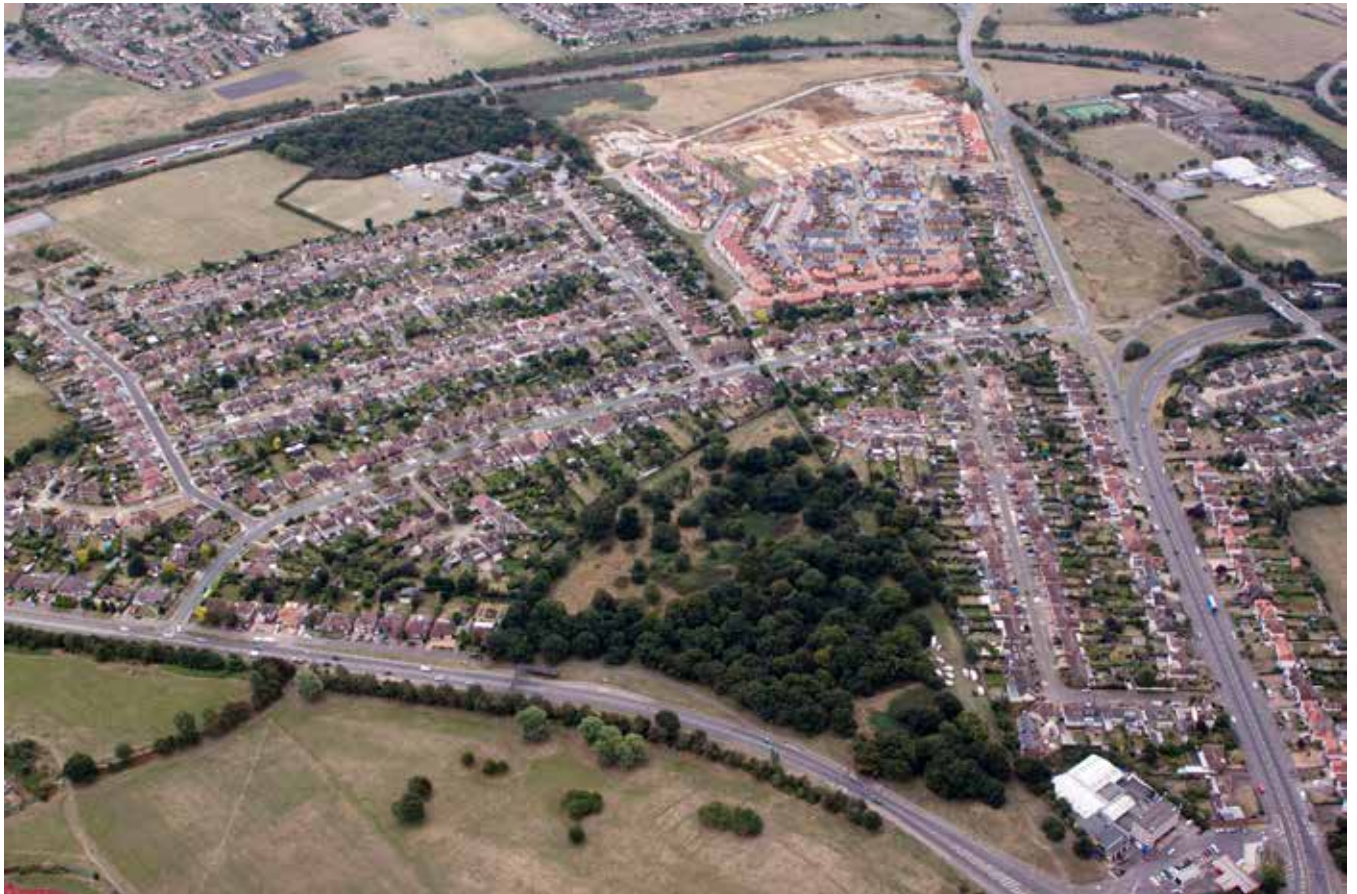
Figure 14 Hangman's Wood in its wider setting, with Tyrells Heath behind and Orsett Heath beyond. The former heathland character of the area is visible in places

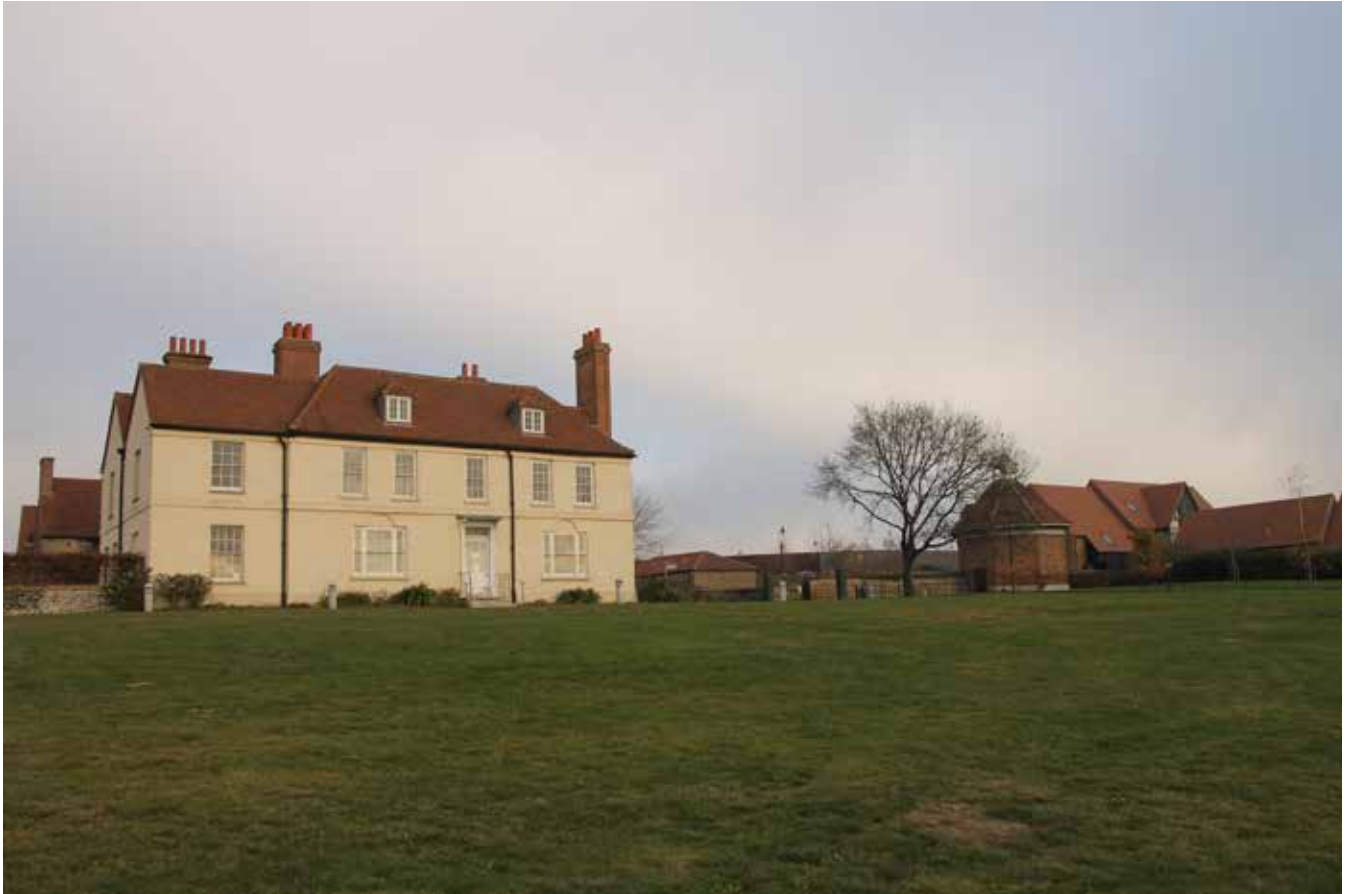
(Left) Figure 15 Location plan showing the principal views to and from the monument

(Right) View 1: High House farmhouse and the dovecote looking north-west, with the farm buildings behind and the modern development to the east of the dovecote.

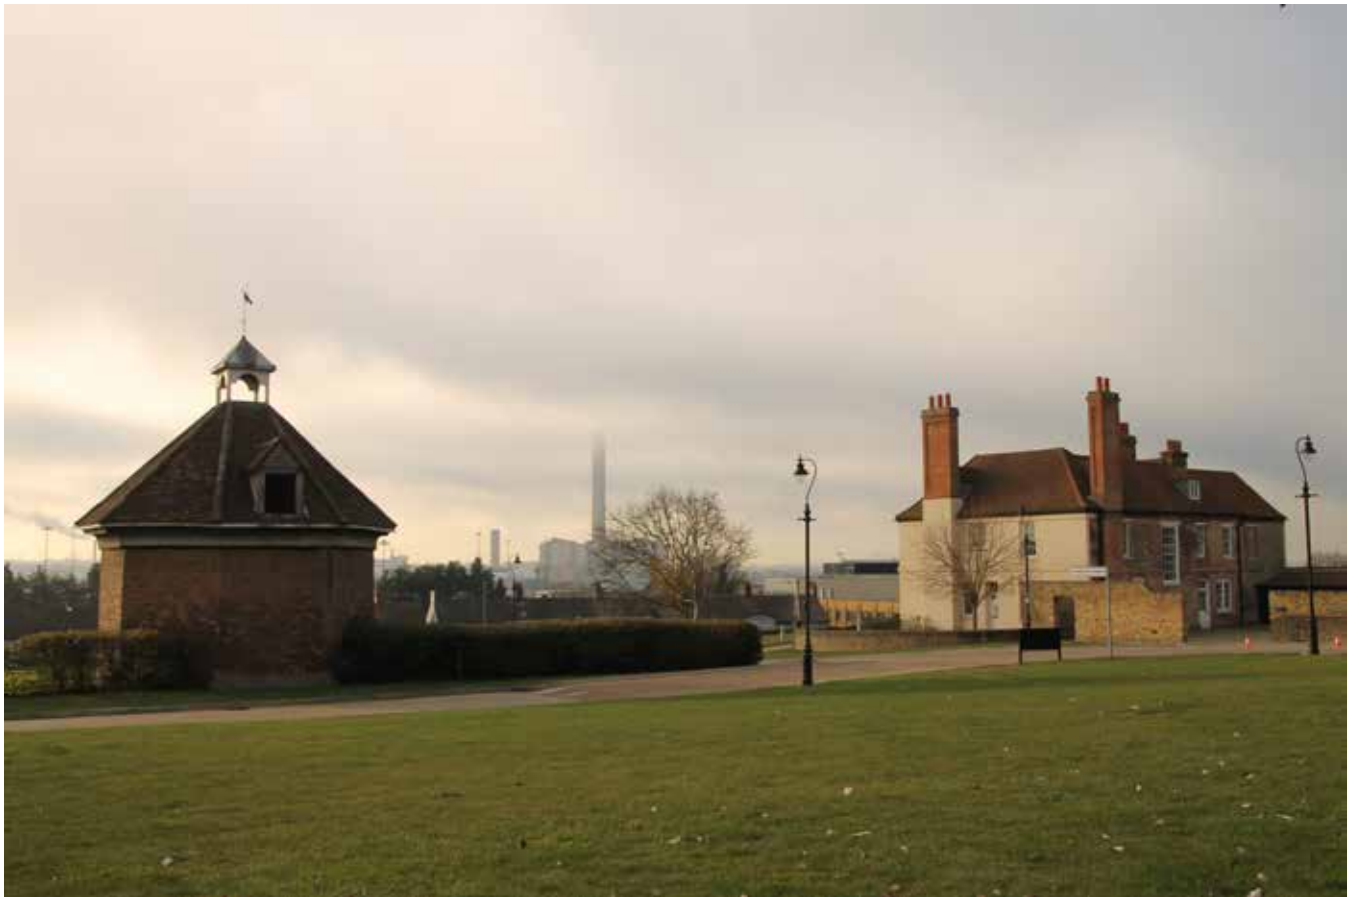
View 2: View south-eastwards showing the dovecote and farmhouse with the backdrop of industry along the Thames.

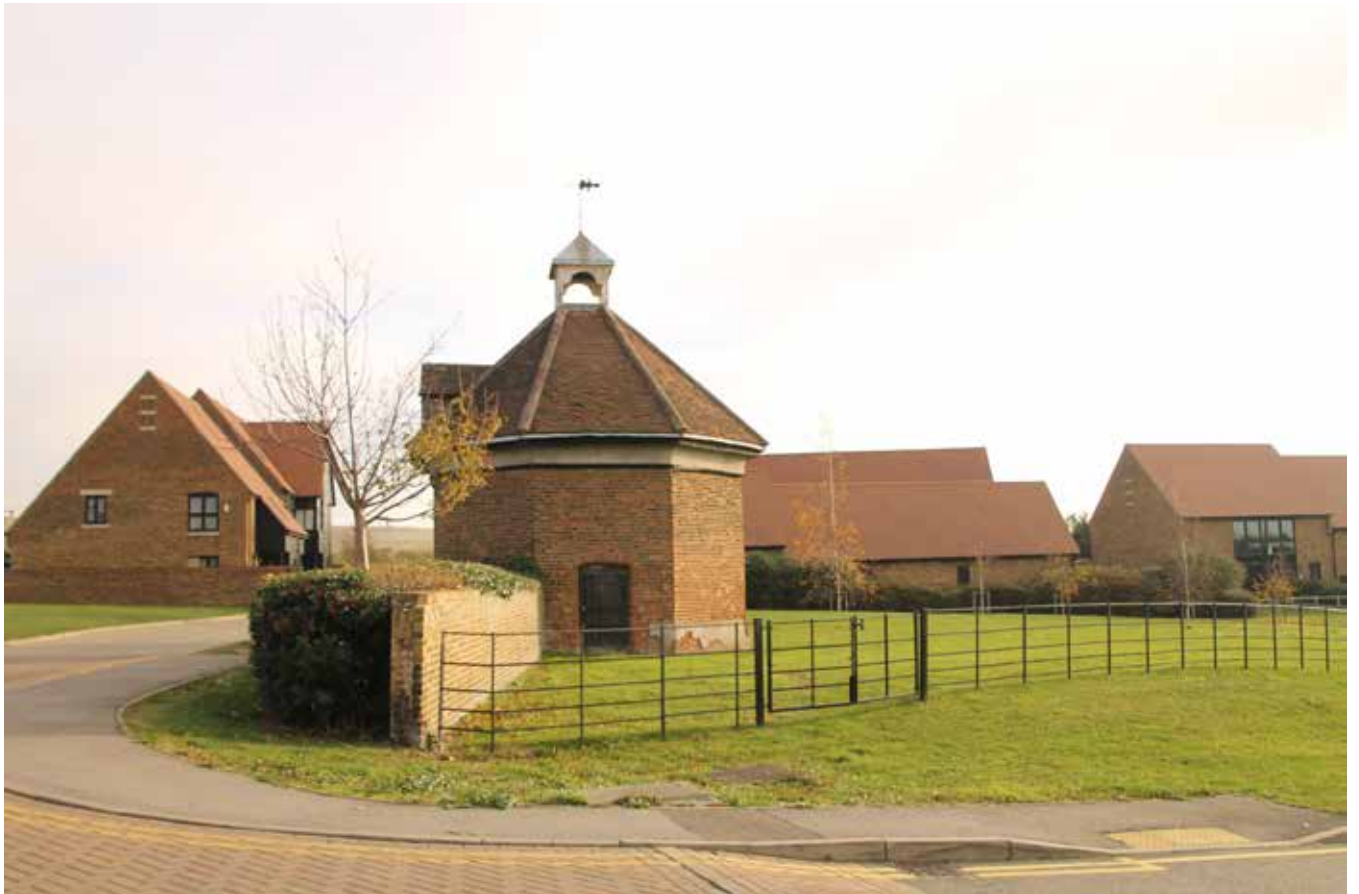
View 3: View of the dovecote from the west, with the modern housing development behind.

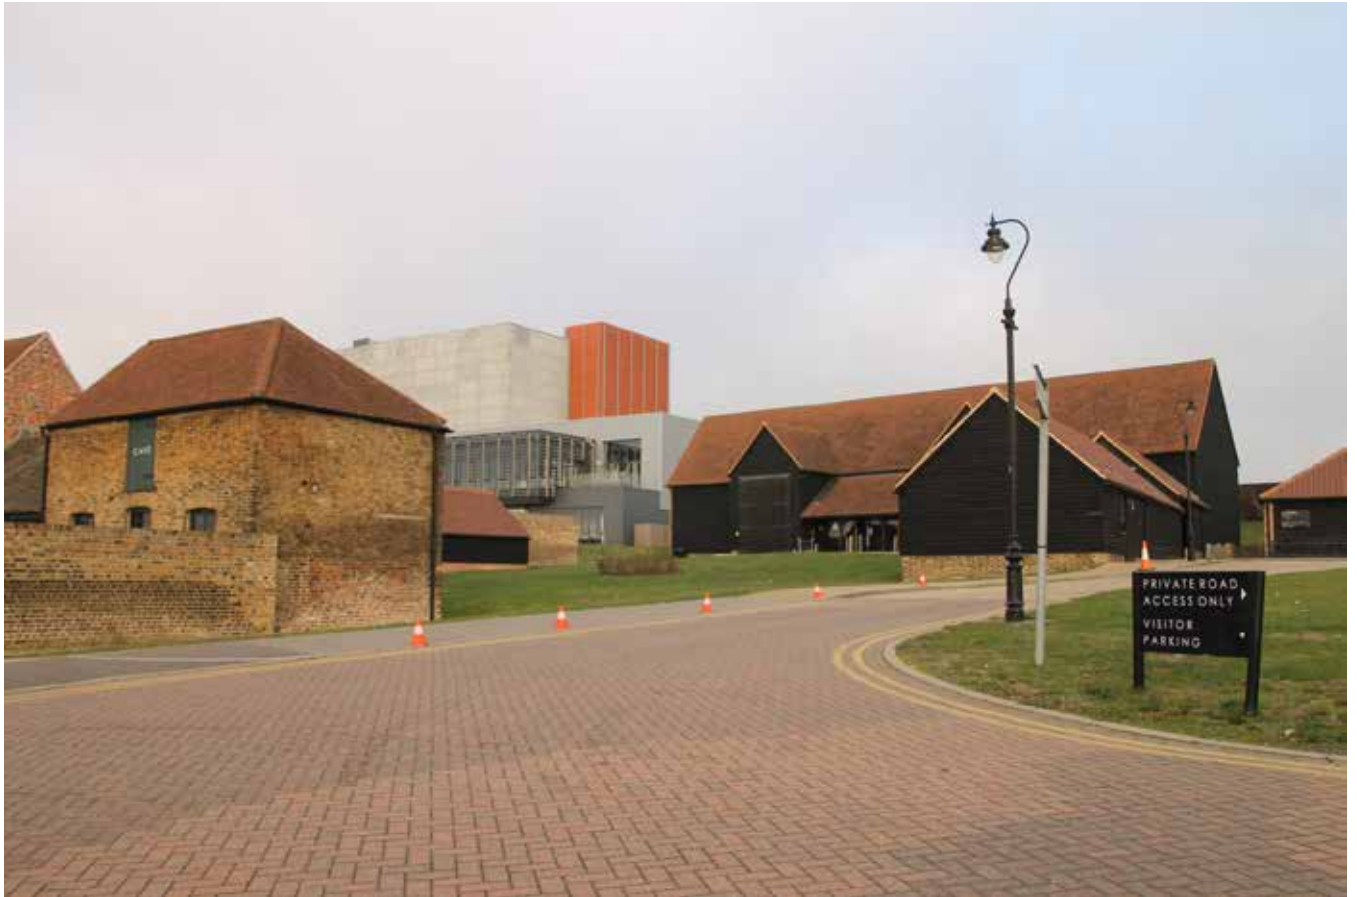
View 4: View of the farm buildings from the dovecote, with modern commercial development behind.

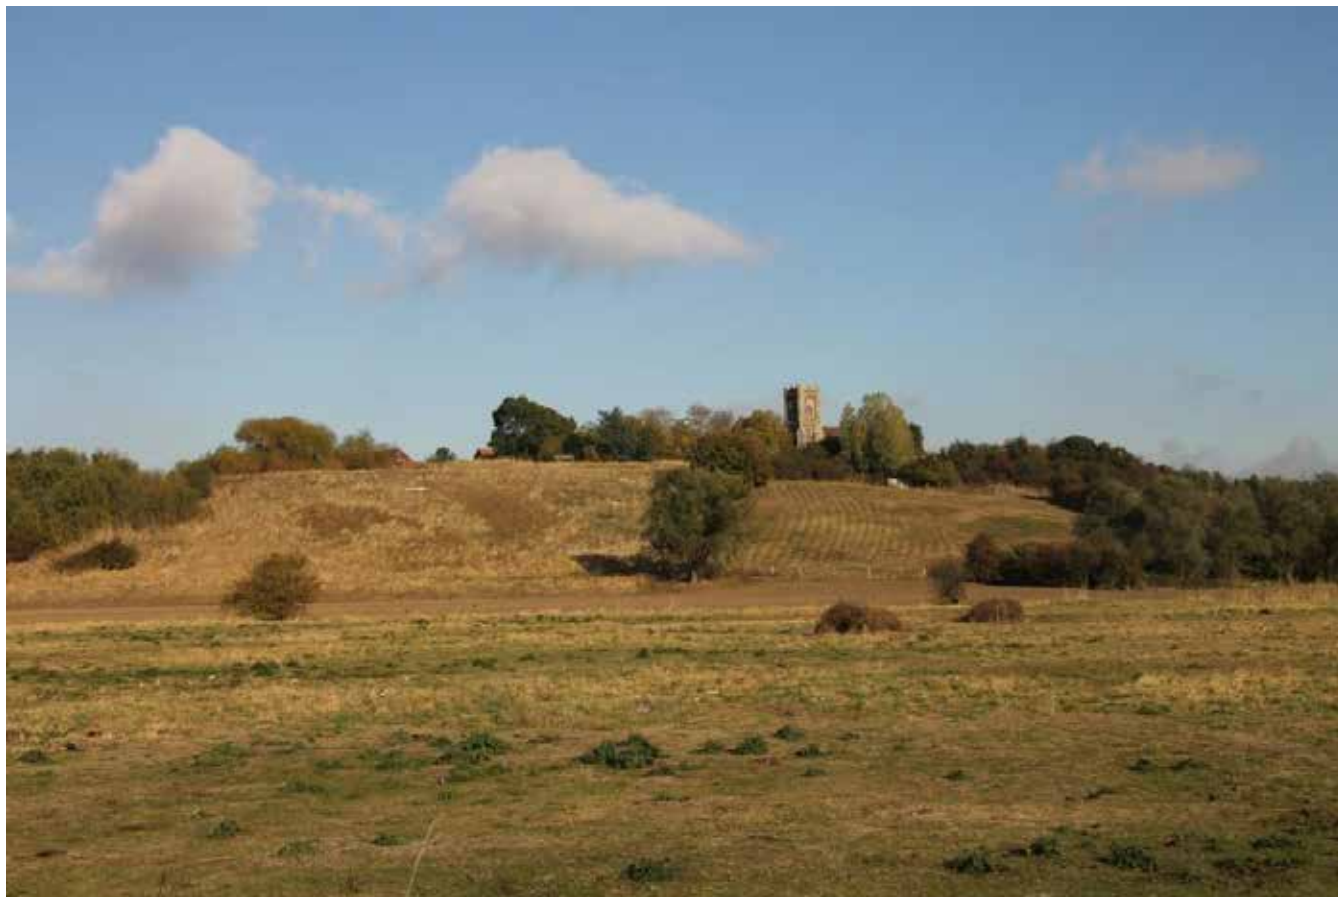
(Left) Figure 16 Location plan showing the principal views to and from the monument (other significant views are indicated by the smaller view-point symbols)

(Right) View 1: View looking northwards from Cooper Shaw Road up the escarpment to the monument with the Church and Hall complex behind

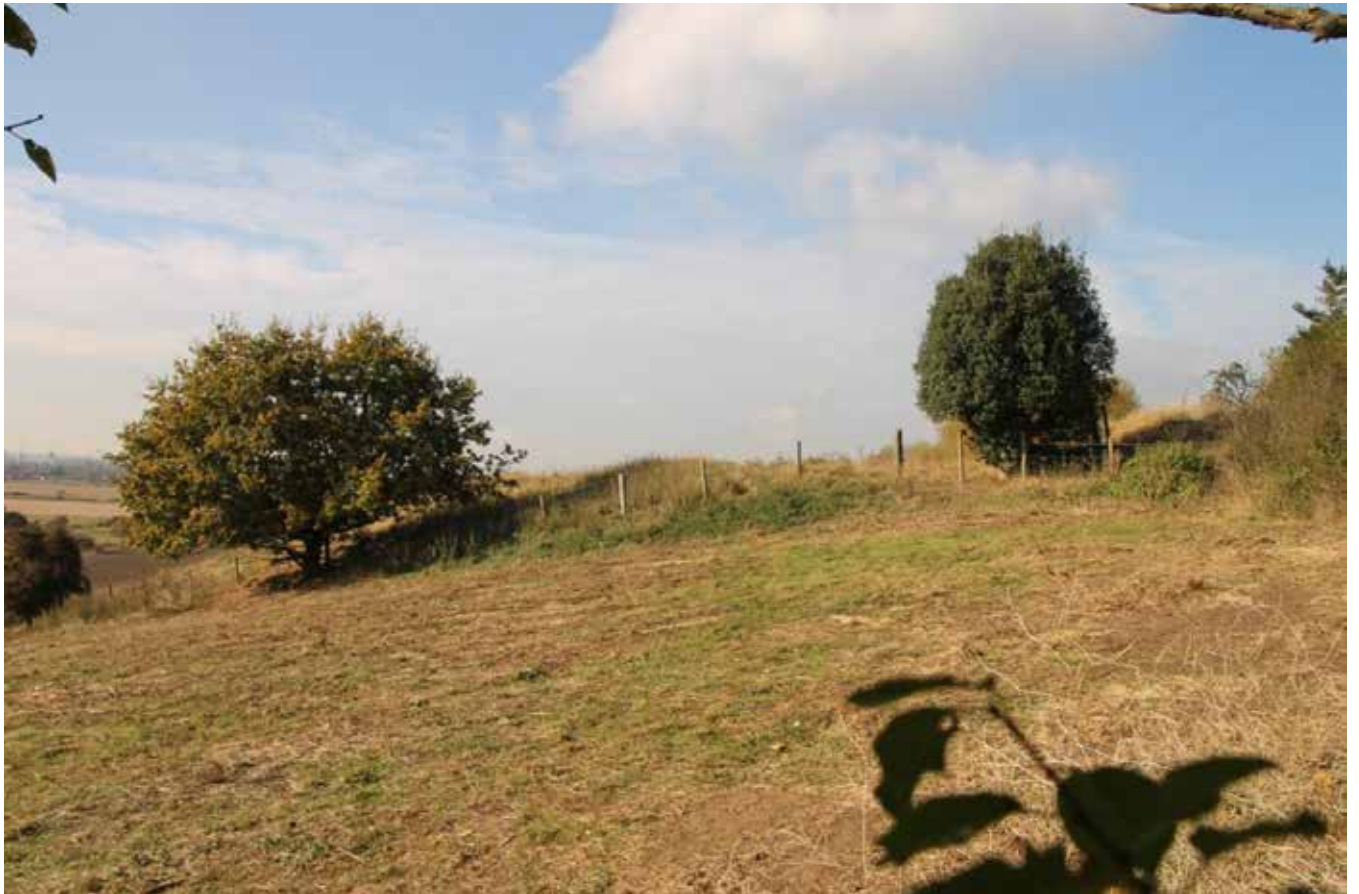
View 3: Looking west into the monument from the new graveyard

Currently the scheduled area appears to be used for rough grazing, and a portion has been colonised by scrub (largely blackthorn). This partially obscures the monument and maybe causing root damage and therefore can be considered as having a minor negative impact on the heritage asset.

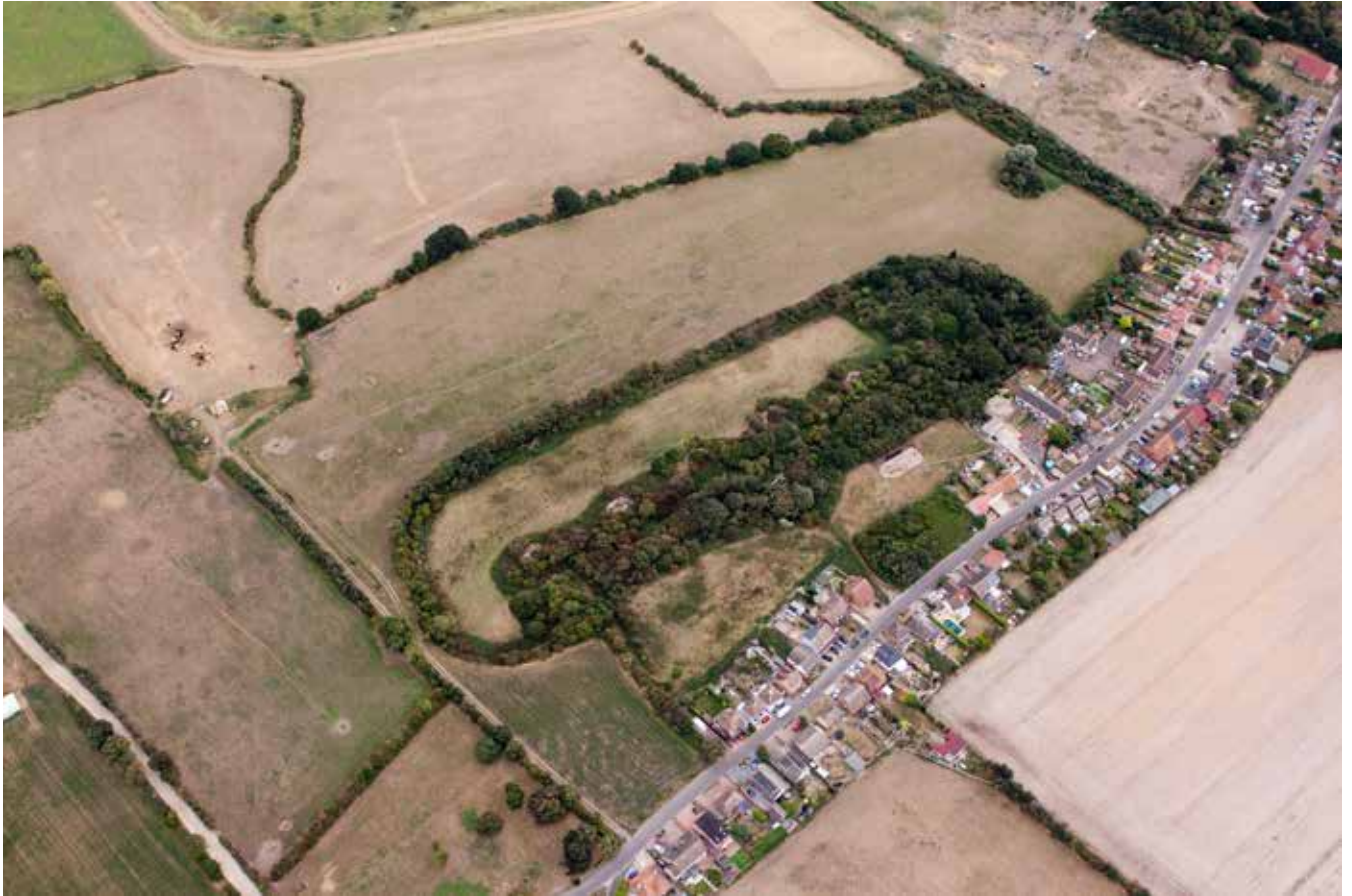
Figure 17 Plan showing the battery and the principal views in and out of the monument (other significant views are indicated by the smaller view-point symbols)

Figure 18 This aerial view shows some of the gun emplacements, but other structures are obscured by the vegetation. This also shows the former marshland (upper half of photo), now agricultural land between the battery and sea wall. East Tilbury is located to the rear of the battery.

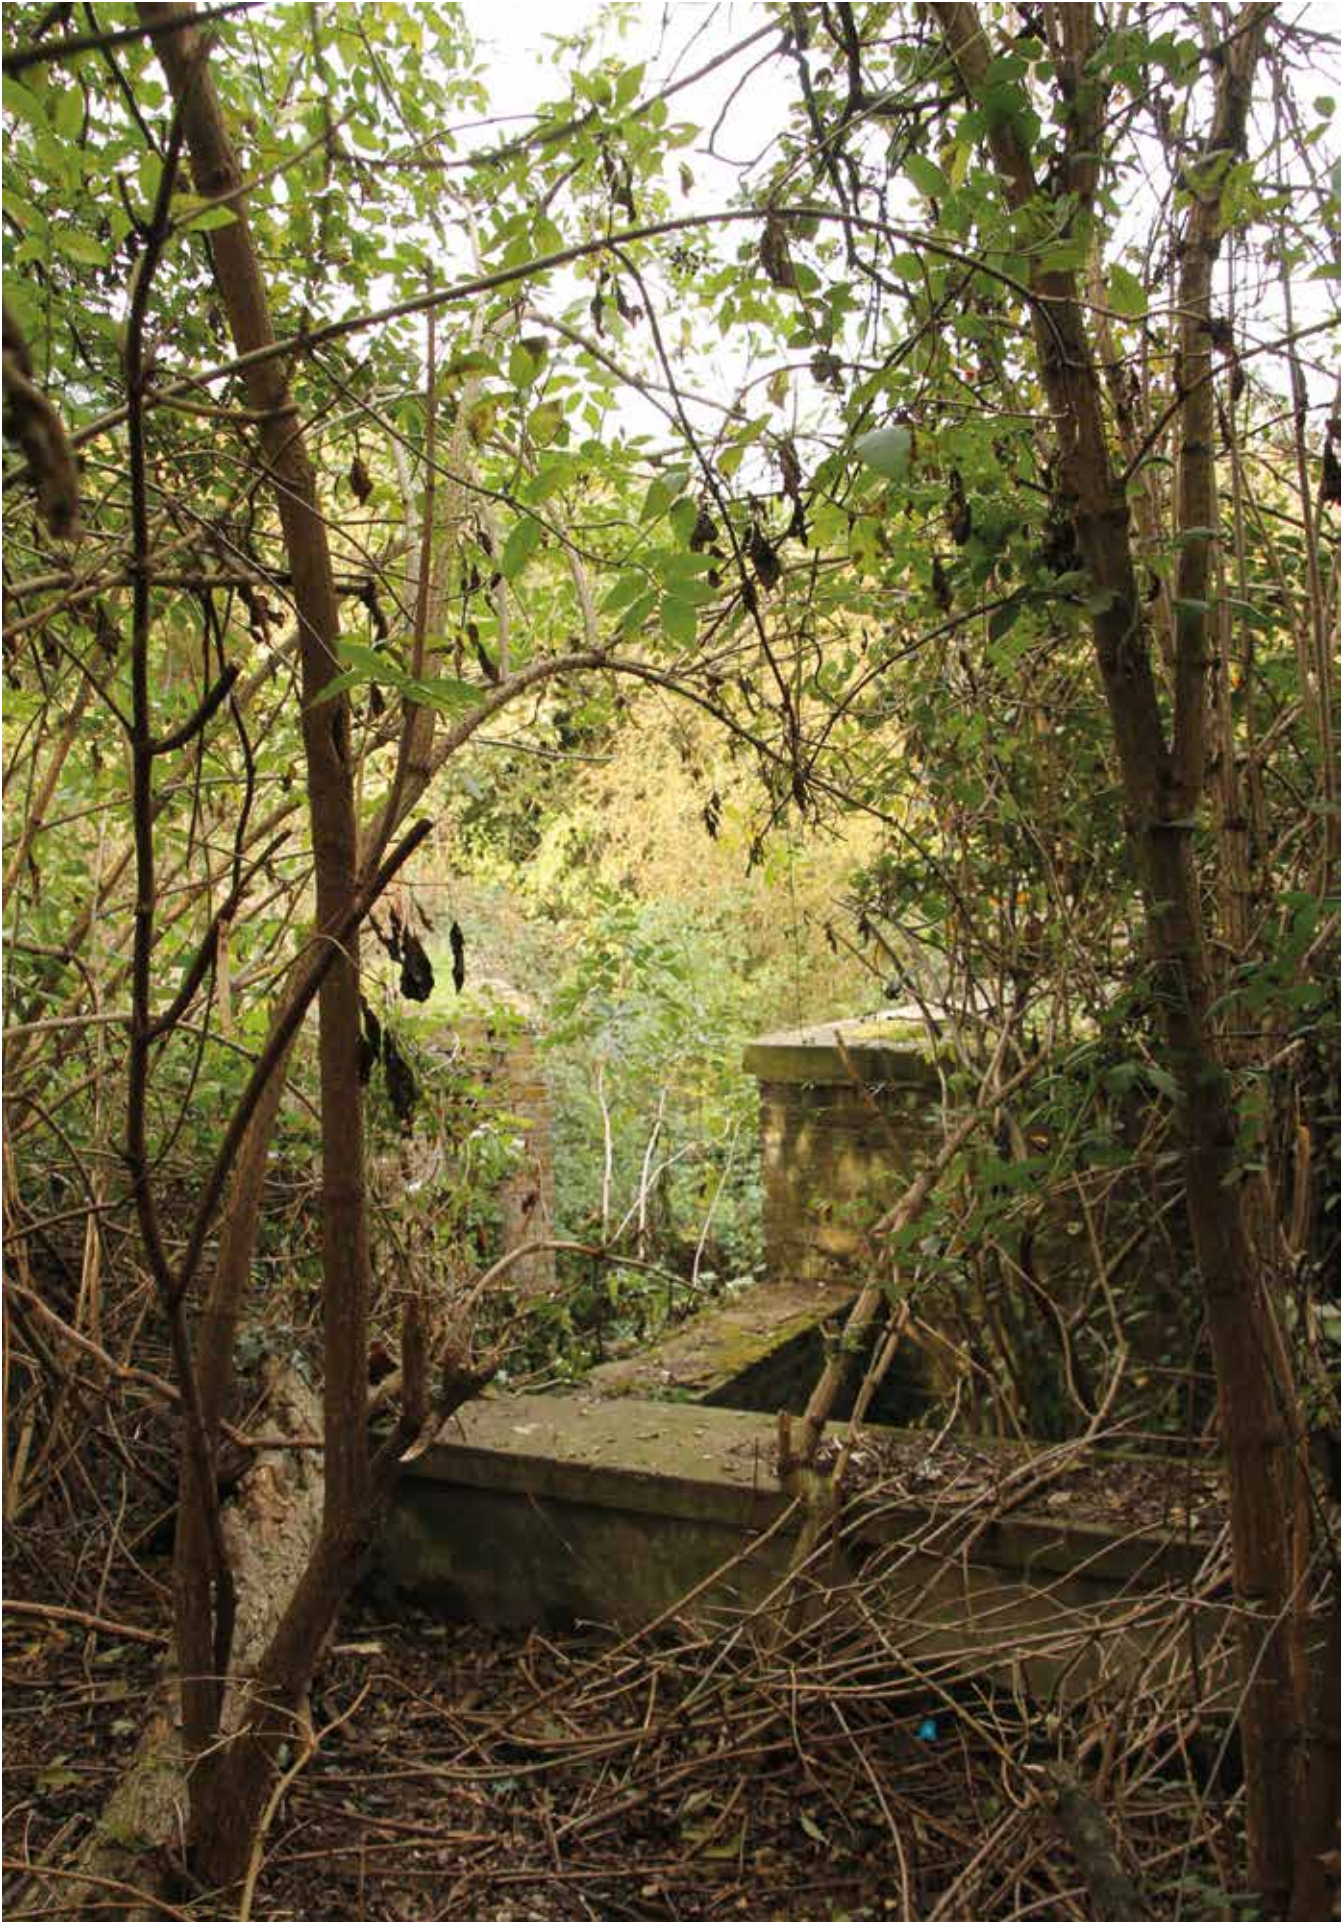
View 1: Part of the battery structure showing the undergrowth which has grown up around it.

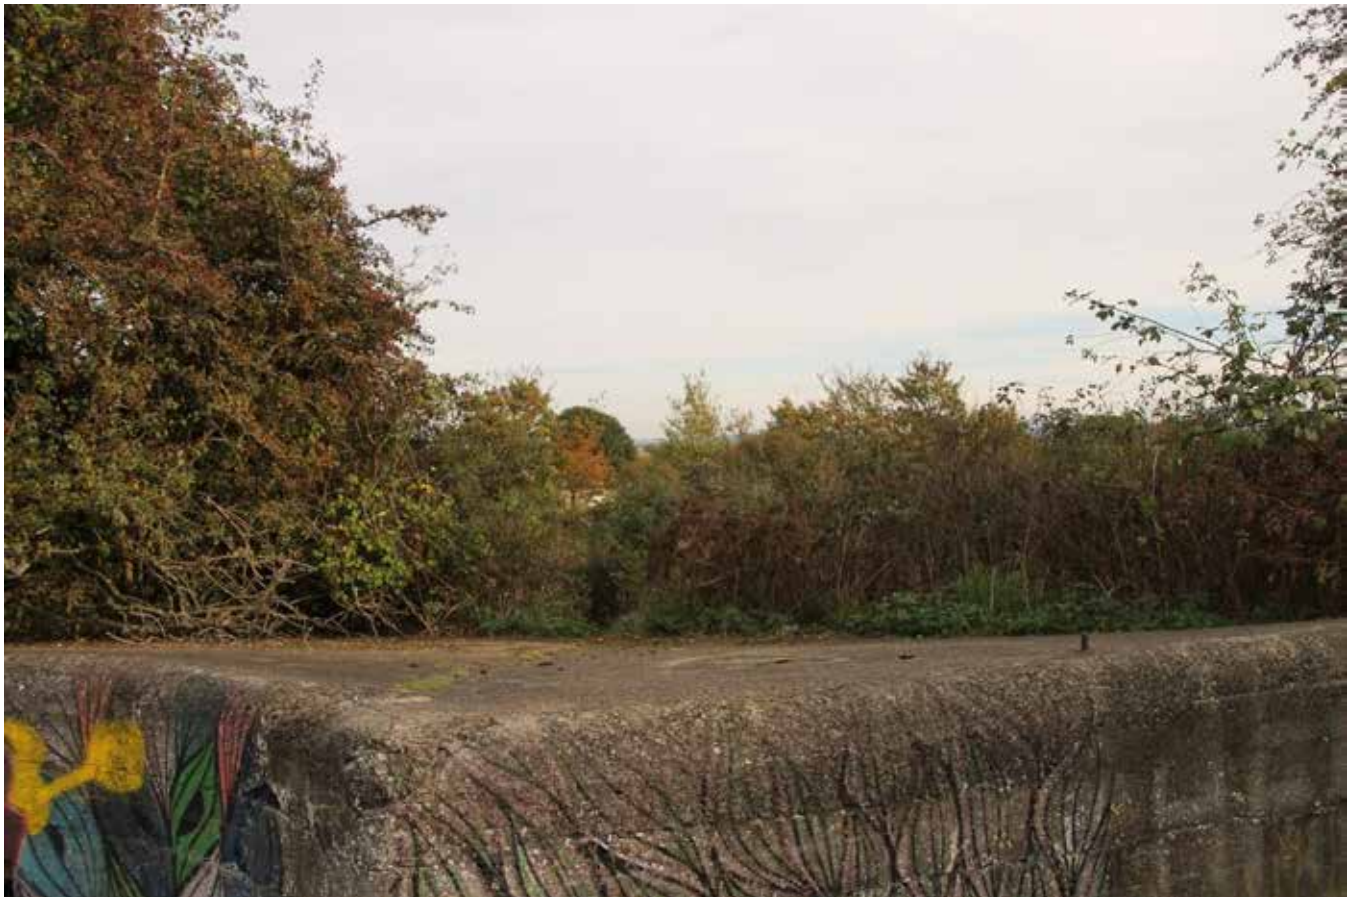
View 2: View eastwards from one of the gun positions towards the marsh and river, which are no longer visible.
