Planning, Transport, Regeneration Overview and Scrutiny Committee

Page
1. Apologies for Absence	
2. Minutes	5 - 20
To approve as a correct record the minutes of the Planning, Transport, Regeneration Overview and Scrutiny Committee meeting held on 4 July 2023, 30 August 2023 (Extraordinary) and 28 September 2023 (Extraordinary).	
3. Items of Urgent Business	
To receive additional items that the Chair is of the opinion should be considered as a matter of urgency, in accordance with Section 100B (4) (b) of the Local Government Act 1972. To agree any relevant briefing notes submitted to the Committee.	
4. Declaration of Interests	
5. Thurrock Scheduled Ancient Monuments: Assessment of	21 - 176

The Thurrock Scheduled Ancient Monuments: Assessment of Settings is a technical baseline document that provides a detailed assessment of the significance and setting of these Scheduled Ancient Monuments (SAMs), as well as initial recommendations as to how the setting and significance of each SAM can be preserved and enhanced. It has been prepared to support the plan-making process as well as to better enable evidence-led decision making within Development Management.

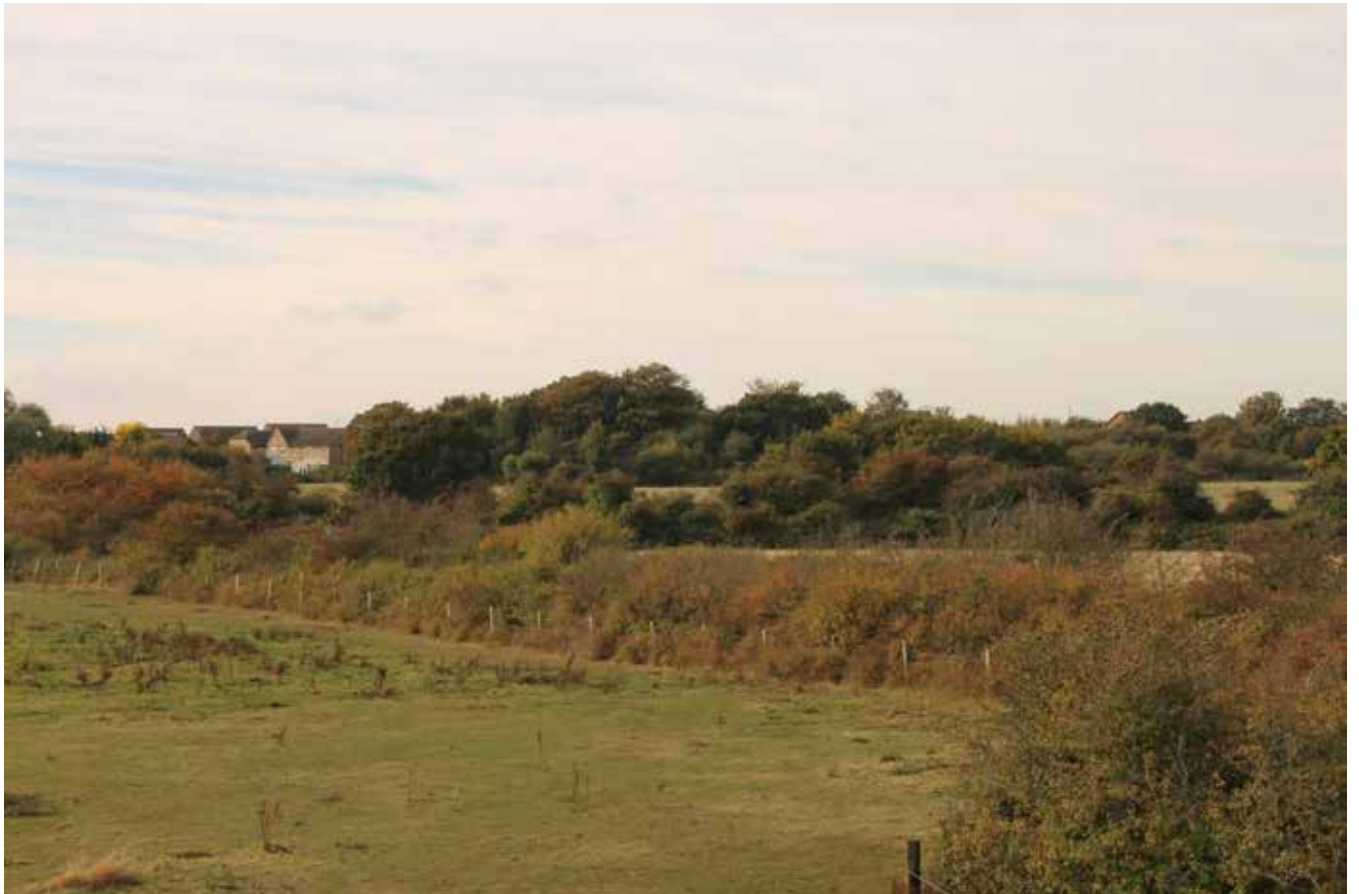
View 3: View of the battery from the east on the seawall, showing the tree and shrub growth on the scheduled monument.

The battery was constructed with a clear view across the marshes and sea wall to the Thames. The nature of the marshes has changed, with improvement around the edges of the marsh by drainage and some enclosure of individual fields. There are now mature hedge lines blocking that view across the marsh. The battery went out of use before the First World War and the guns removed. The rest of the structure survives very well with what appears to be little damage, apart from graffiti and some rubbish dumping. The battery is now covered by tree growth, which may lead to structural damage. It is also impossible to see an overall view of the battery.

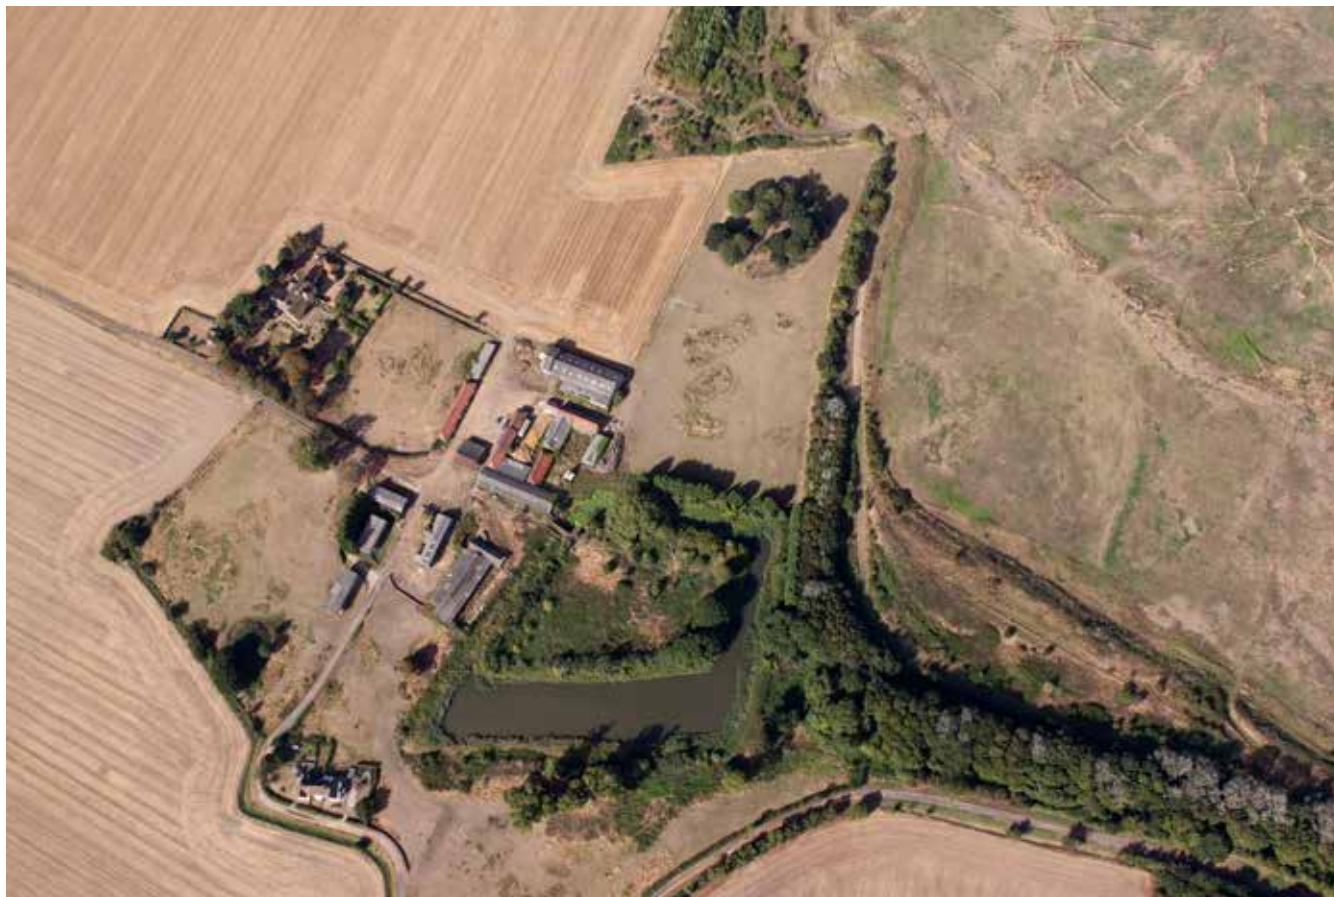
Figure 19 Location plan showing the principal views to and from the monument (other significant views are indicated by the smaller view-point symbols)

Figure 20 Aerial photograph of both the Scheduled moat and of the Roman barrow to the north, together with the associated farm complex. The clay-pit is located on the right-hand side of the photo

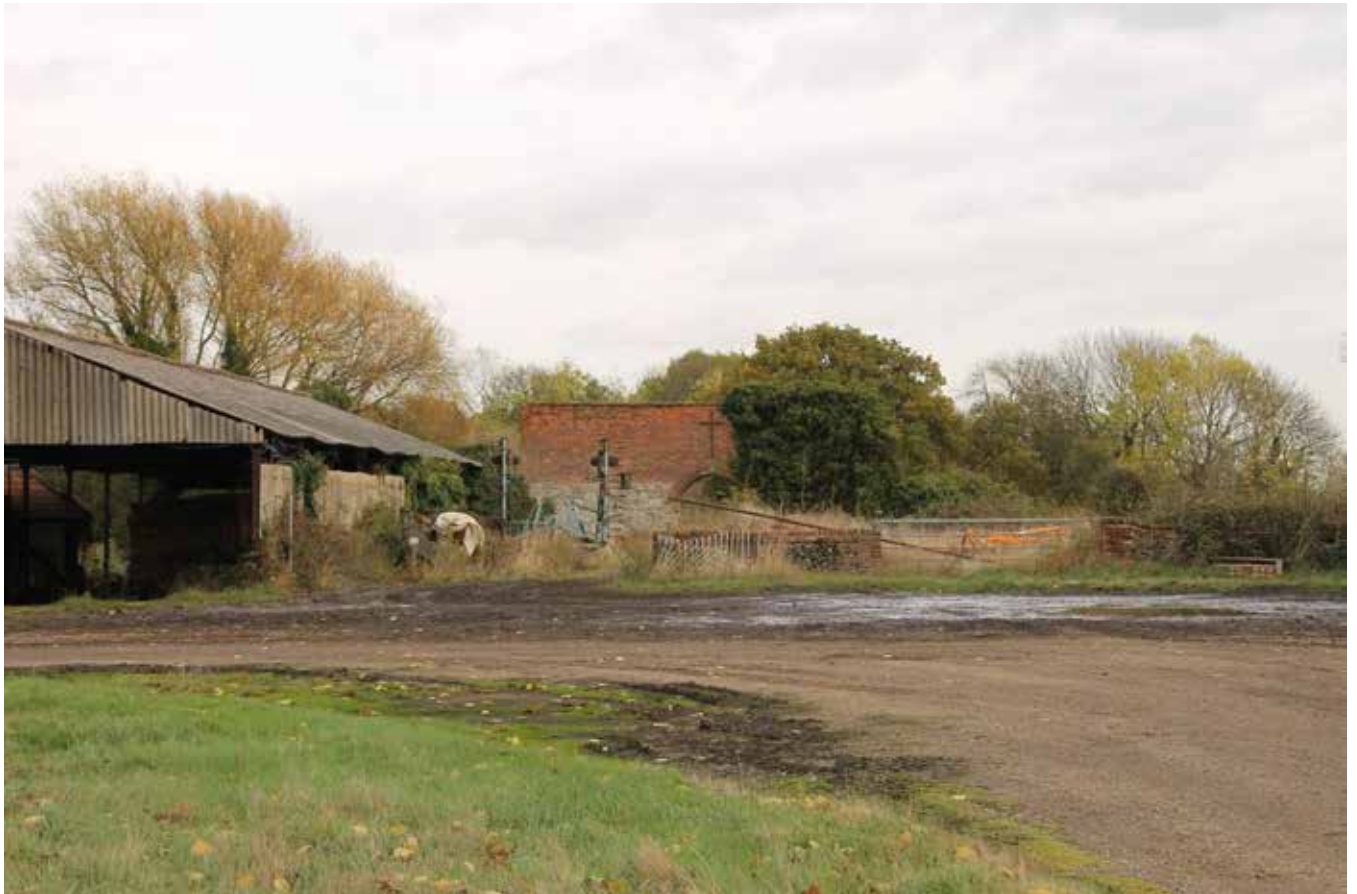
View 2: Looking from the farmyard access road to the gatehouse, the moated site is under the vegetation to the rear of the gatehouse.

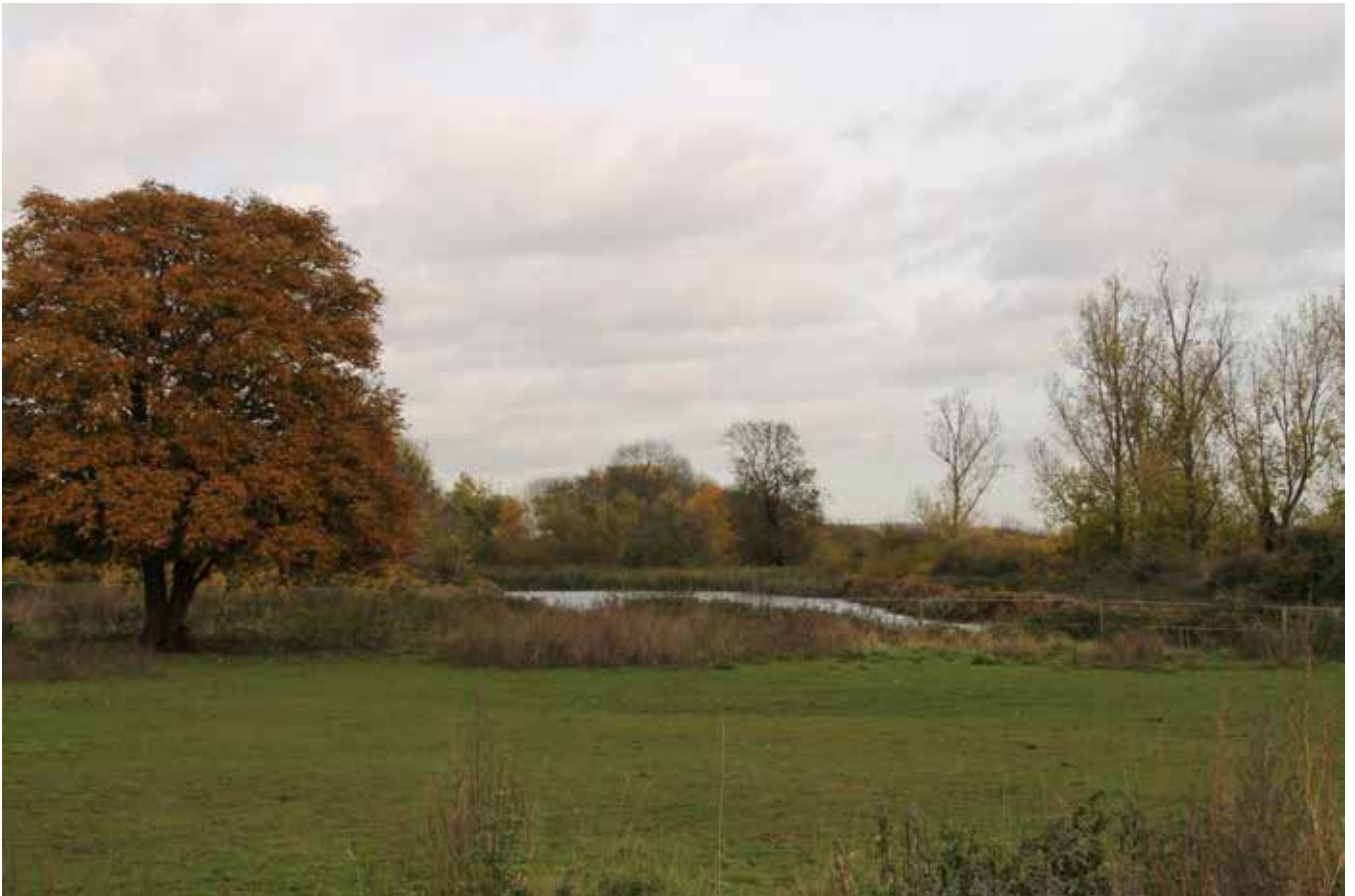
View 4: Looking from the footpath eastwards into the moated area

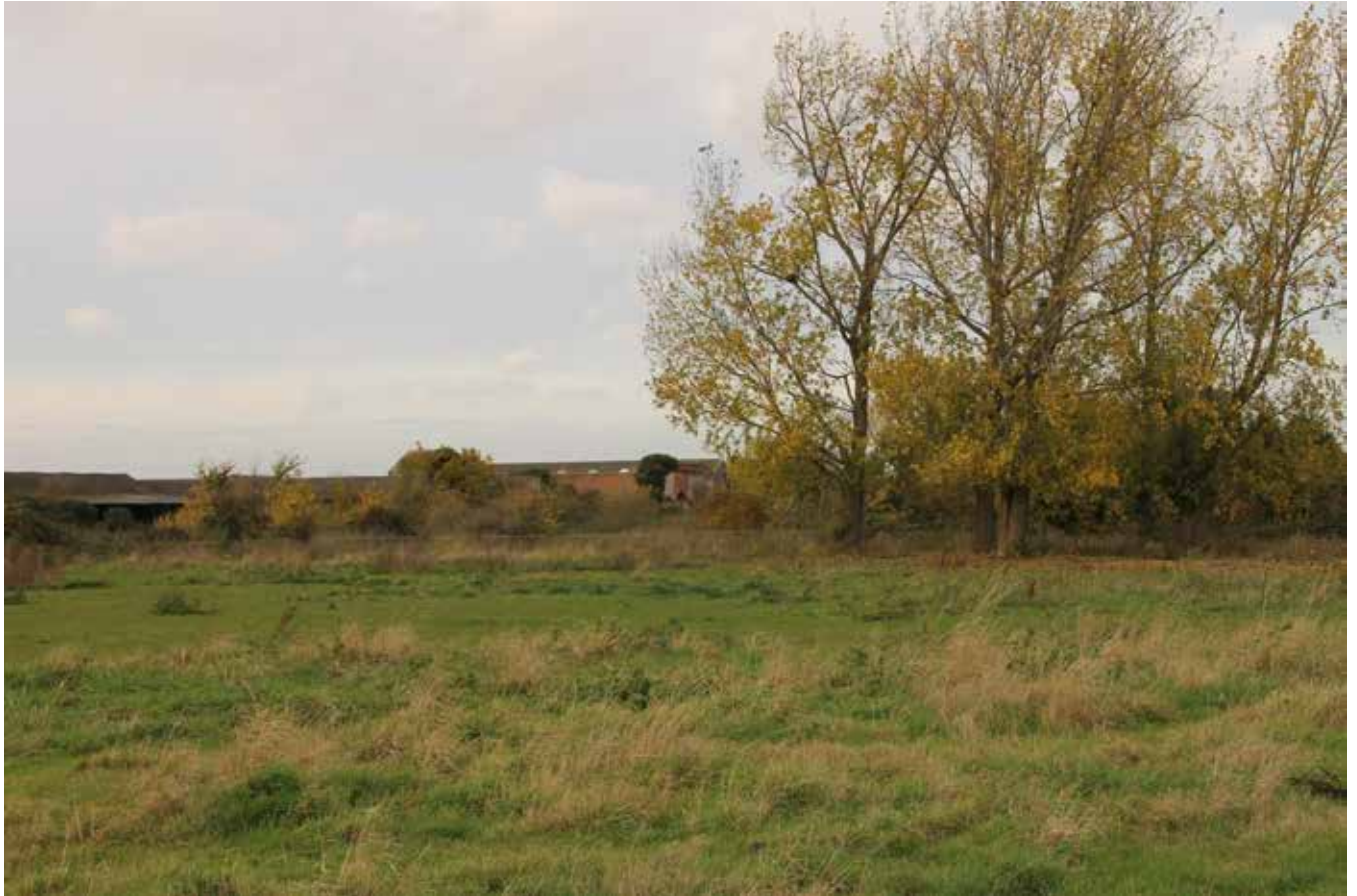
View 5: Looking from the footpath north-westwards across the moated area to the farmyard, the rear of the Scheduled gatehouse is visible in the centre of the photo

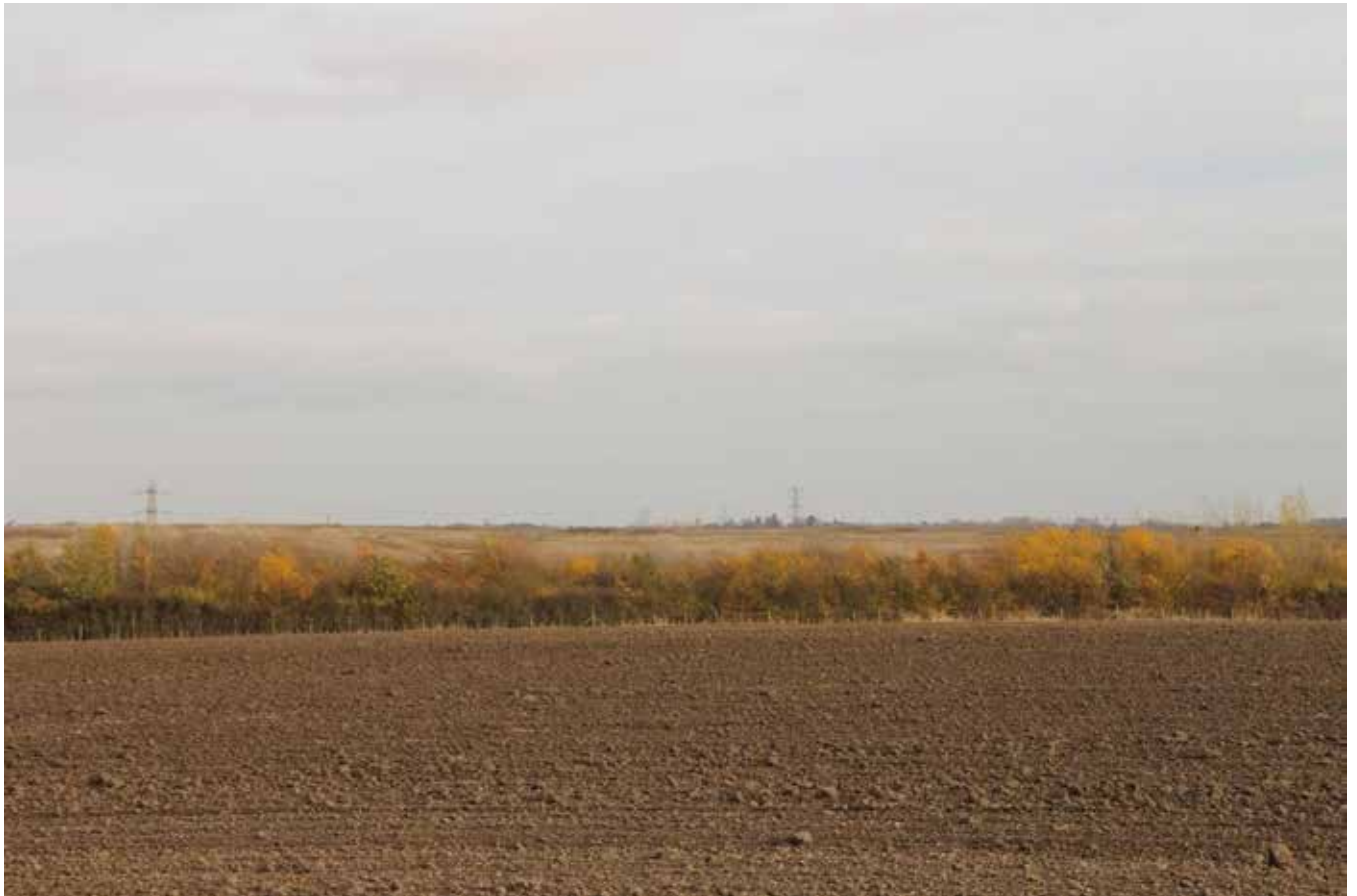
View 6: Looking from the footpath to the south-east, showing the raised levels relating to the reinstated quarries, the cranes of the London Gateway port are visible on the horizon

pair of farm cottages. To west there is open arable farmland with the historic settlement of South Ockenden beyond. These together make a major positive contribution to the setting of the monument. The land to the east and south-east has been quarried, and in part reinstated as agricultural land, altering the contour of the land in this area, the quarry immediately adjacent to the site is still being reinstated and is screened from the site by a thick belt of trees. They represent a moderate negative impact to the setting of the heritage asset.

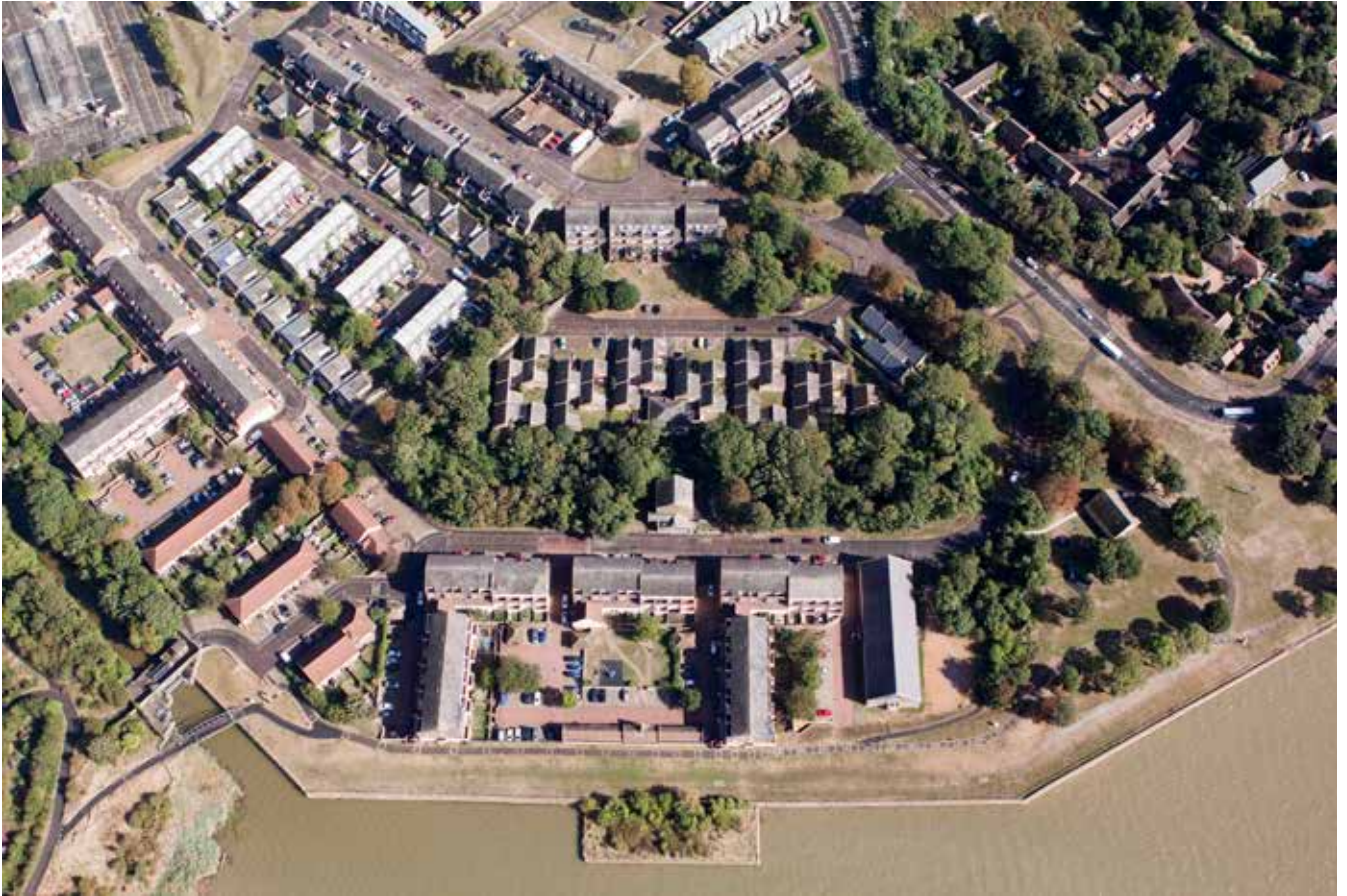
Figure 21 Location plan showing the principal views to and from the monument

Figure 22 Aerial view of Purfleet Magazine looking north, showing its Thameside setting.

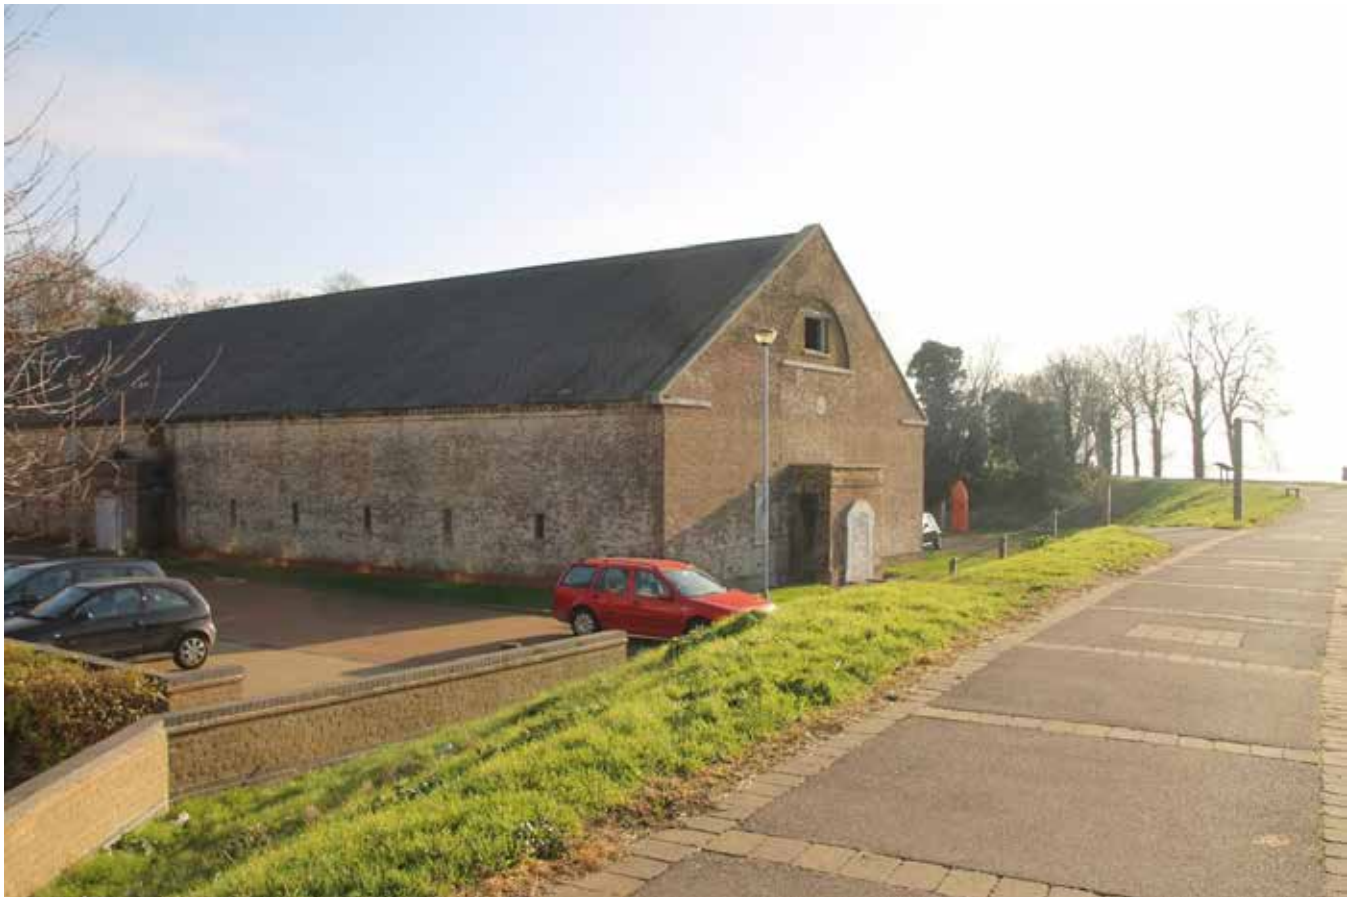
View 1: View looking southwards along the seawall to the Magazine building and beyond to the corner of the park and the Thames

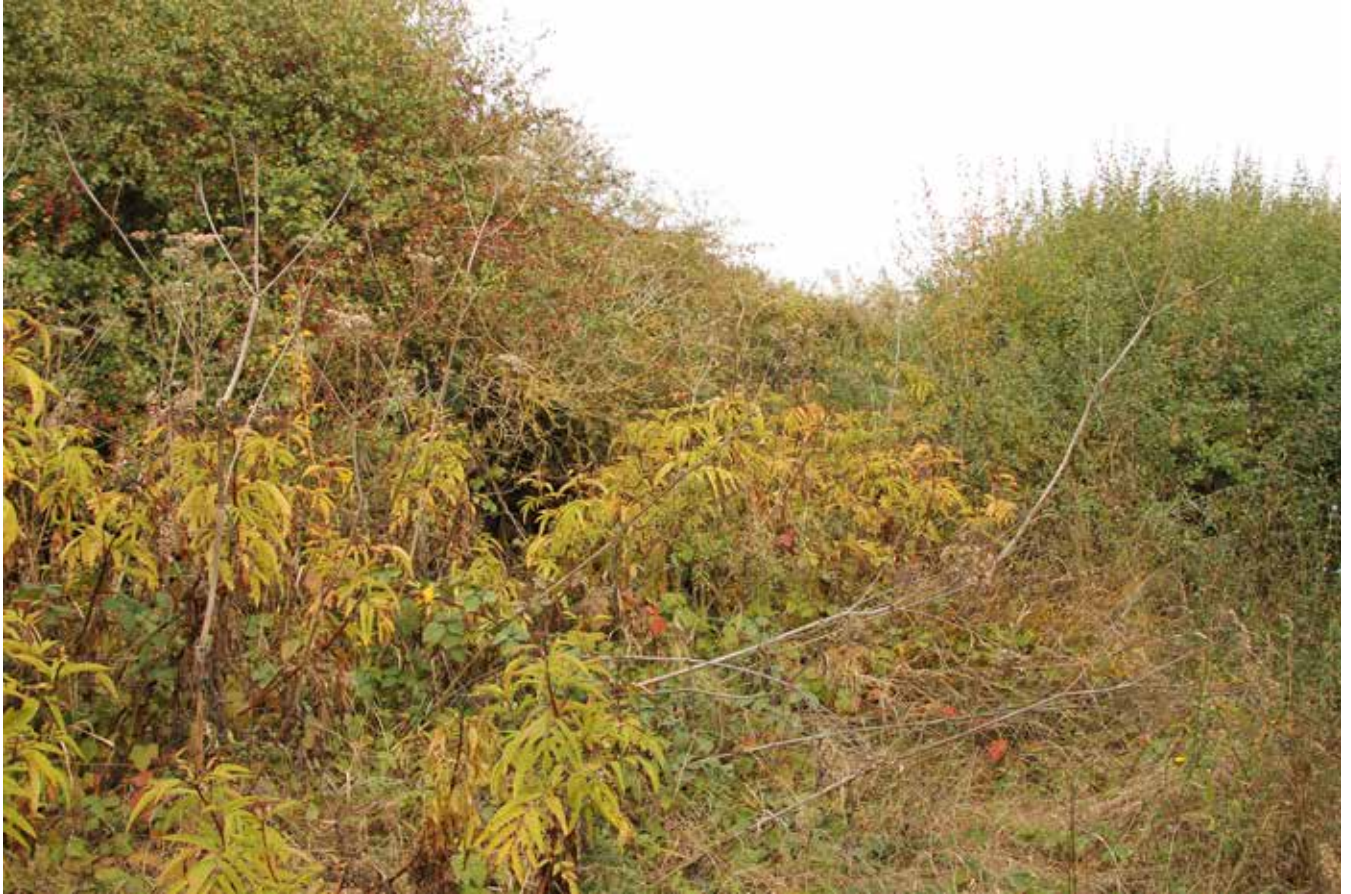
Figure 25 Plan showing the location of the battery and the principal views in and out of the monument. Also shows the other scheduled monuments in immediate vicinity (other significant views are indicated by the smaller view-point symbols)

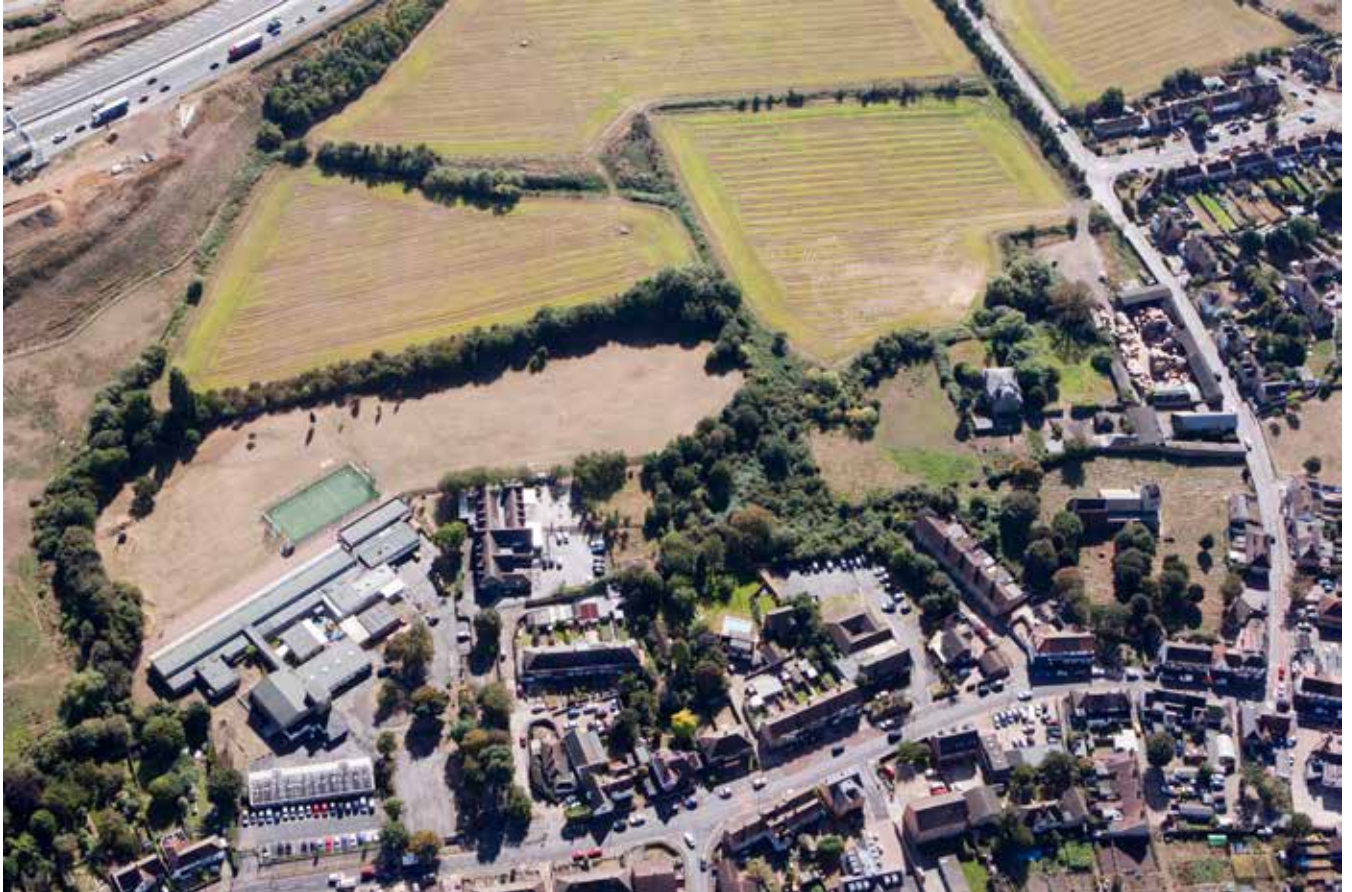
Figure 27 Location plan showing the principal views to and from the monument (other significant views are indicated by the smaller view-point symbols)

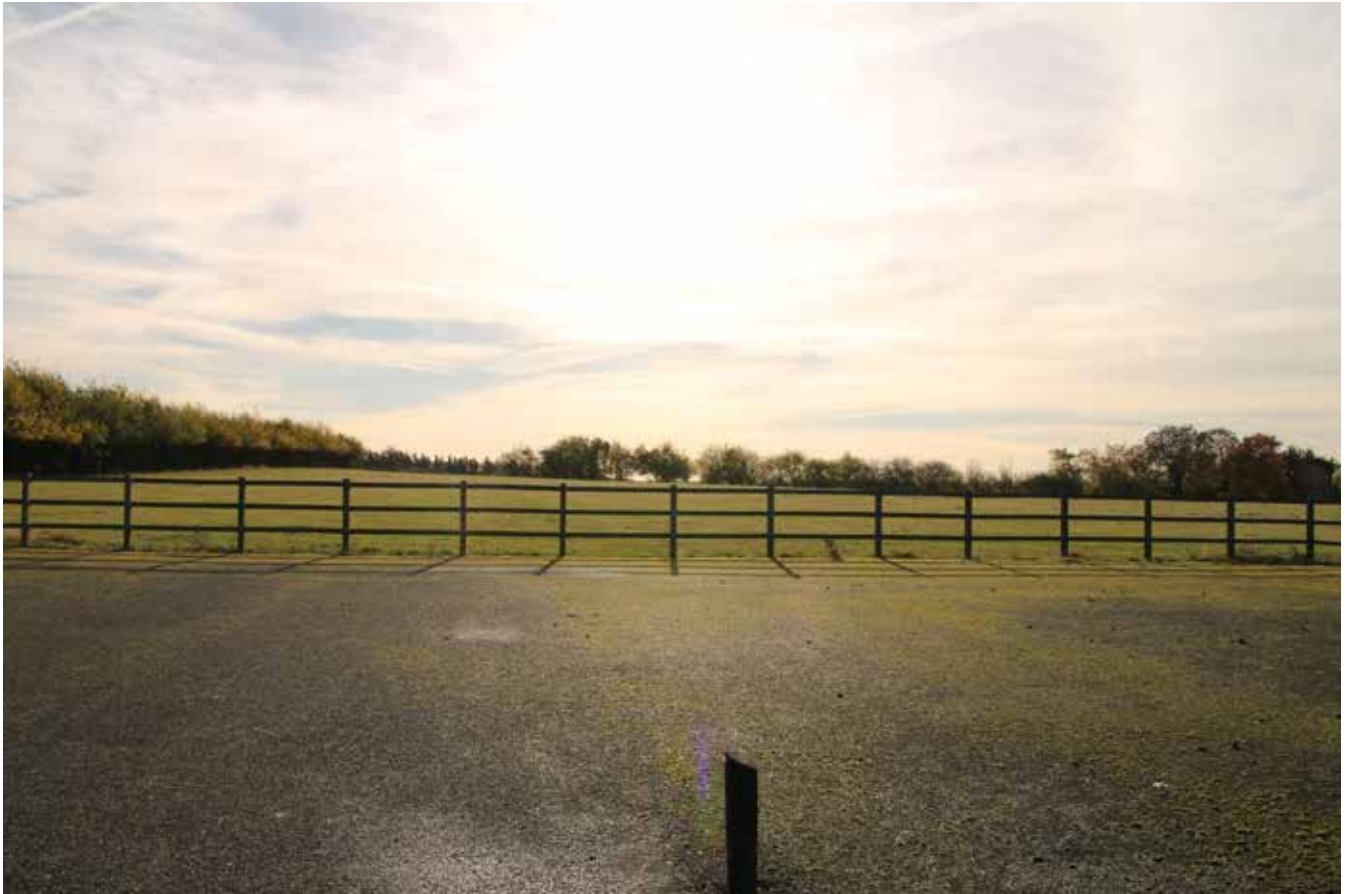
Figure 29 Location plan showing the principal views to and from the monument

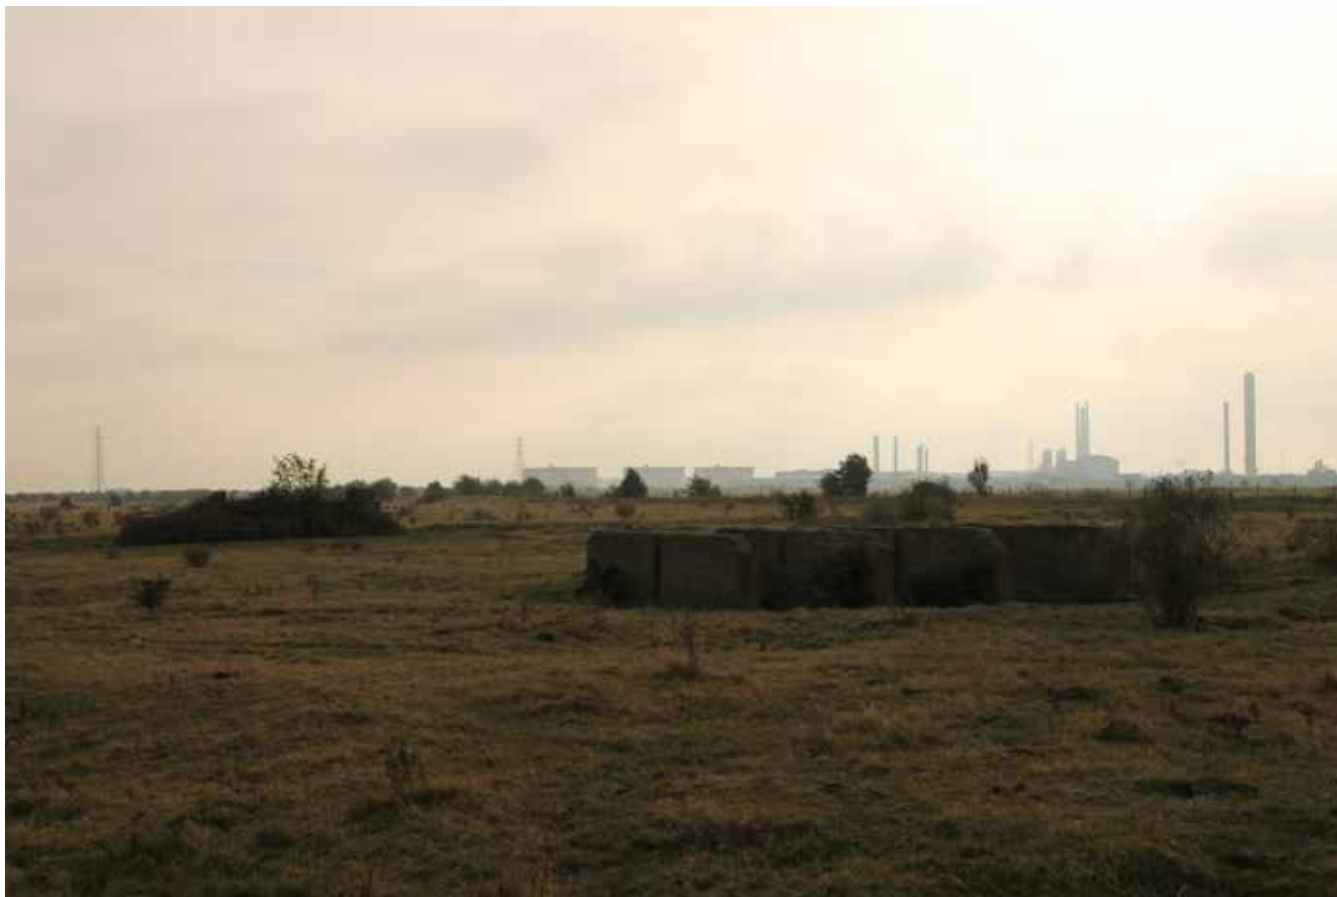
Figure 33 Location plan showing the principal views to and from the monument

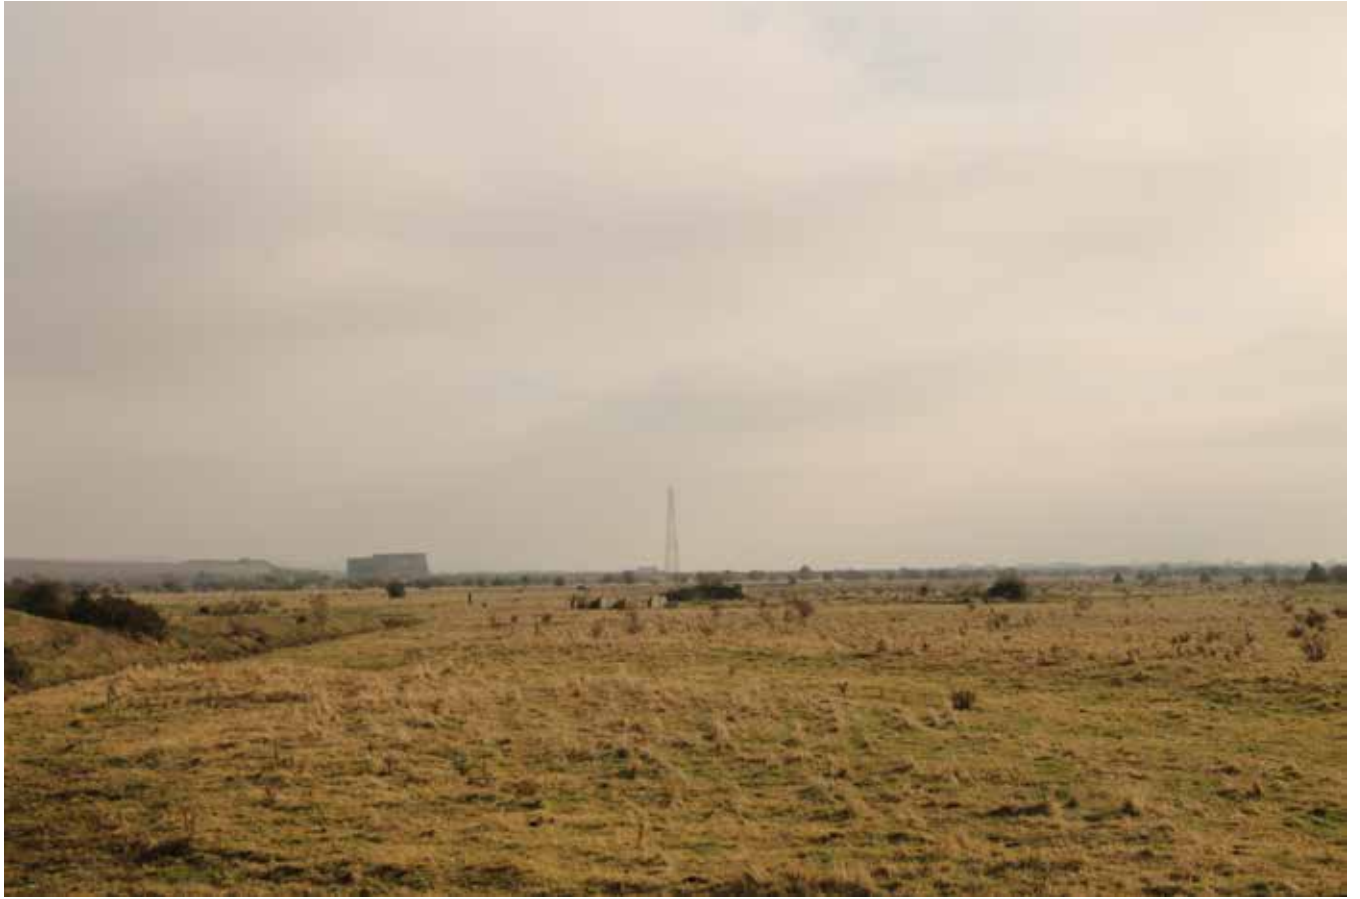
View 4: View to the east from the night-shelter to Canvey Island showing the open aspect of the marshland in this direction. The structure in the middle distance is the flood barrier on Holehaven Creek. The raised ground to the left of this is the Canvey Island land-fill site

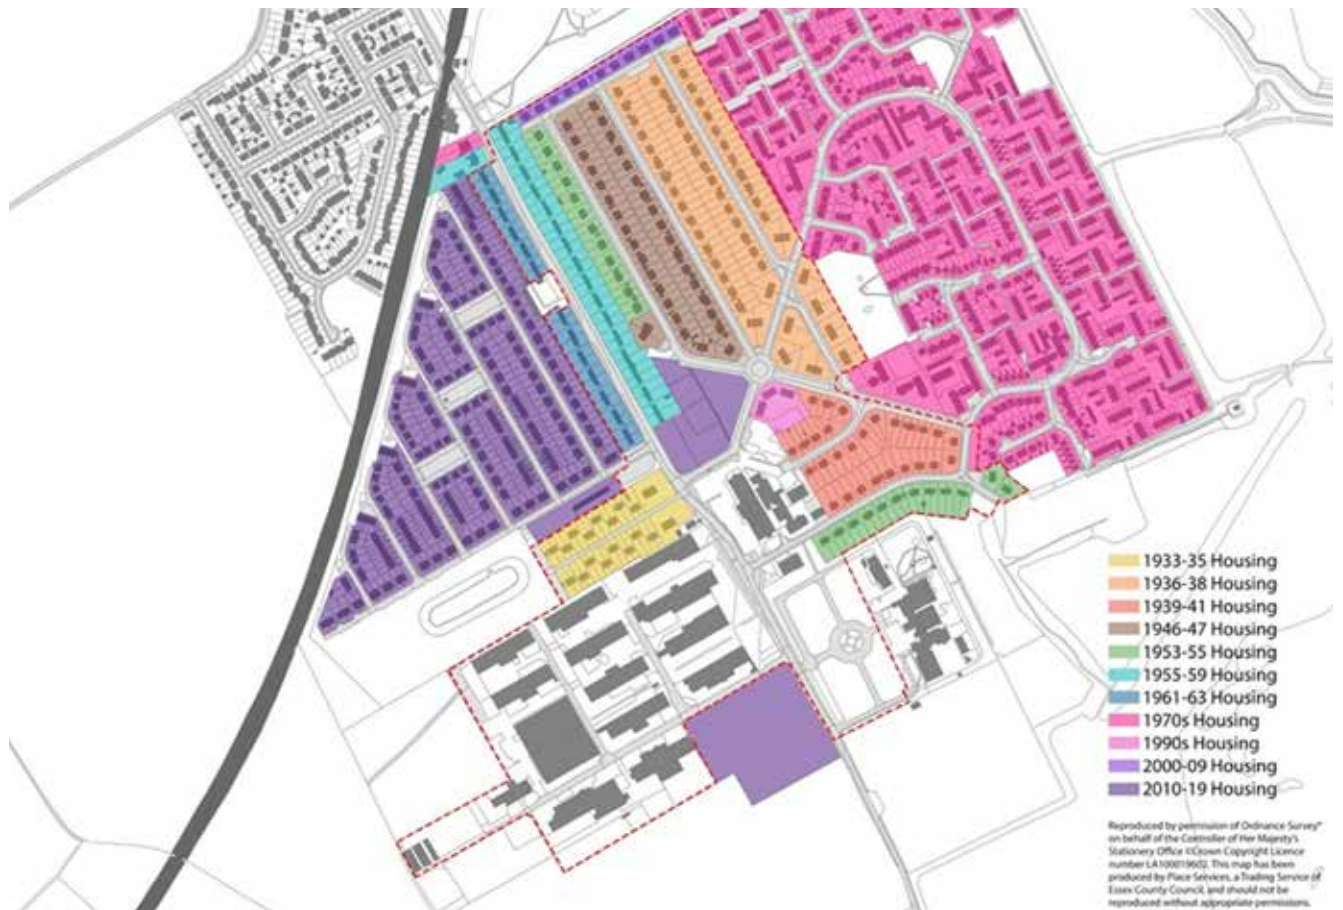
Figure 8: Housing phasing map

Housing was built in stages between 1933 and the mid-1960s (Figure 8). The oldest properties (located in Bata Avenue) are very much in the Czech style and set in a staggered 'chequerboard' layout to maximise the garden space to each property. Early properties such as those on Queen Elizabeth Avenue are exact copies those in Zlin with standard materials such as doors, windows, internal joinery and electrical fittings being imported from Czechoslovakia.

limited available materials. Following the end of World War Two, the construction of flat roofed Czech Modernist houses resumed, though utilising standard British materials. The properties to the south of Gloucester Avenue continued as pitched roof houses, presumably to match those constructed during World War Two across the road. By the late 1950s and early 1960s the Bata houses represented a more English taste .

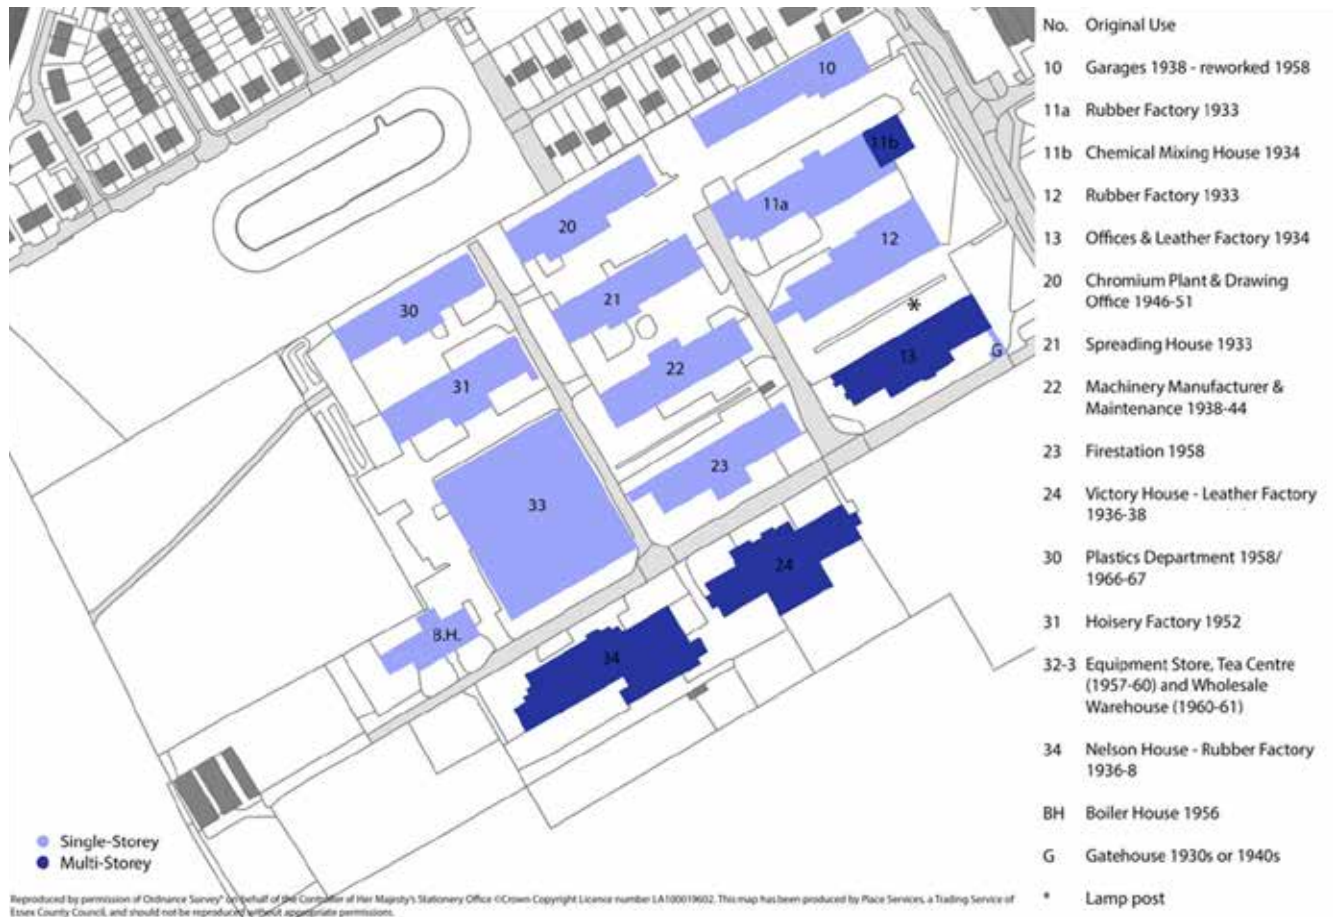
Figure 9: Factory Phasing Map

The factory buildings were constructed at East Tilbury between 1933 and 1968 and are laid out in a grid pattern with structures rising to five stories in height (Figure 9).

Building 12, a former rubber factory, was the first to be constructed and is a single-storey steel-framed building which was designed in Zlin with the steel being imported from Czechoslovakia. Buildings 10, 11a, 12 and 21 are all constructed in this manner between 1933 and 1938. The multi-storey buildings (Buildings 11b, 13, 24 and 34) were erected between 1934 and 1938 using reinforced concrete frames in defined modules, a standard design transferred directly from Zlin. The other factory buildings are single-storey, either in steel or concrete, and dating from 1948-52. The final building to be constructed on the factory site was the Computer Centre in 1967 (since demolished).

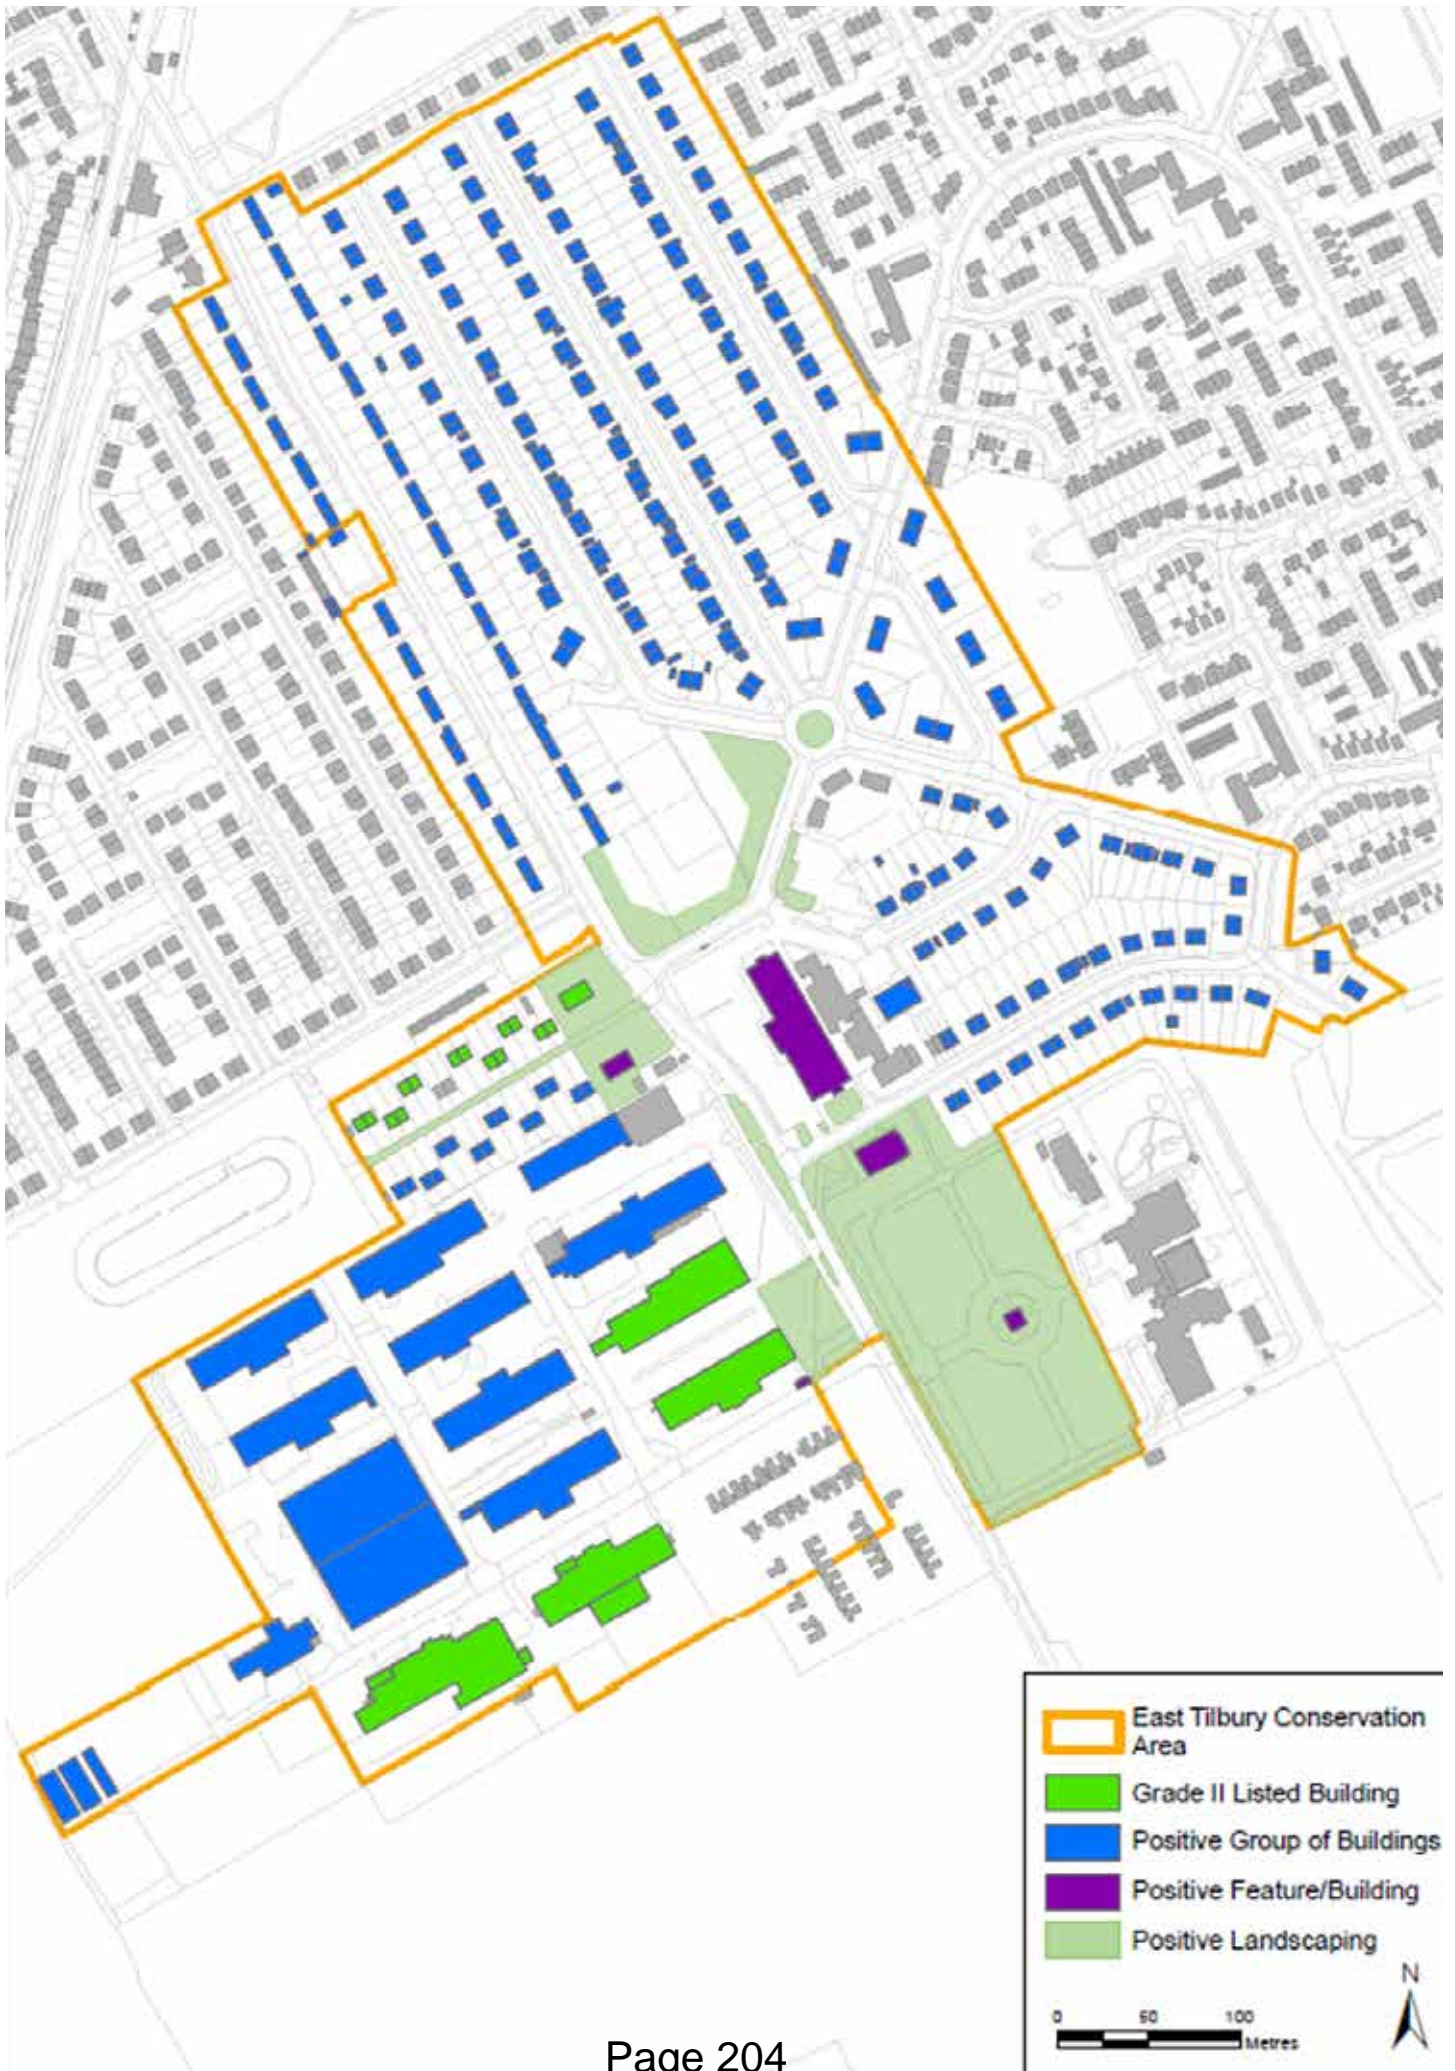
Figure 13: Map of significance and contributors
