Planning, Transport, Regeneration Overview and Scrutiny Committee

Page
1. Apologies for Absence	
2. Minutes	5 - 20
To approve as a correct record the minutes of the Planning, Transport, Regeneration Overview and Scrutiny Committee meeting held on 4 July 2023, 30 August 2023 (Extraordinary) and 28 September 2023 (Extraordinary).	
3. Items of Urgent Business	
To receive additional items that the Chair is of the opinion should be considered as a matter of urgency, in accordance with Section 100B (4) (b) of the Local Government Act 1972. To agree any relevant briefing notes submitted to the Committee.	
4. Declaration of Interests	
5. Thurrock Scheduled Ancient Monuments: Assessment of	21 - 176

The Thurrock Scheduled Ancient Monuments: Assessment of Settings is a technical baseline document that provides a detailed assessment of the significance and setting of these Scheduled Ancient Monuments (SAMs), as well as initial recommendations as to how the setting and significance of each SAM can be preserved and enhanced. It has been prepared to support the plan-making process as well as to better enable evidence-led decision making within Development Management.

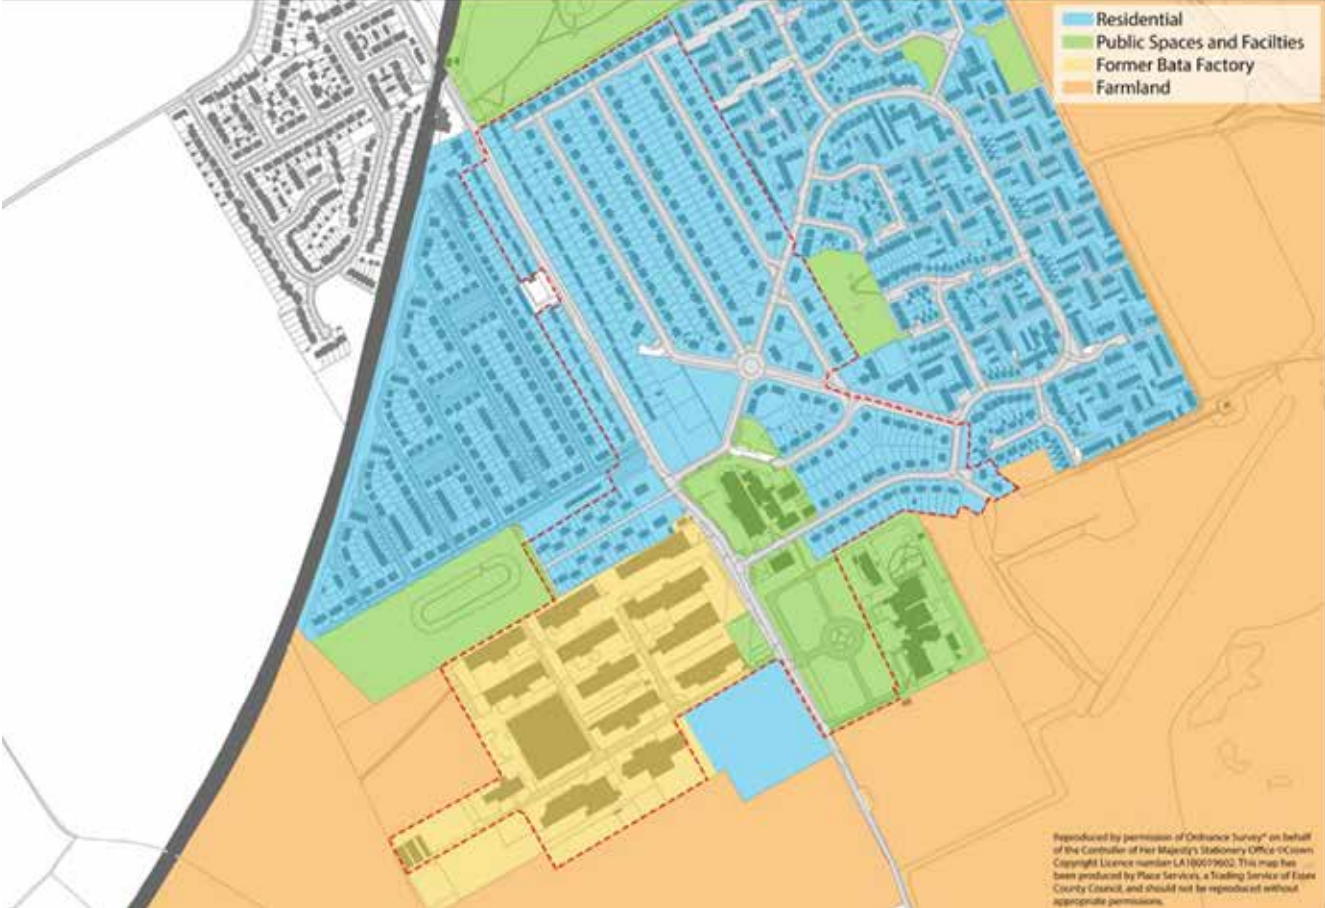
Figure 14: Functional Zoning Map (2019)

The zoning of functions (work, leisure and home) is an integral and unique feature of East Tilbury, with each element contributing to the whole. Retaining these different functions is vital to the preservation of the area’s significance. For example, by continuing to use the factory site as workspace and through the enhancement of leisure and social facilities, designated areas of land use can be retained, and the masterplan understood.

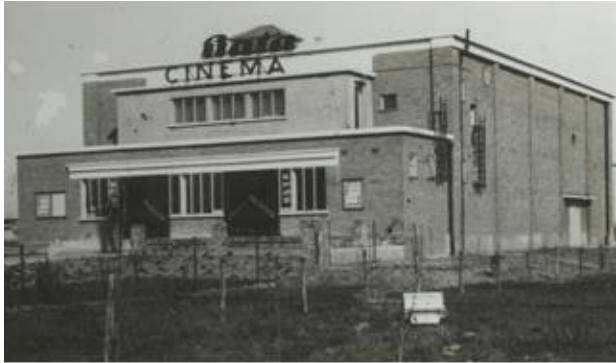
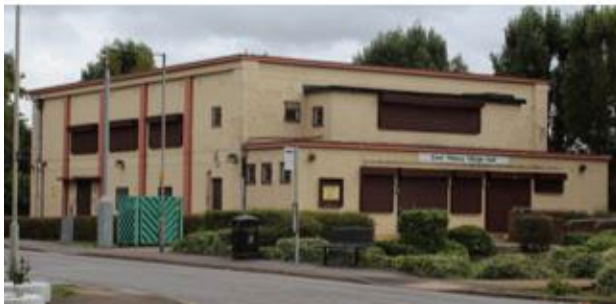
East Tilbury Village Hall occupies the original Bata Cinema building constructed in 1938 and retains its characteristic blocky two storey frontage with hall behind. In use as a cinema until 1965, it was converted to the Village Hall in 1967 and was refurbished in the late 1990s following a successful Heritage Lottery Grant bid. Despite some unsympathetic alterations, including external shutters, loss of original signage and installation of modern signage, it still retains much of its original detailing deriving from its structural elements and fenestration arrangement. The building is in a deteriorating condition and suffers from vandalism and graffiti, but it still contributes positively to the conservation area and presents an opportunity for enhancement .

Figure 24 & 25: Bata Cinema © Bata & East Tilbury Village Hall

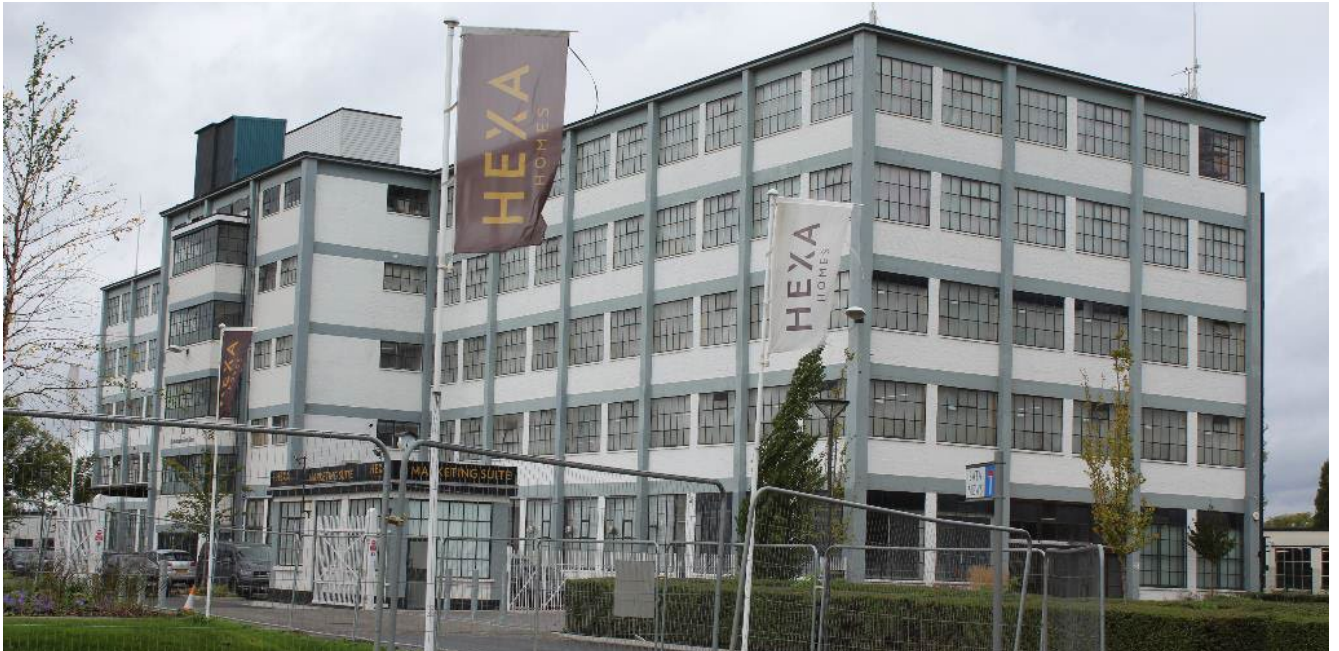
Figure 37: Bata Factory Building 13, former Offices & Leather Factory (1934)

The three largest buildings on the factory site are **Victory House: former Leather Factory (1936-38)** (factory building no. 24), **Nelson House: former Rubber Factory (1936-38)** (factory building no. 34) and the former **Offices & Leather Factory (1934)** (factory building no. 13). These buildings are very characteristic of the modernist movement style and mirror the design and scale of building in the parent company town of Zlin. The characteristic pale blue and white buildings and surviving red 'Bata' logos within the factory complex at East Tilbury are visible in long views afforded by the flat landscape. Due to their height and position along Princess Margaret Avenue, the **Bata Factory Buildings 12 (former Rubber Factory (1933)) and 11a & 11b (former Rubber Factory (1933) and Chemical Mixing House (1934))** are landmark buildings within the Conservation Area along with the Bata Factory Building 13, whilst **Bata Factory Buildings 24 and 34** command views from both within and outside the Conservation Area.

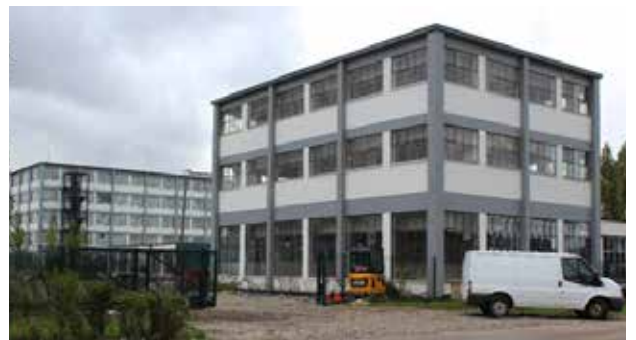
Figure 38: Bata Factory Buildings 11a & 11b, former Rubber Factory (1933) and Chemical Mixing House (1934)

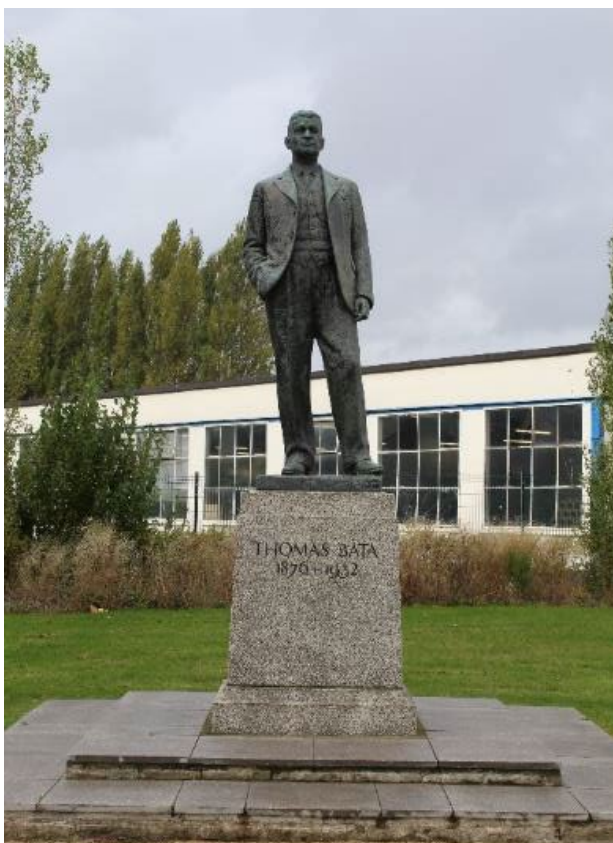
Figure 40: Thomas Bata Statue

The **Thomas Bata Statue** stands on one of the paths within the Factory Garden. It is a bronze full height figure, sculpted by Joseph Hermon Cawthra and unveiled in 1955. It makes a positive contribution to the conservation area due both to its aesthetic value and as a visual reminder of the founder of the Bata settlement in East Tilbury.

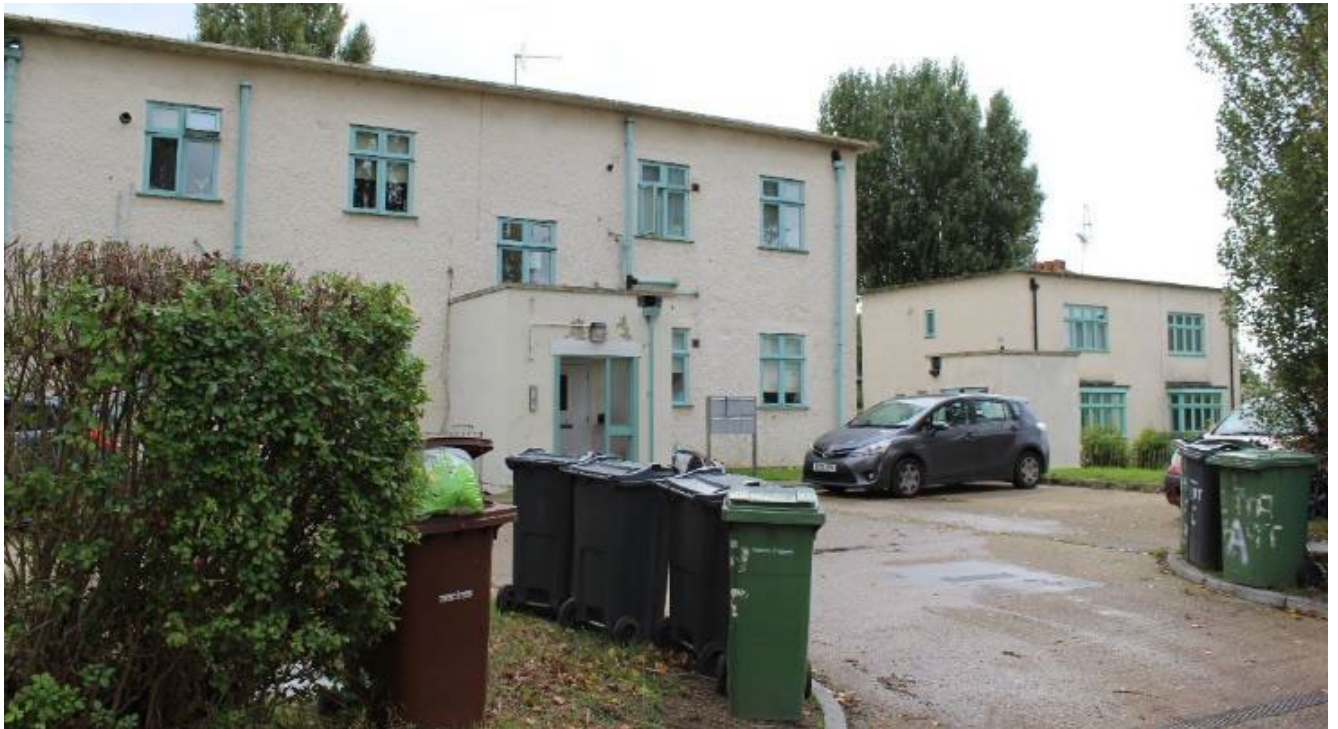
Figure 45: Number 1 Bata Avenue

These properties are the oldest houses on the estate. Although some of the houses closest to the factory site were demolished by Bata, they were replaced with replicas of the originals. The remaining properties on the other side of the avenue, have been listed as buildings of Special Architectural or Historic Interest (Grade II). The late twentieth century replacement buildings have successfully replicated the Bata Avenue character; their spacing, staggered building line, scale, style and detail all successfully mimic the original houses.

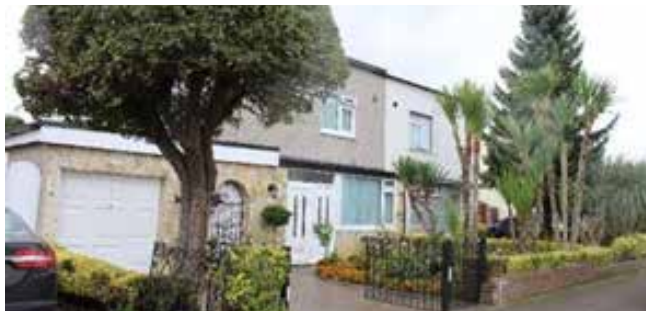
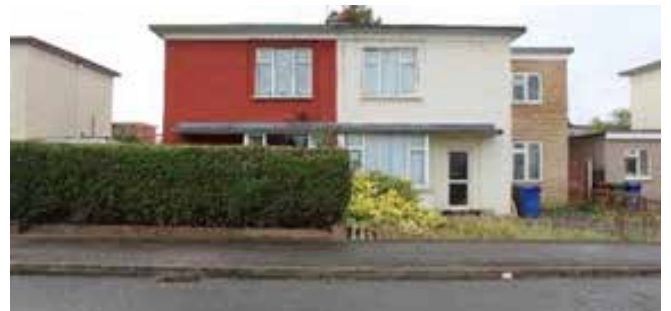
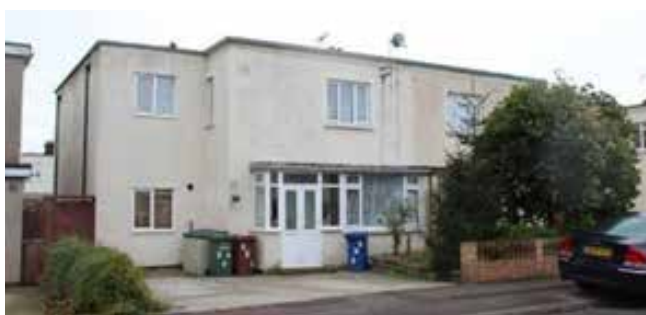
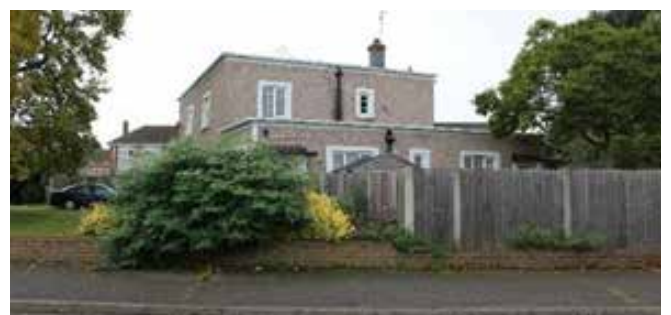
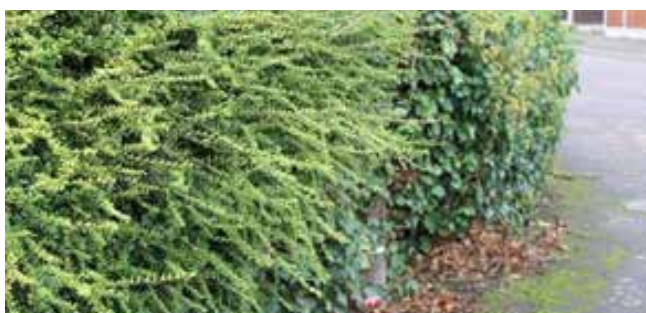
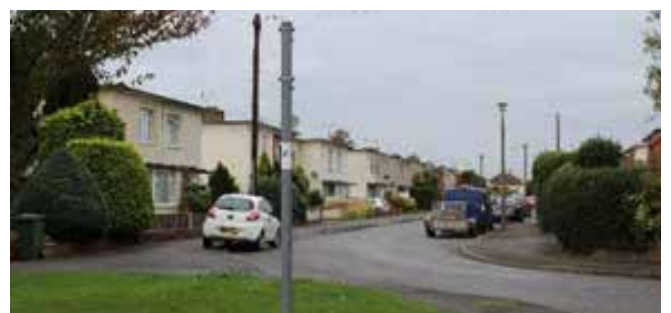
Figure 47-52: Character palette for area 4.

rendered. These variations in external house finishes are in legible blocks and represent three phases of building (1936-1938, 1939-1941 and 1953-1955). Originally, the doors and windows of whole streets were fitted with a standard design. There is some evidence of original doors and windows, however, most have been replaced with new double-glazed units of various styles and designs. There was some variety in the original styles, some of which were first installed to open inwards, which may explain why some adjoining properties had slightly different window types although original or mimicking the original design.

Many properties have had extensions or porch additions, some with pitched roofs.

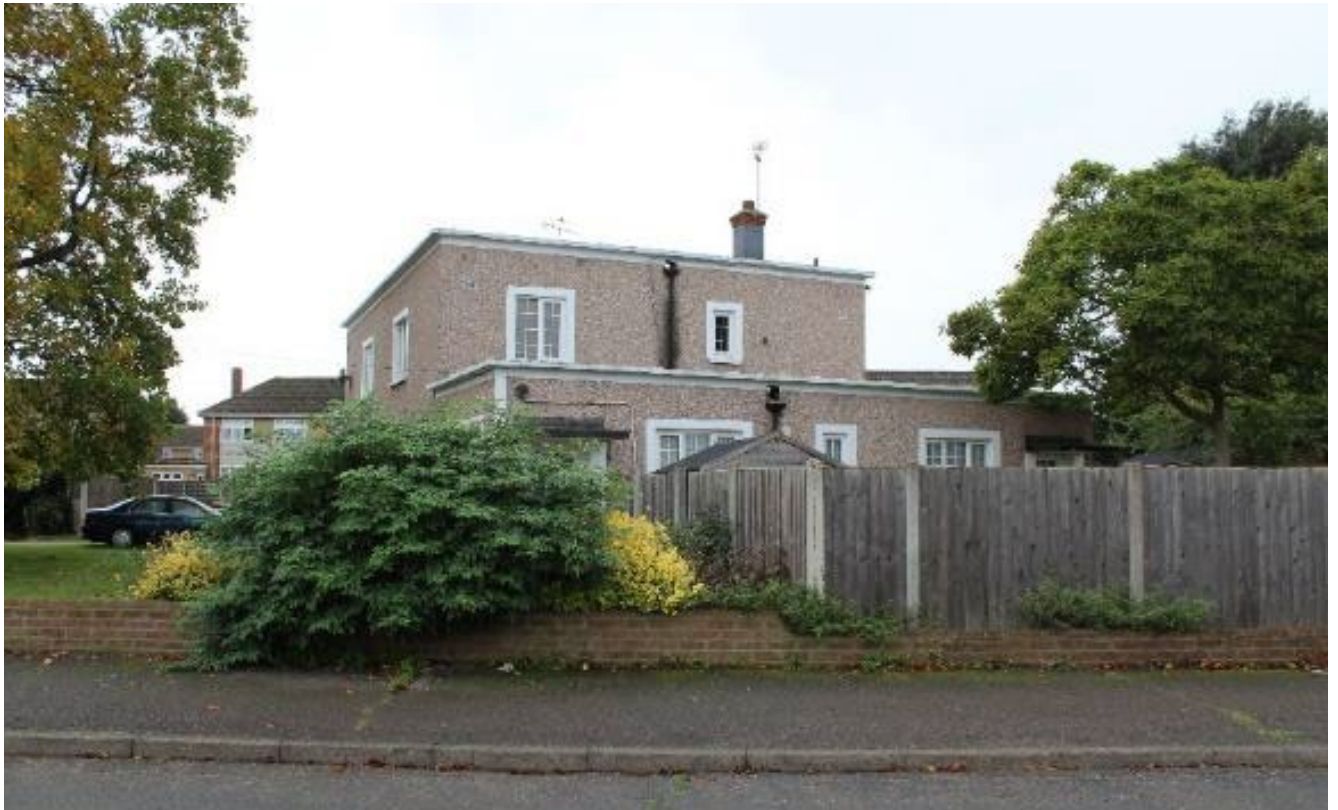
Figure 53: Large corner plots to the south of the Character Area

While the majority of the buildings within this area are significant for their group value, there are a number of buildings located in larger, prominent plots which are notable in their own right. At the roundabout where the five main routes through the area meet, four Bata houses with balconies overlook the focal point of this crossing. Another building at the south of Bata Avenue (1 and 1a) is also orientated to overlook the street. These plots are typically orientated against the grain of the majority of development in the area and are planted with mature trees.

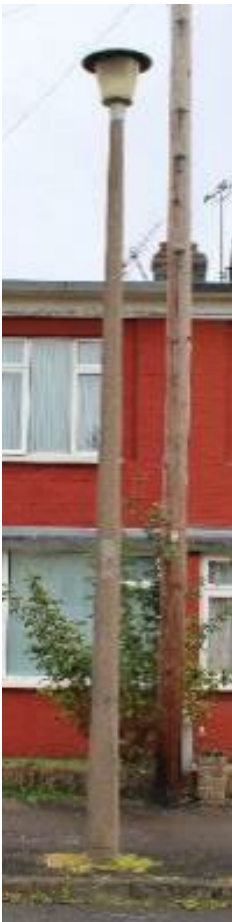
Figure 55: Lamp posts

Walls delineate the boundaries of the front gardens of the properties. Often backed by hedges, these were characteristic of the original landscaping. Boundary treatments are predominantly low, single courses of brick walls, usually in sand-faced bricks. Many boundary walls have been partially removed facilitate off road car parking or vehicular access to garages, but they remain an important design detail of The Avenues. Another unifying feature is the type of lamppost used in all parts of the Conservation Area (except Princess Margaret Road). Some lampposts have been replaced with modern units which detract from the character of the area and the appearance of the streetscene.

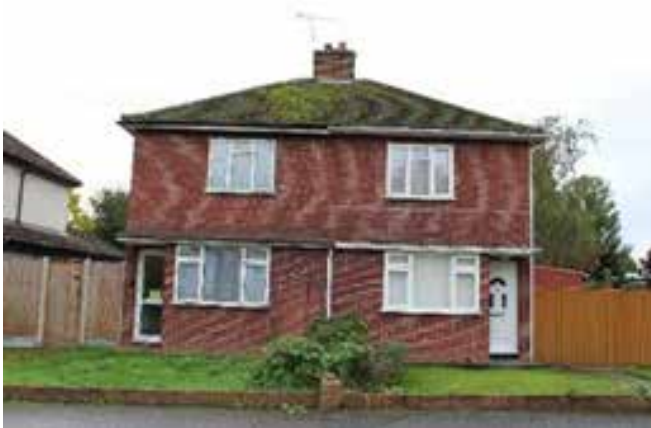
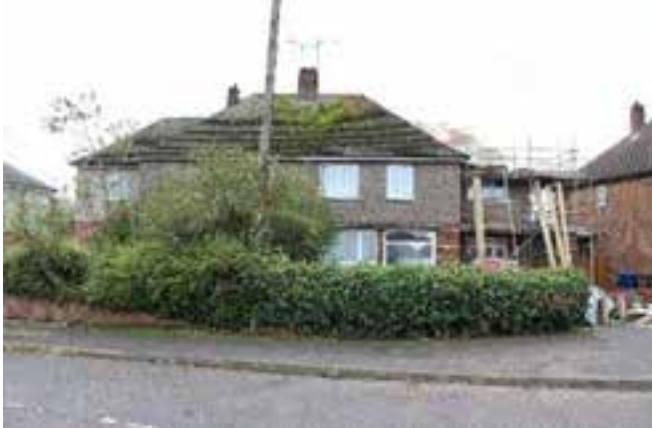
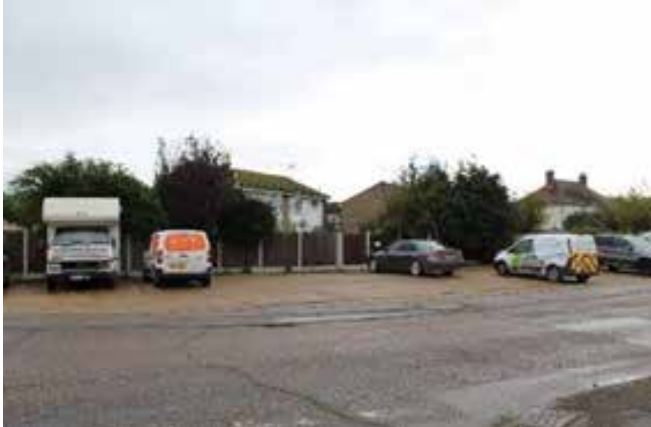
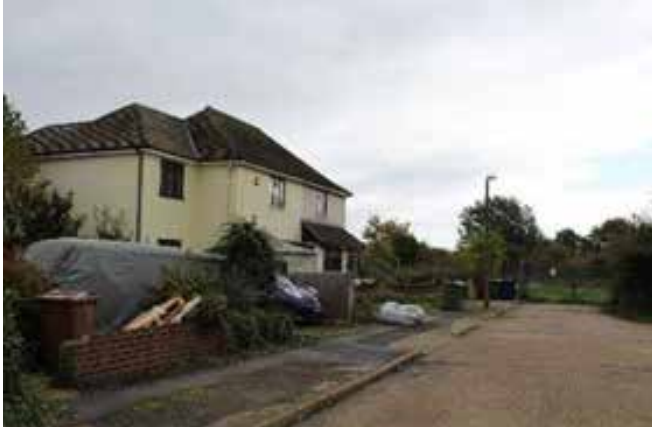
Figure 57-60: Character palette for area 5

Mary Avenue) are arranged in semi-detached pairs under hipped concrete tile roofs with a central chimney stack. Constructed from brick, there are three types of elevational treatment: brick; brick at ground floor with roughcast render at first floor level; and roughcast render with brick quoins. Those constructed between 1953-55 (south side of Gloucester Avenue) are similar but with additional smaller chimneys to the rear and either a pebble-dashed front elevation or pebble-dashed at first floor level.

The vast majority of properties have replacement windows and a number of these properties have been altered or extended. As a result, the sense of consistency and uniformity, which is a key characteristic of the Conservation Area, has been eroded.

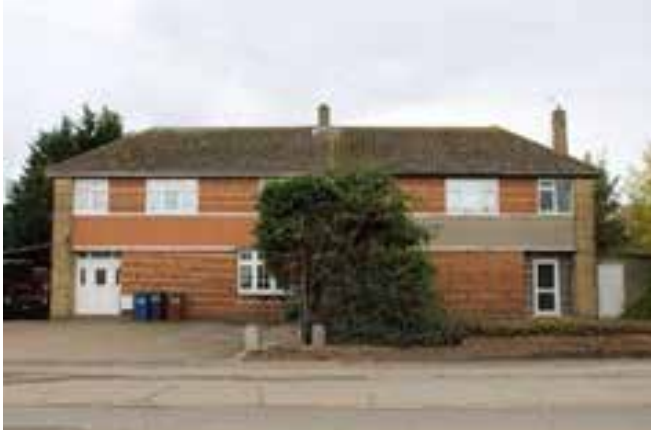
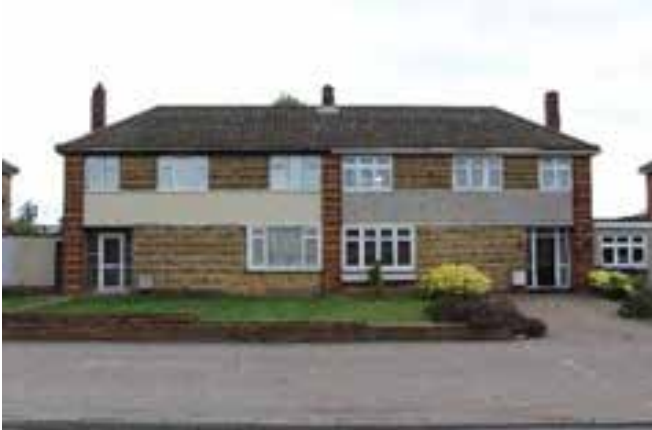
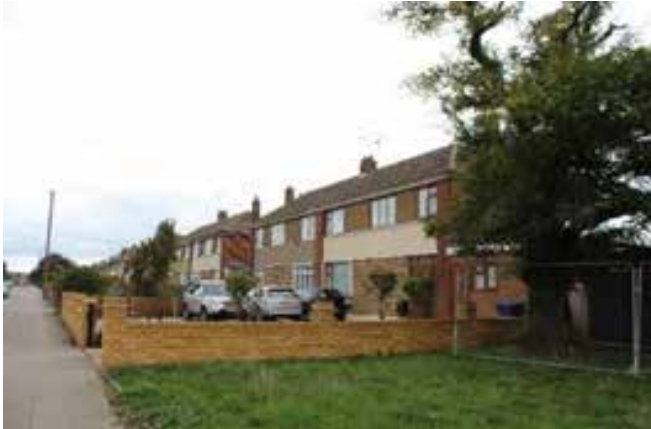
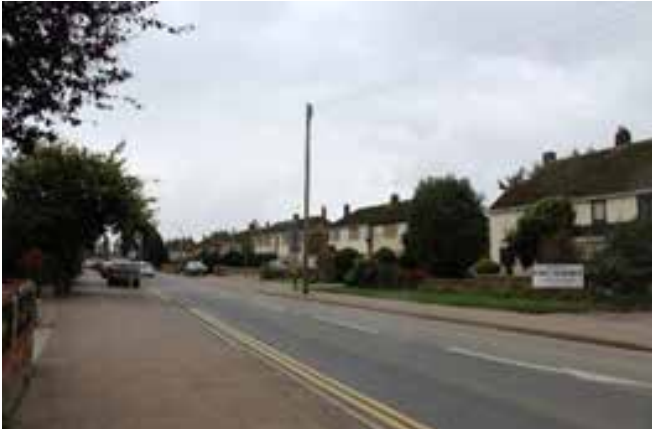
Figure 61-64: Character palette for area 6

The houses form semi-detached pairs under hipped concrete tile roofs with a central and two end chimney stacks. The elevations are constructed in alternating two-tone brickwork with a rendered band between ground and first floor levels. The decorative red and yellow brickwork at ground floor level adds interest to the front facades and the character of the streetscene. Some houses retain the original glass brick detailing beside the front door.

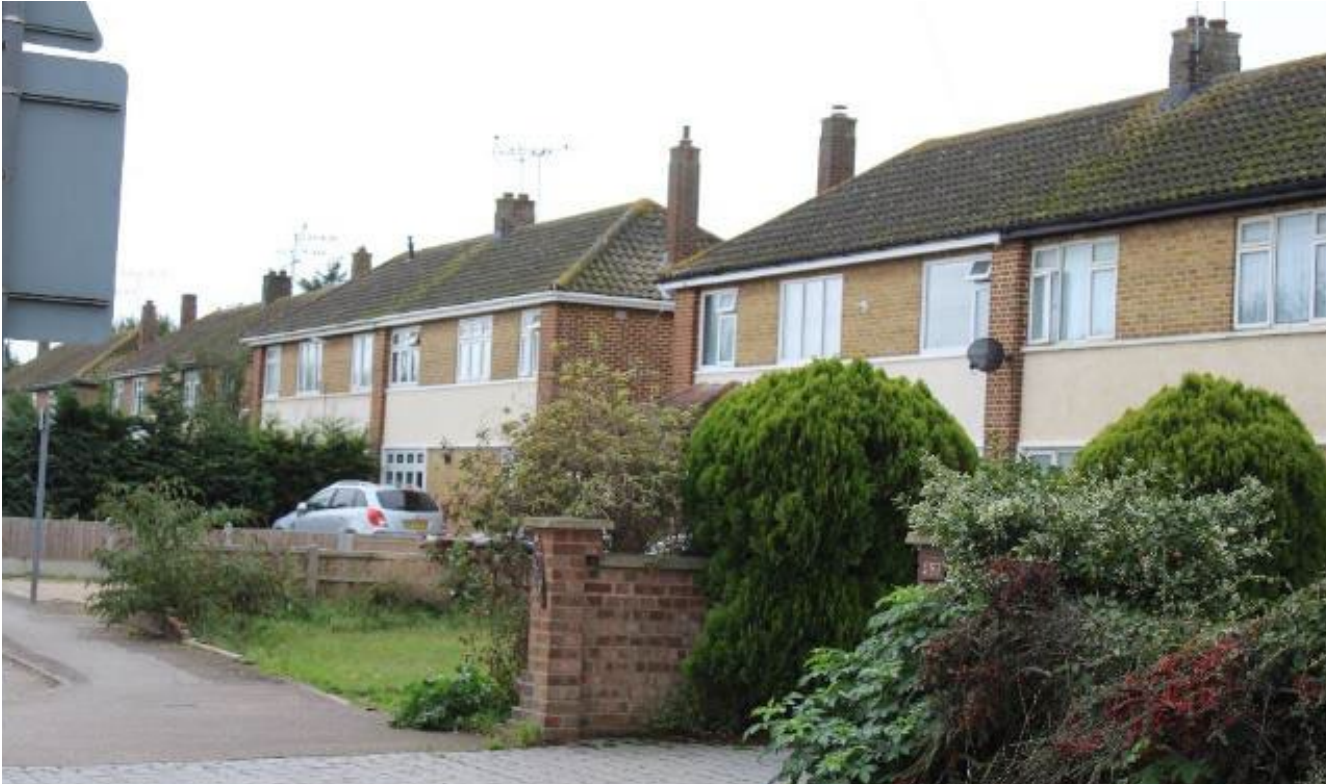
Figure 65: Boundary treatment and garden planting

The wide front gardens contribute to the green aspect of the streetscene and are the main element of landscaping within this Character Area. The boundary walls were originally in sand-faced bricks, however, many have been replaced and there are now contrasting materials and colours creating a piecemeal approach to the detriment of the once uniform character of the streetscene. The majority of gardens are well maintained and contain mature trees, making an important contribution to local amenity and the overall character of the Conservation Area.

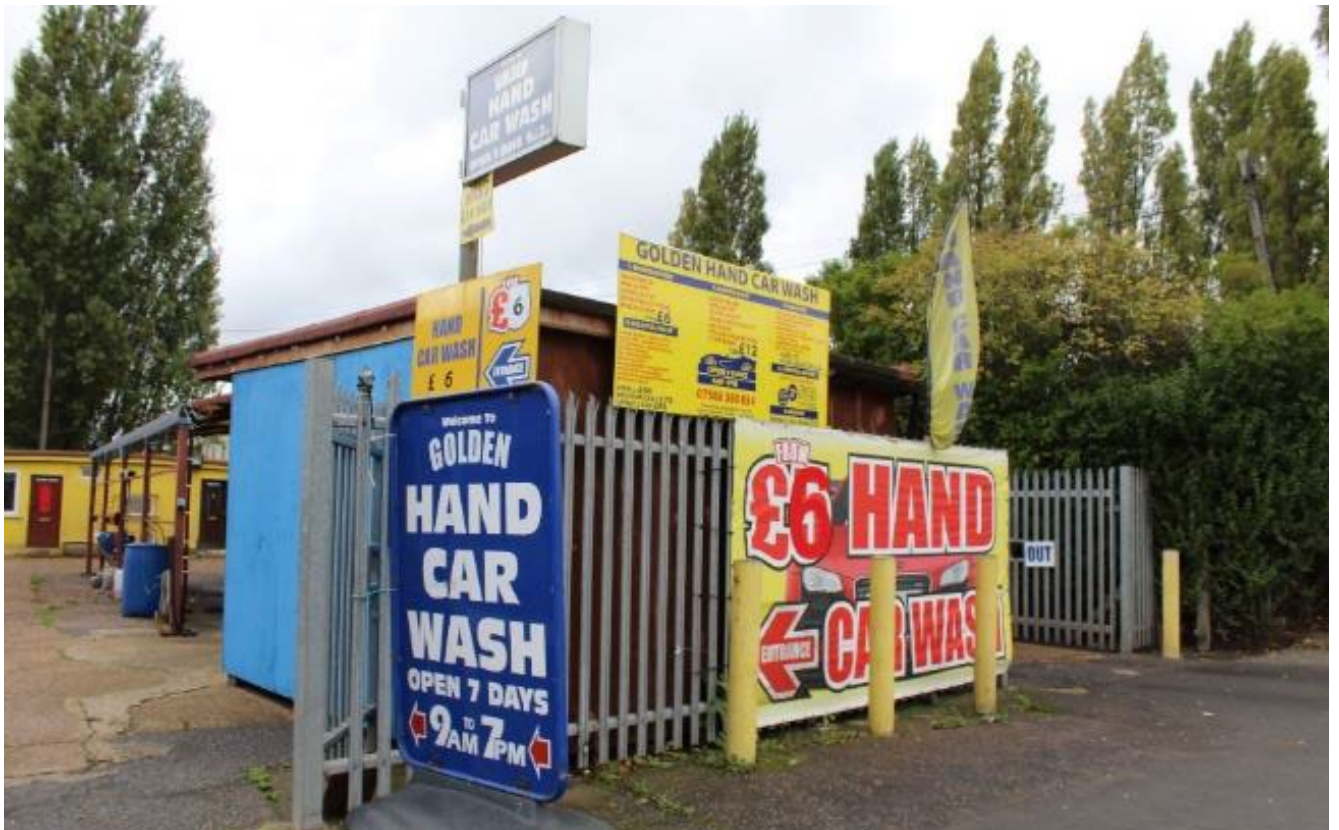
Figure 71: Unsympathetic signage in the Conservation Area

The site of the former Bata Auto Garage, now occupied by a hand car wash, is highly visible from the Central Core (Character Area 1) and detracts from the character and appearance of the Conservation Area in its present form. Alterations to the building, the signage and railings are unsympathetic and detract from the streetscene. There is an opportunity to improve the appearance of this site through the replacement of signage and railings with more sympathetic alternatives.

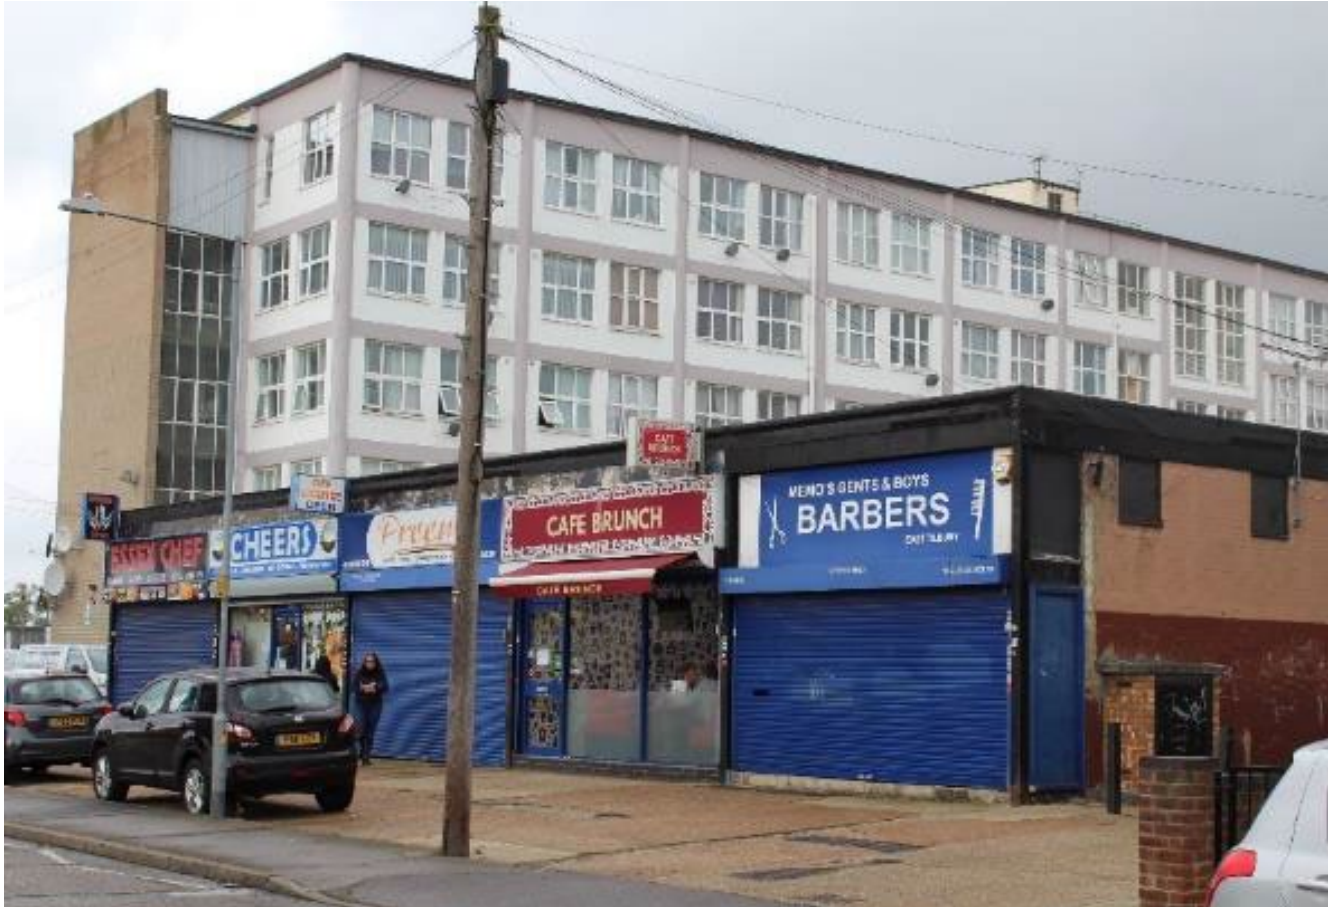
Figure 72: Former Espresso Bar

Former Espresso Bar (now shopping parade)
The former Espresso Bar now contains five retail units with modern signage and external shutters. It has been heavily altered and in its current form has a detrimental impact upon the character and appearance of the Conservation Area due to inappropriate alterations and the loss of the building's original appearance. Whilst the use of the building has changed, it still serves an important social function and the sympathetic replacement of signage could enhance the appearance of the building and the contribution it makes to the Conservation Area.

As noted above, there are examples of poor quality and unsympathetic signage within the Conservation Area, predominantly on the former Espresso Bar and Stanford House, which detract from the area's character and appearance. Shopfronts and signage have been renewed on a regular basis as successive retailers have made alterations. The majority of inappropriate shopfronts have attempted to impose a standard brand without consideration of the character of the area and detrimental impact a standard approach can have on the buildings and wider streetscene.

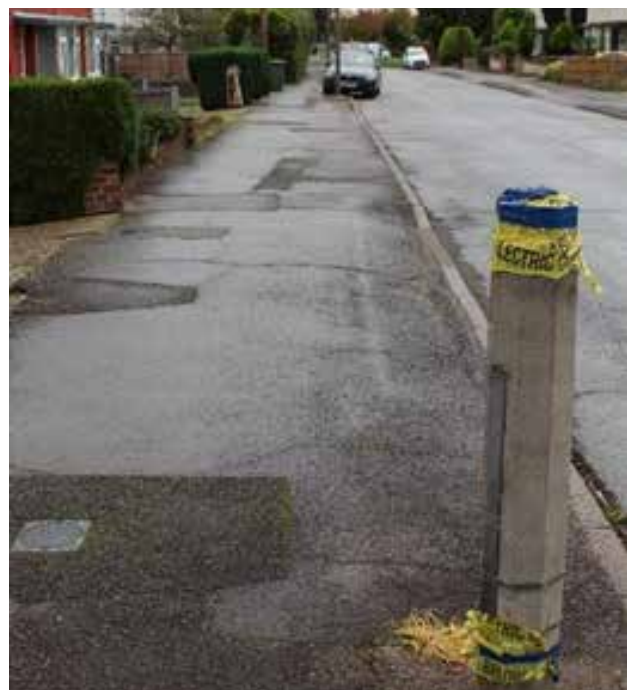
Figure 75: Loss of street furniture

Some parts of the Conservation Area lack a consistent style of street furniture with a varied mix of styles, ages and condition. The loss of original Bata lampposts and benches and their replacement with inappropriate alternatives detracts from the character and appearance of the Conservation Area through the loss of historic fabric and undermining the uniformity of streets.

The replacement of modern lampposts and benches with faithful replicas is an opportunity to enhance the character and appearance of the Conservation Area.

Planning and Highways should work together to agree standard street furniture to ensure consistency over time as elements are introduced or replaced.

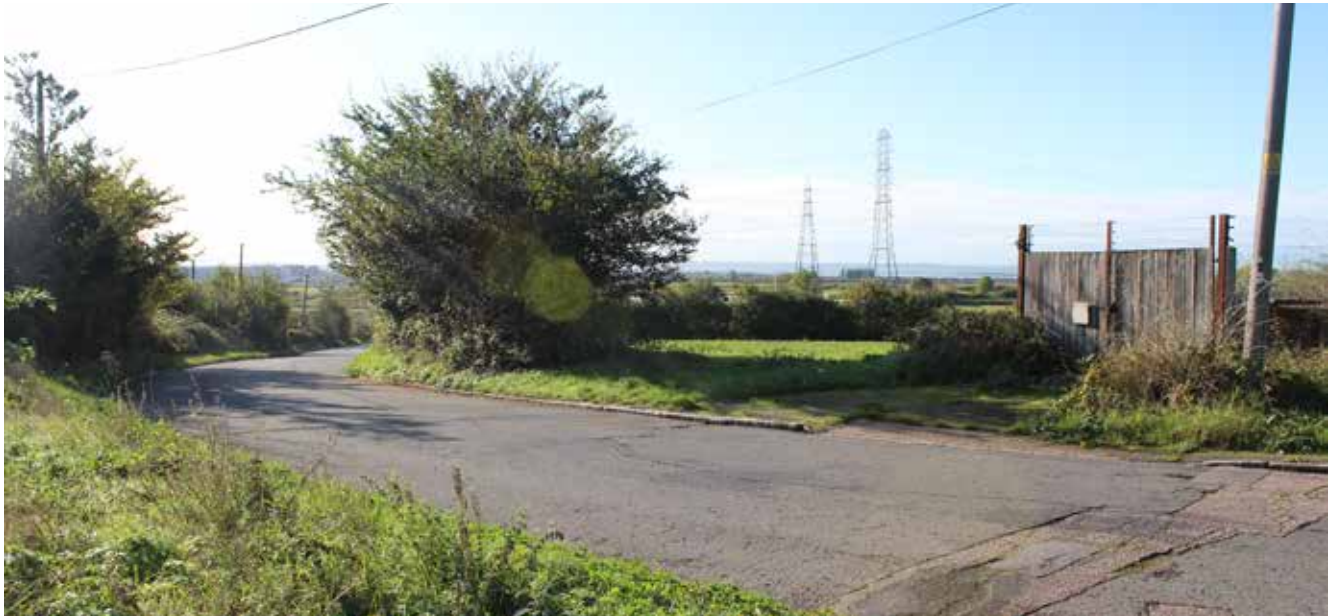
Figure 17-20 (clockwise from top left): Corringham Hall Complex

To the south of the Conservation Area is the gated entrance to the working farm at Corringham Hall. Within the farm is the eighteenth century brick Corringham Hall (Grade II Listed: 1111622), with an attached garden wall and associated farm buildings. The farm backs onto the open fields at the crest of the hill, which descends to the former Corringham Marsh and the River Thames. This creates an open, rural character to the Hall complex with long views over the marshes towards the modern industry along the River.

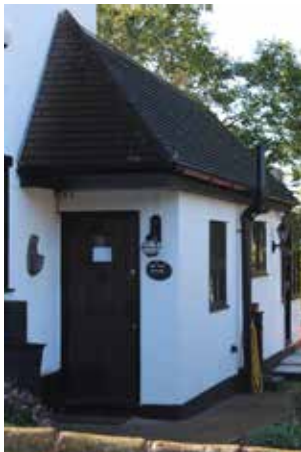
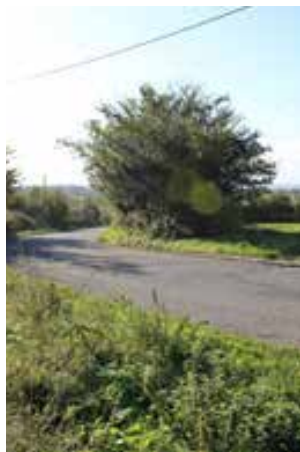
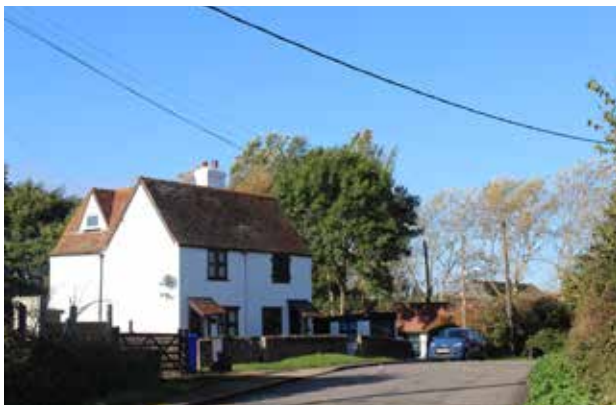
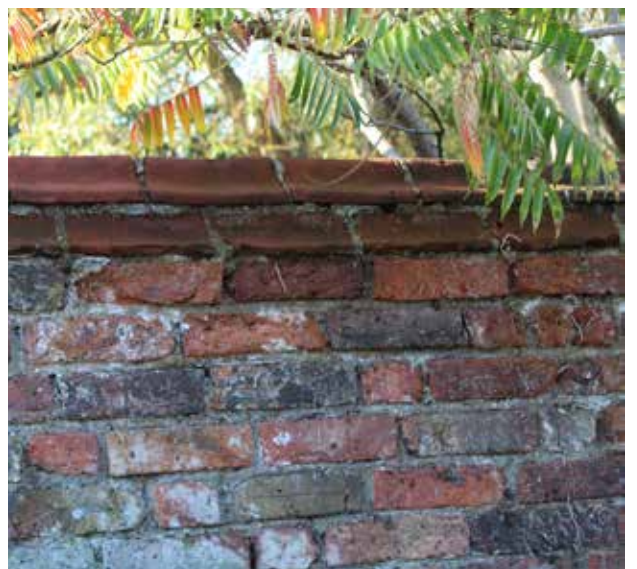
Figure 21-25 (clockwise from top): Images highlighting the character of Rookery Hill

On Rookery Hill are the early nineteenth century former farm dwellings, Old Hall Cottage and Harley Cottage, with small front gardens behind a brick wall. This area is open and green in character, the buildings isolated within large garden plots and surrounded by wide reaching views south towards the marshes contributing to an open character.

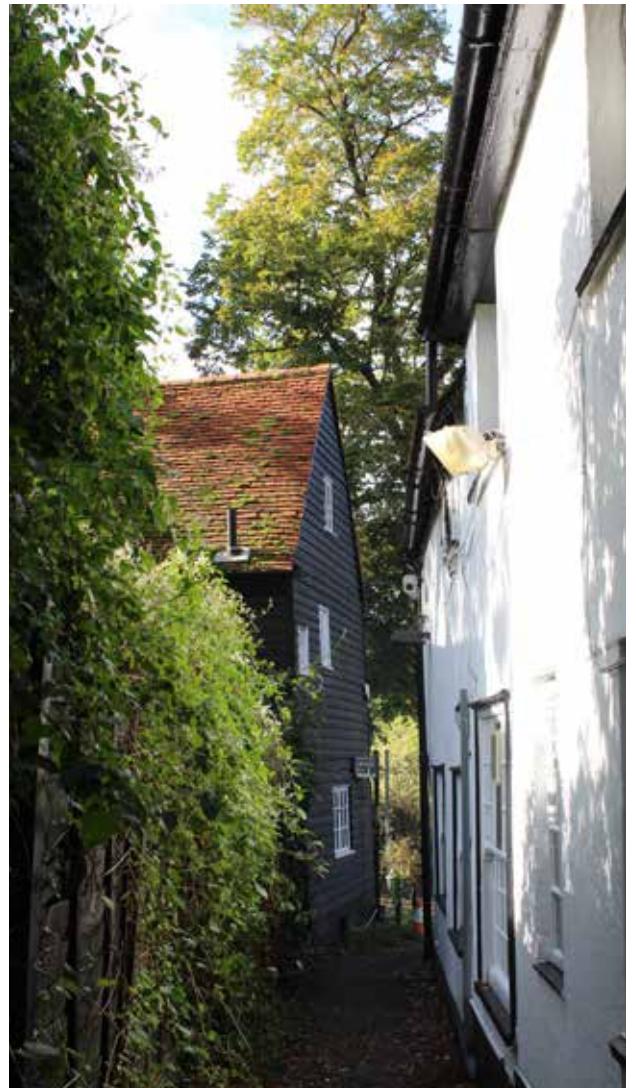
Figure 27: View west along footpath

A footpath separates Hall Farm Cottages from the building to the north, the fifteenth century The Bull Inn (Grade II Listed: 1111620). The footpath makes a positive contribution to the area, and has an enclosed character which contrasts with the open spaces it leads to.

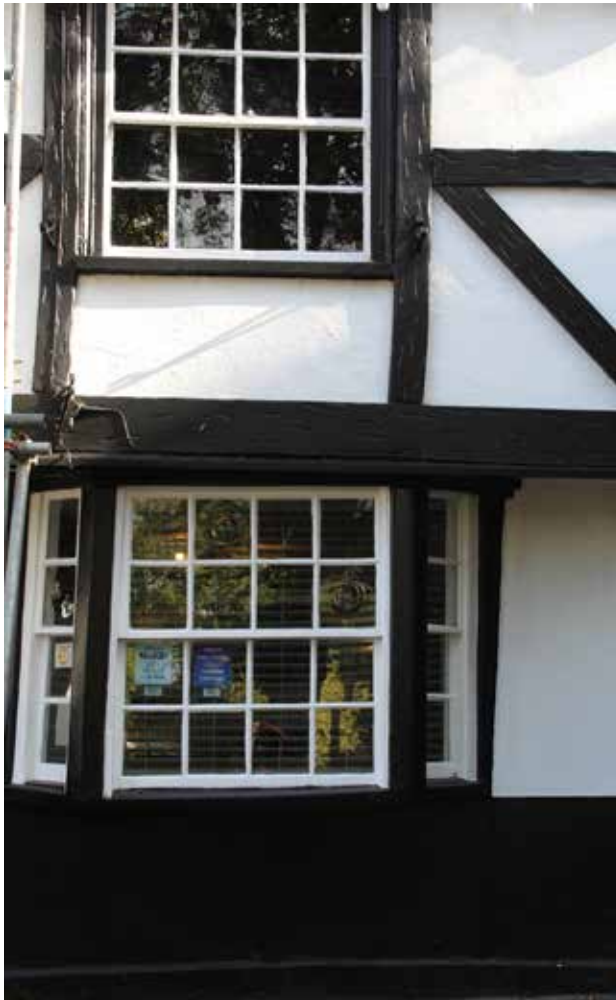
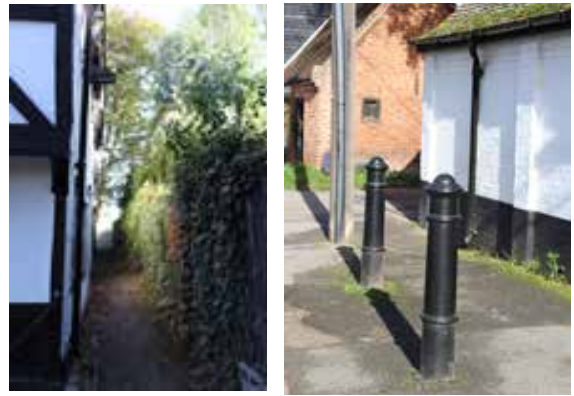
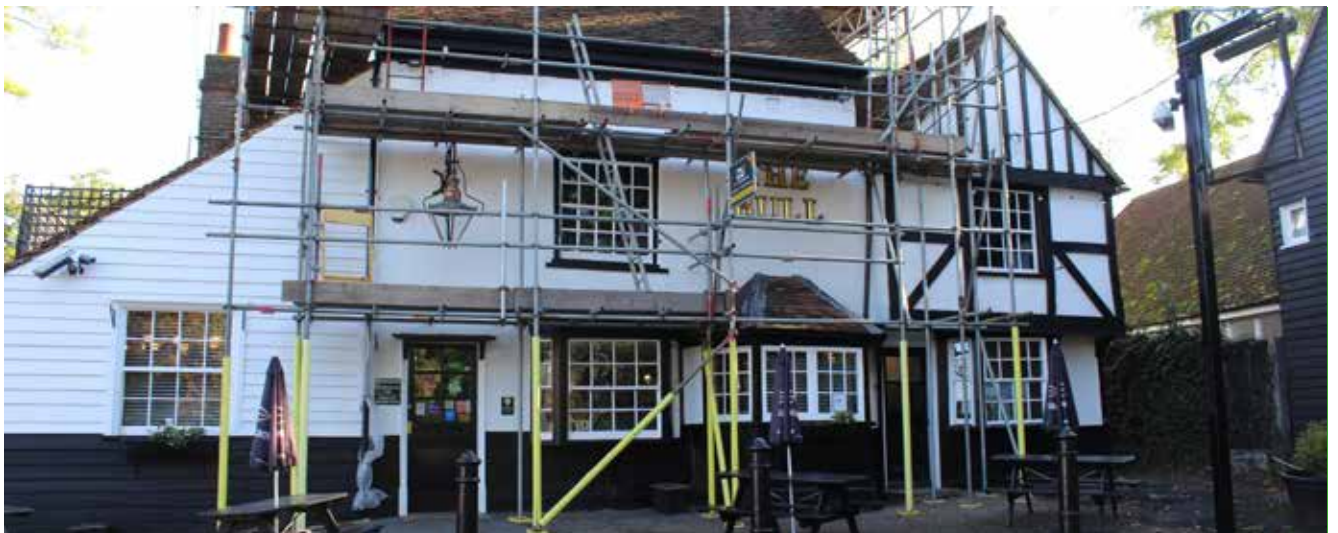
Figure 28-31 (clockwise from top left): Images of the Bull Inn

The Bull Inn also overlooks the open churchyard to the west. The Inn's core is timber framed and jettied with pantile roofing, and has eighteenth century weather-boarded extensions to the north. The building is set back from the road behind a small area of paving currently used for benches and outdoor seating and marked by bollards, and has a large rear yard used mainly for parking and a small garden. It is of communal and historic value to the Conservation Area, contributing to the only group of community spaces within the Conservation Area, comprising the church, churchyard and green. The footpath beside the Inn crosses over Church Road and continues into the churchyard.

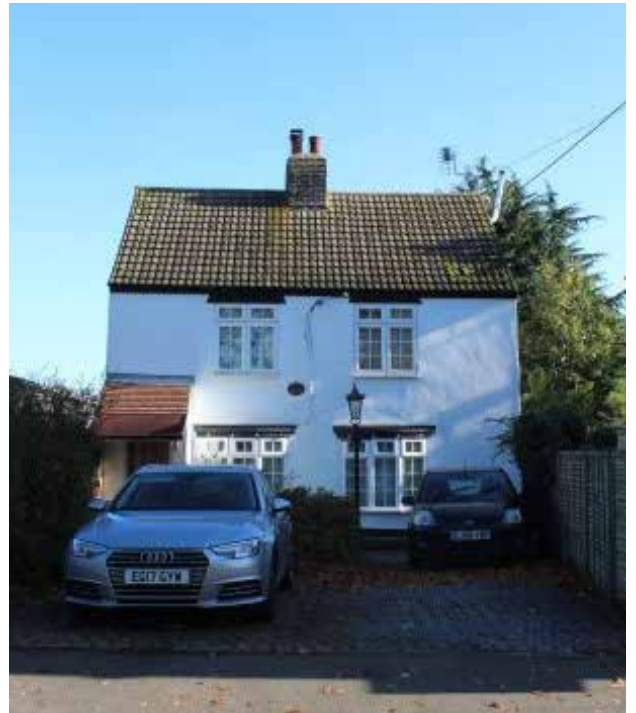
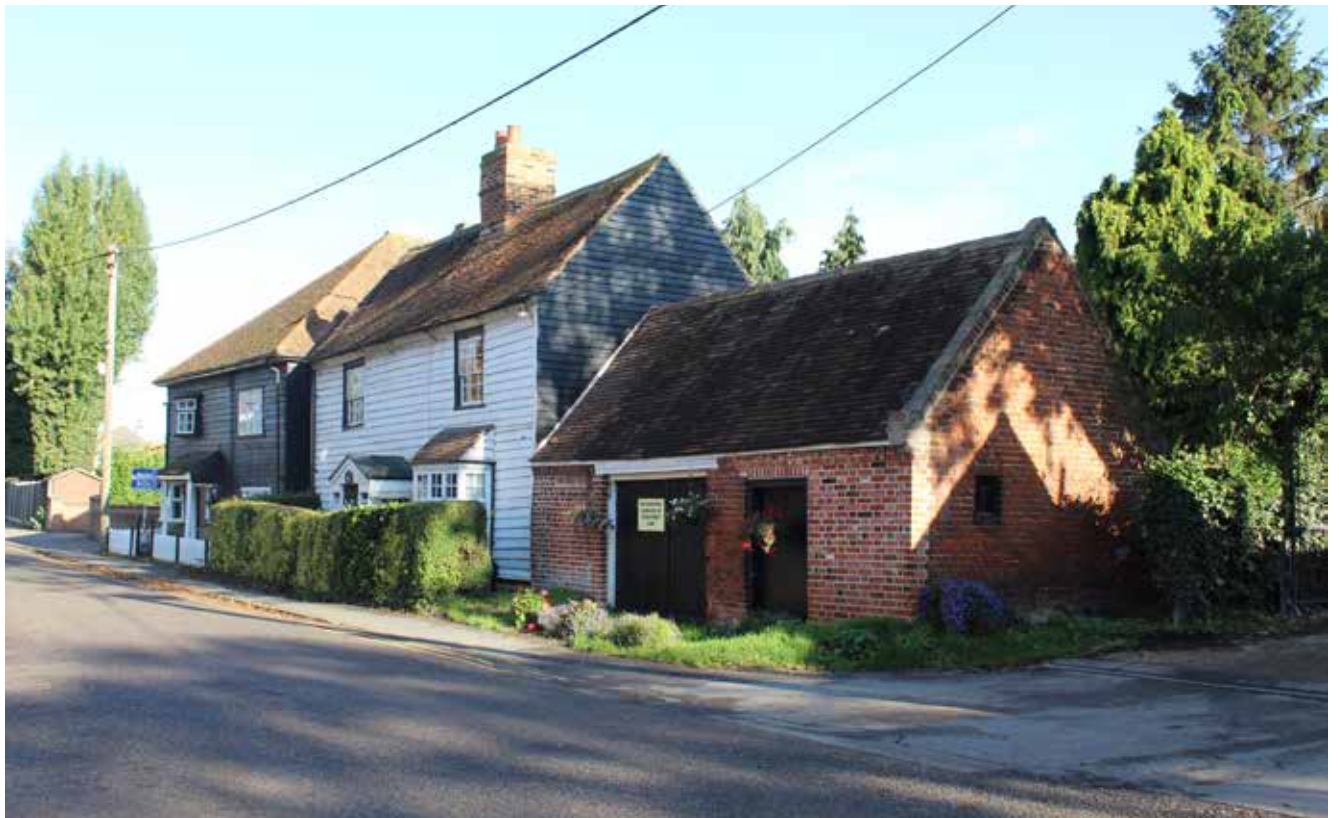
Figure 32 (top): Bell House, and Figure 33 (bottom): Ainsworth Cottages

To the north of The Bull Inn is the timber framed and weather-boarded Bell House (Grade II Listed 1111619). This building is set behind a small front garden with low box hedge boundary, and has a garden with trees to the rear. Numbers 3 and 4 Ainsworth Cottages are located to the immediate north of Bell House, and make a positive contribution to the historic character of the area. Constructed in the eighteenth century, they are clad in black painted weather boarding under a pantile roof, with an oriel window on the first floor. They have a small front garden bounded by a low white picket fence, and long rear garden. Numbers 1 and 2 Ainsworth Cottages, constructed in the nineteenth century, to the north are set back from the pavement with a brick wall to the north and close boarding to the south. They are also important to the historic character of the Conservation Area.
