Planning, Transport, Regeneration Overview and Scrutiny Committee

Page
1. Apologies for Absence	
2. Minutes	5 - 20
To approve as a correct record the minutes of the Planning, Transport, Regeneration Overview and Scrutiny Committee meeting held on 4 July 2023, 30 August 2023 (Extraordinary) and 28 September 2023 (Extraordinary).	
3. Items of Urgent Business	
To receive additional items that the Chair is of the opinion should be considered as a matter of urgency, in accordance with Section 100B (4) (b) of the Local Government Act 1972. To agree any relevant briefing notes submitted to the Committee.	
4. Declaration of Interests	
5. Thurrock Scheduled Ancient Monuments: Assessment of	21 - 176

The Thurrock Scheduled Ancient Monuments: Assessment of Settings is a technical baseline document that provides a detailed assessment of the significance and setting of these Scheduled Ancient Monuments (SAMs), as well as initial recommendations as to how the setting and significance of each SAM can be preserved and enhanced. It has been prepared to support the plan-making process as well as to better enable evidence-led decision making within Development Management.

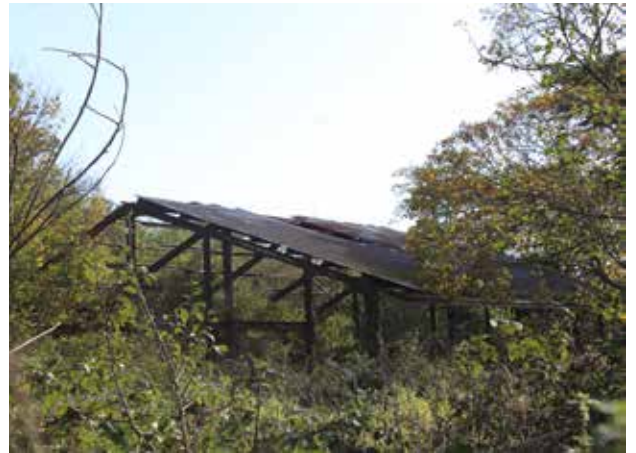
Figure 50: Structure remaining in the former Rectory grounds

To the north west of the Conservation Area are the grounds to the former nineteenth century Rectory, accessed from the tree lined Chestnut Walk. While the rectory has been lost and the Kashody Clinic which later replaced it has fallen into disrepair, parts of the Rectory grounds, garden features (including a tiled pool) and planting survive. Towards the rear field boundary of the grounds, a large metal framed structure clad in corrugated sheeting is in a poor state of repair and at risk of rapid deterioration. This has a negative impact on the appearance of the Conservation Area.

The former Rectory is a private site, although there is evidence of access informally via the tree lined Chestnut Walk and through missing fence panels which line the footpath here. The site is of historic interest, with the foundations and some walls of the former Rectory still discernible. The site is not currently maintained and is at risk of further deterioration. It appears to attract anti-social behaviour including littering and vandalism. Despite this, the site makes a positive contribution to the Conservation Area as private grounds, due to its former use, historic value, and its visibility from the road which allows it to contribute to the green character of the area.

- The site of former Rectory is a private site accessed via the tree lined Chestnut Walk. The site is of historic interest, with the foundations and some walls of the former Rectory still discernible. There is evidence that the site is being accessed through broken fence panels, with litter and graffiti within the grounds highlighting its use for anti-social behaviour. This area has potential for enhancement through the maintenance of existing boundaries, the stabilisation or removal of the metal framed structure within the grounds, and a considered approach to protecting and preserving any remaining features of the Rectory grounds.

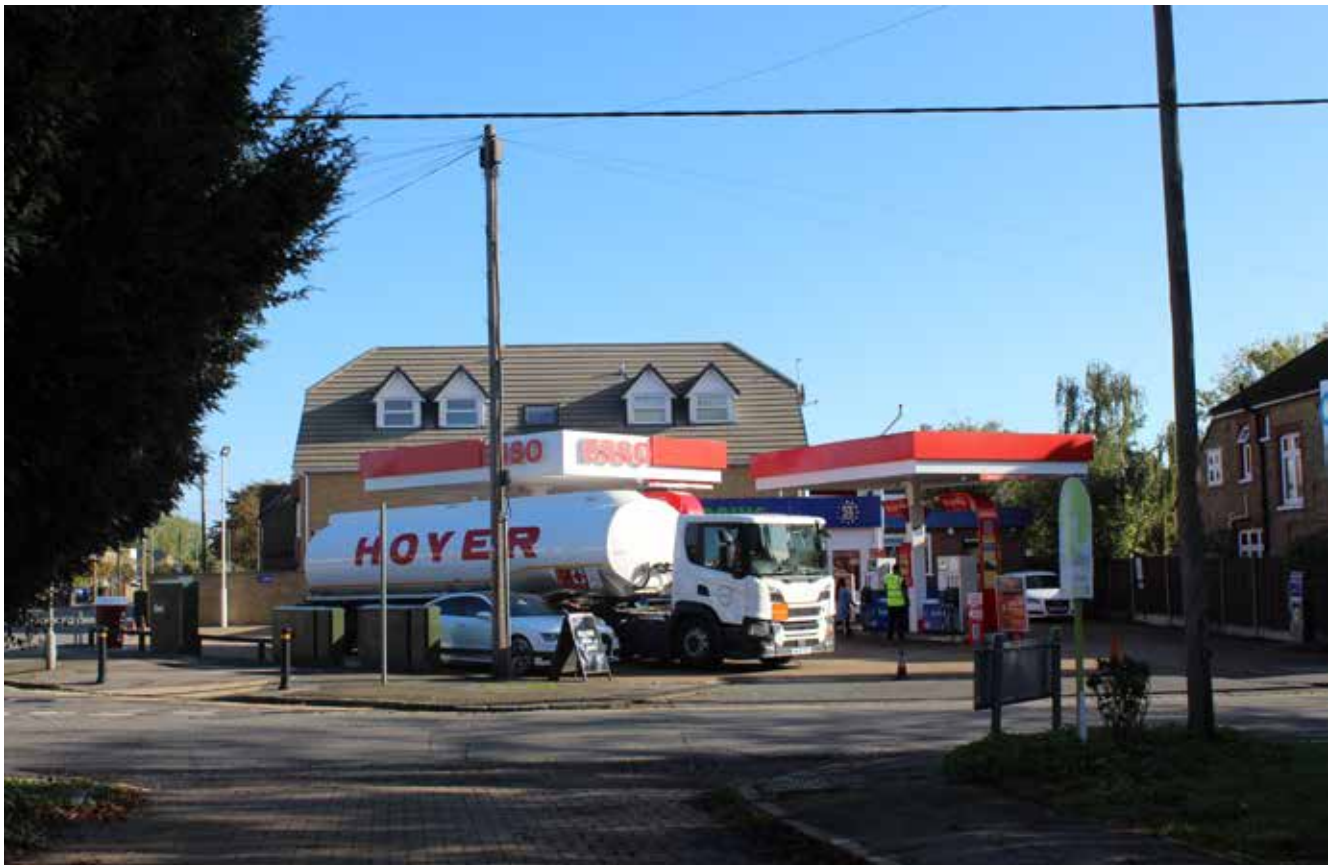
The large and extensive area of modern Corringham developed north of the Conservation Area, principally in the 1960s and 1970s. While this has not fundamentally impacted upon the historic village, the location of the petrol station does currently adversely affect the ability to experience and appreciate the significance of the Conservation Area. It is located at the gateway to the Conservation Area when approaching from the north; its bright colour palette, modern materials, street furniture, and regular vehicular access make the site an intrusive feature within the setting of the Conservation Area.

Figure 79: View east towards petrol station from the Conservation Area.

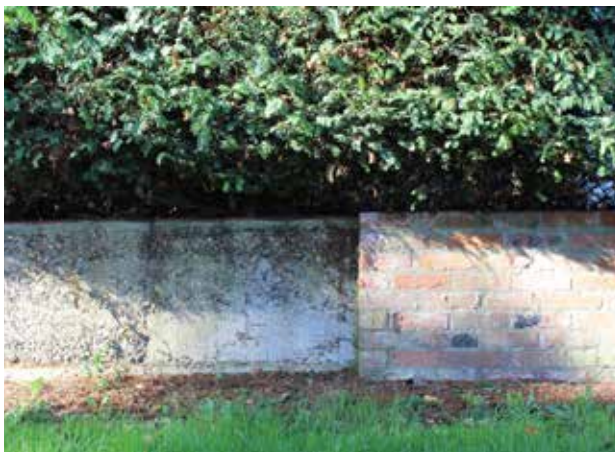
Figure 82: Replacement of low brick wall with concrete, which is out of keeping with the material palette of the area

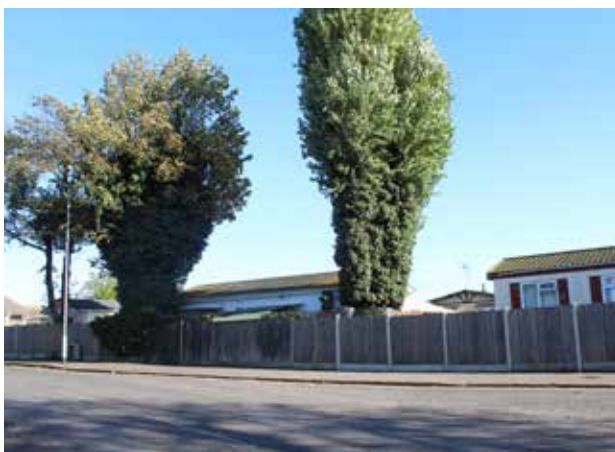
Figure 83: Example of close board fencing

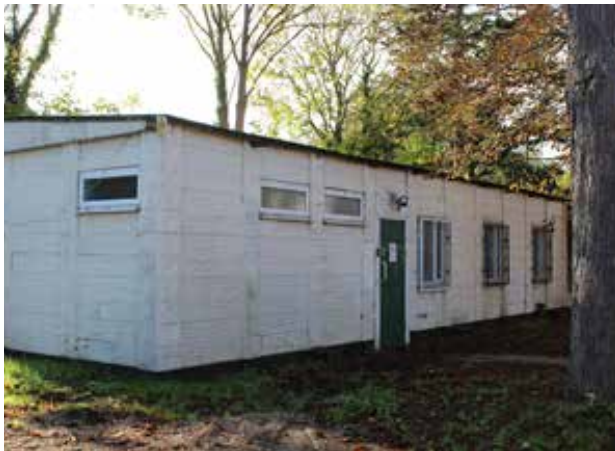
Figure 84: The Hall on Chestnut Walk

Corringham has suffered from the gradual, and in some cases irrevocable, loss of architectural detail which gave the village its unique and distinctive character. This includes the removal of historic doors, windows and rainwater goods and installation of replacements which do not match the quality of the original in material, craftsmanship or detailing.

Poor maintenance leads to the deterioration of the fabric of the built environment and results in a loss of architectural details. Improved awareness of simple maintenance and repair which is in keeping with the character, details and materials of the Conservation Area would be conducive with the preservation of Corringham's built heritage.

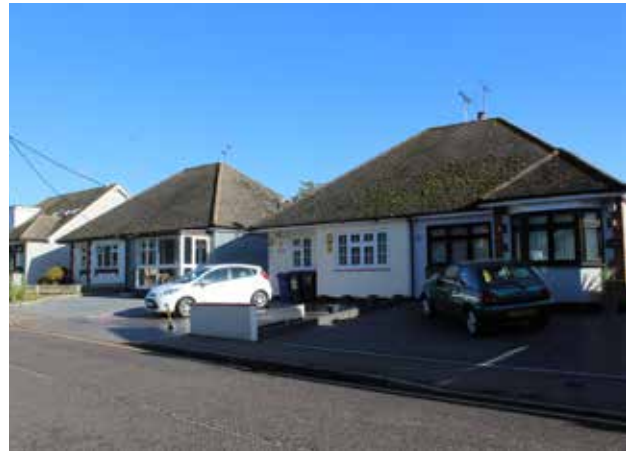
Figure 85: Twentieth century bungalows

A proportion of buildings make a neutral contribution to the character and appearance of the Conservation Area. The dilution of positive buildings amongst those which are neutral can lead to indistinctive overall character. It is considered that and twentieth century bungalows on Church Road and modern development to the north of Chestnut Walk make a neutral contribution to the character of the area, and the Chalet Park makes a neutral/negative contribution. These developments introduce new mass and grain to the area, often with inappropriate boundary treatment.

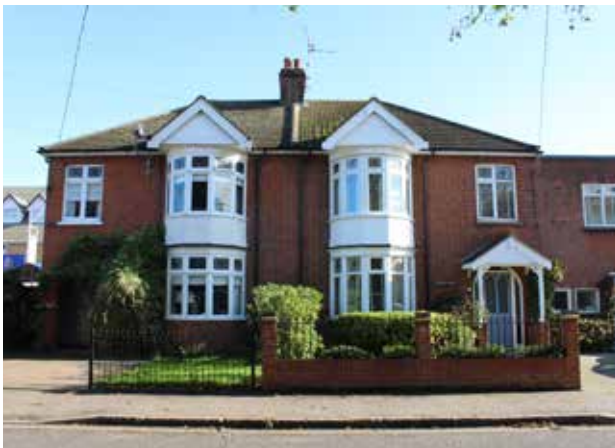
Figure 86: Two dwellings showing the impact of alterations. Window replacements, concrete roof tiles, porch and a garage extension have affected character.
