Assessment of Settings

Thurrock Scheduled Ancient Monuments

April 2023

Authored by Historic Environment Team,
Place Services, Essex County Council

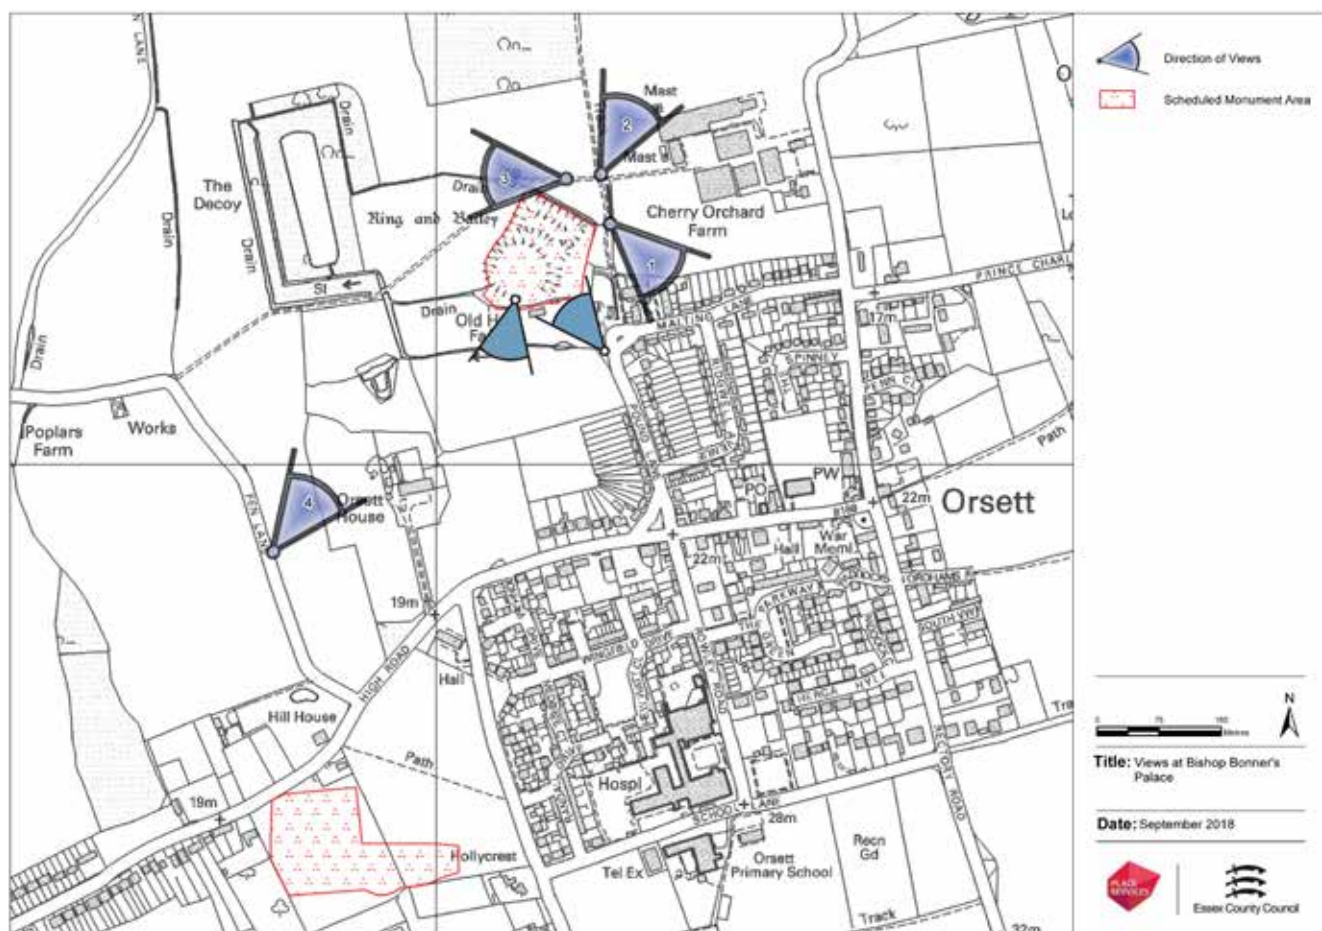
Figure 2: Location plan showing the principal views to and from the monument (other significant views are indicated by the smaller view-point symbols)

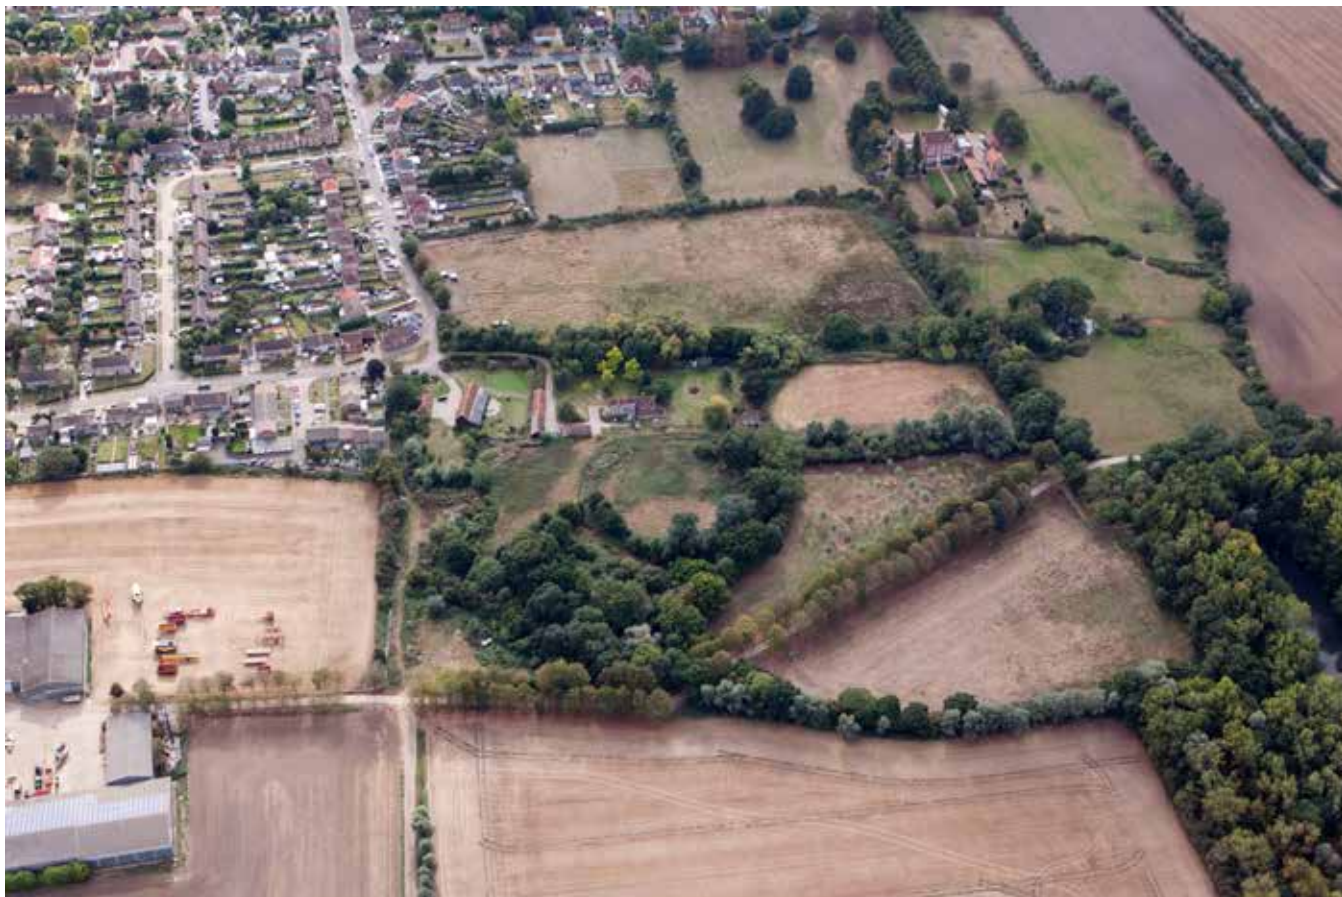
(Left) Figure 3 Aerial view of Bishop Bonner's Palace looking southwards, the ringwork is clearly visible, with the bailey located under the trees beside it. In the top-left of the photo is Orsett Church, Old Hall Farm is located immediately above the earthwork and The Decoy in the bottom-right of the photo.

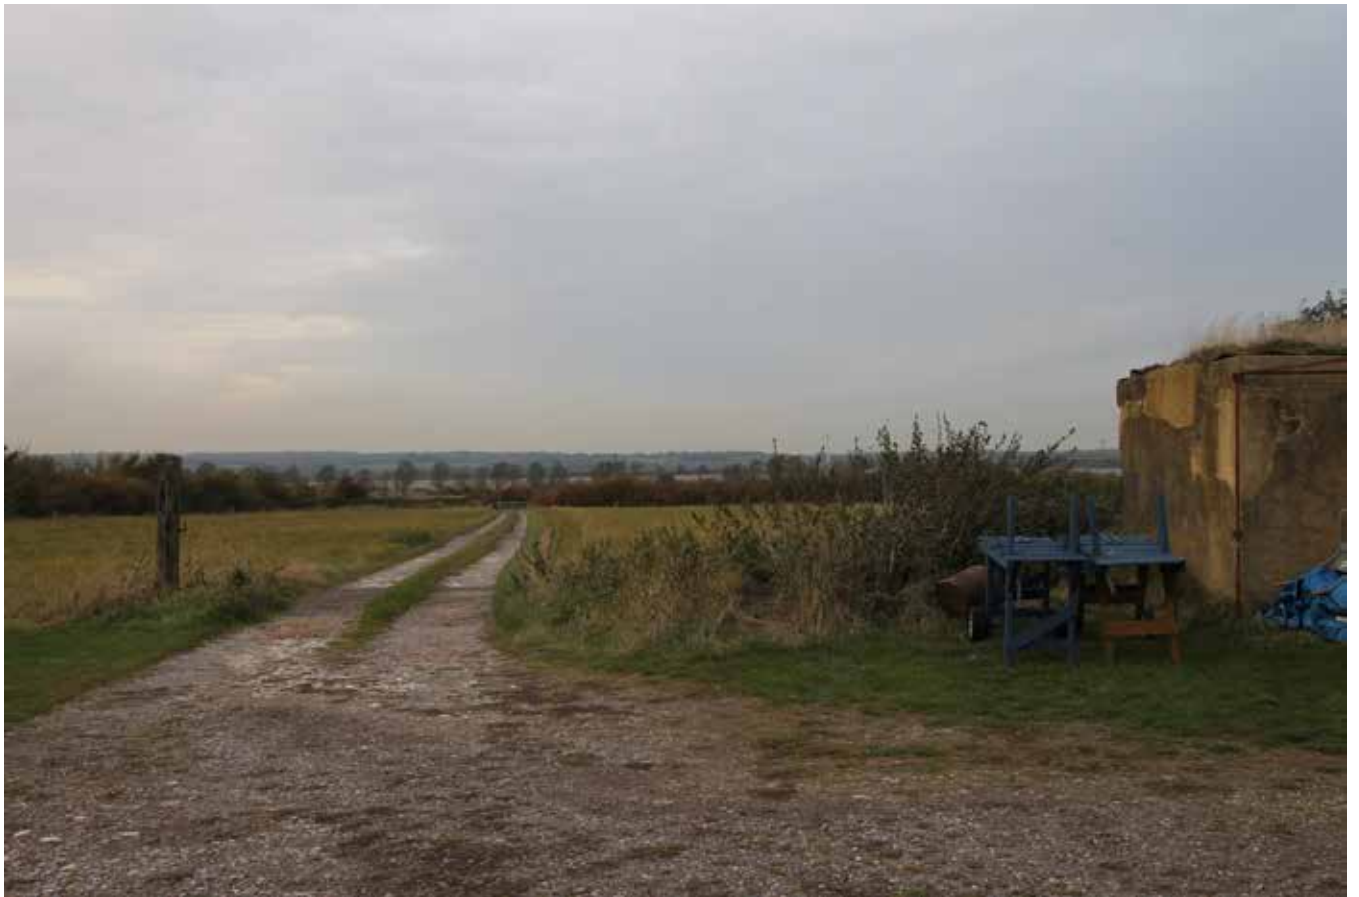
View 2: View looking northwards past the night-shelter to right, showing the long view over the former decoy airfield and beyond to open countryside.

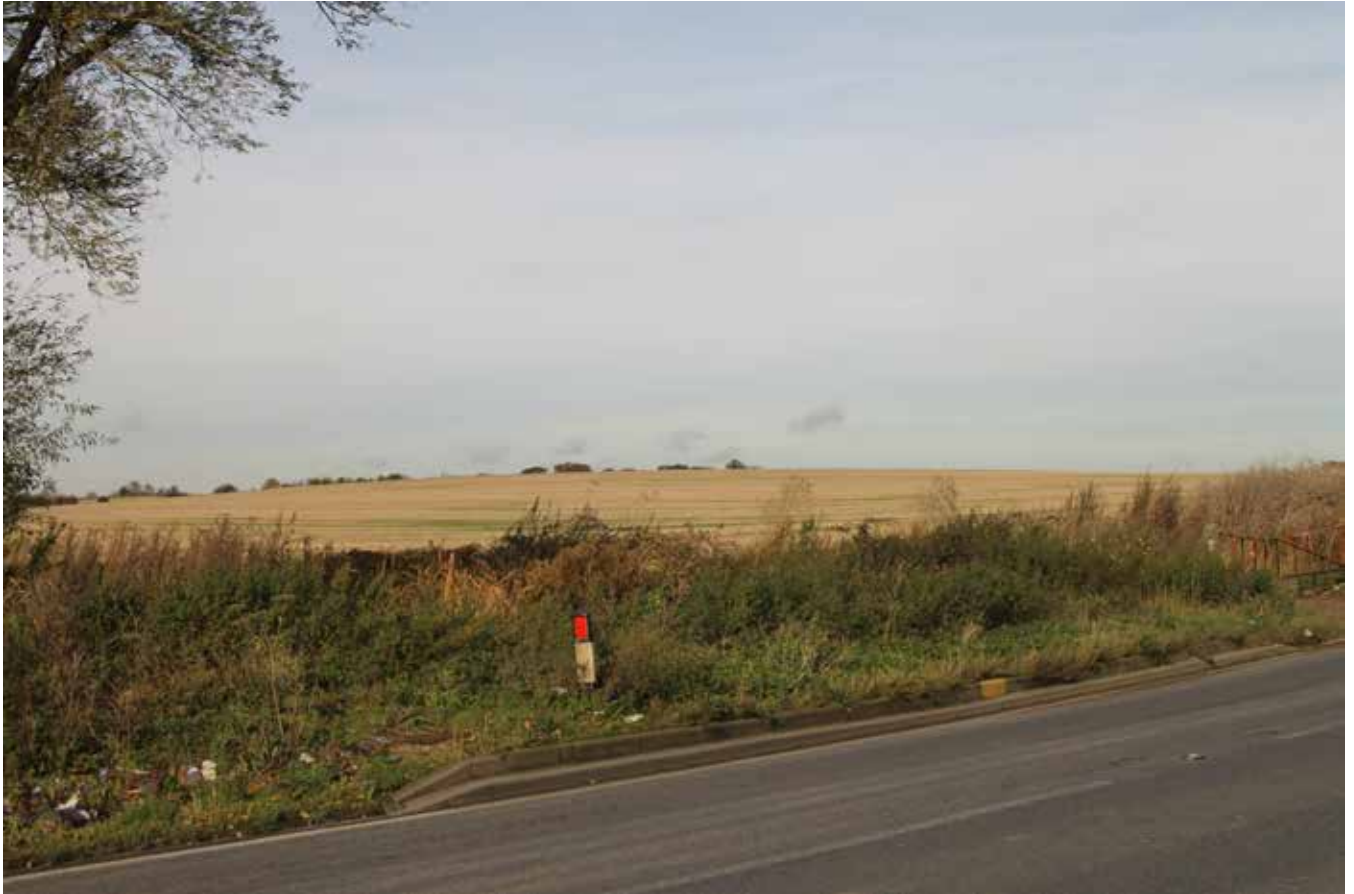
(Left) Figure 5 Location plan showing the principal views to and from the monument (other significant views are indicated by the smaller view-point symbols)

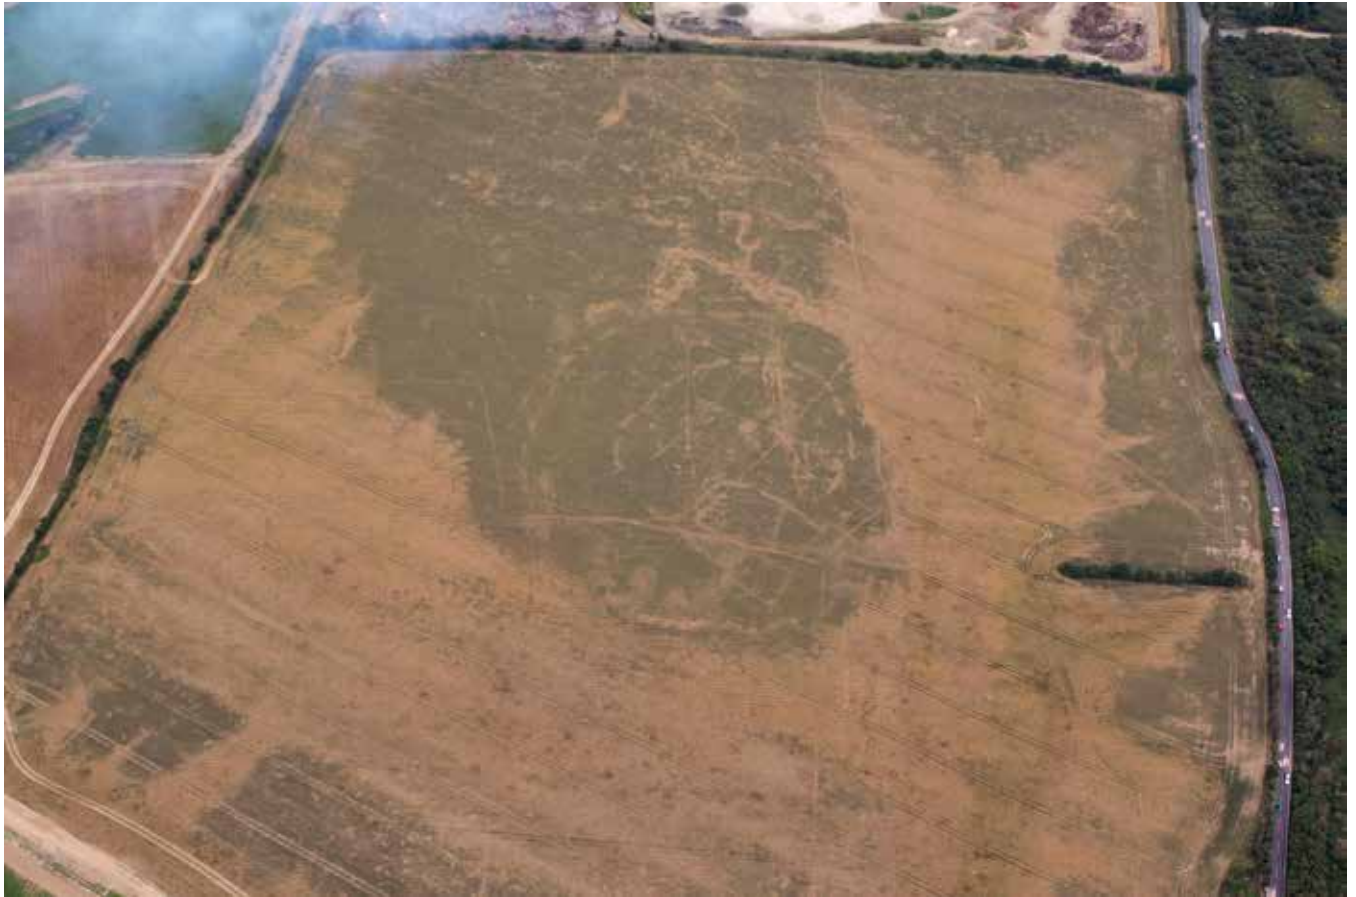
Figure 6 Aerial view of the cropmarks, looking north, the causewayed enclosure is visible in the centre of the photographs as the lighter dashed lines forming two concentric circles. (EX11_04_048 ©ECC)

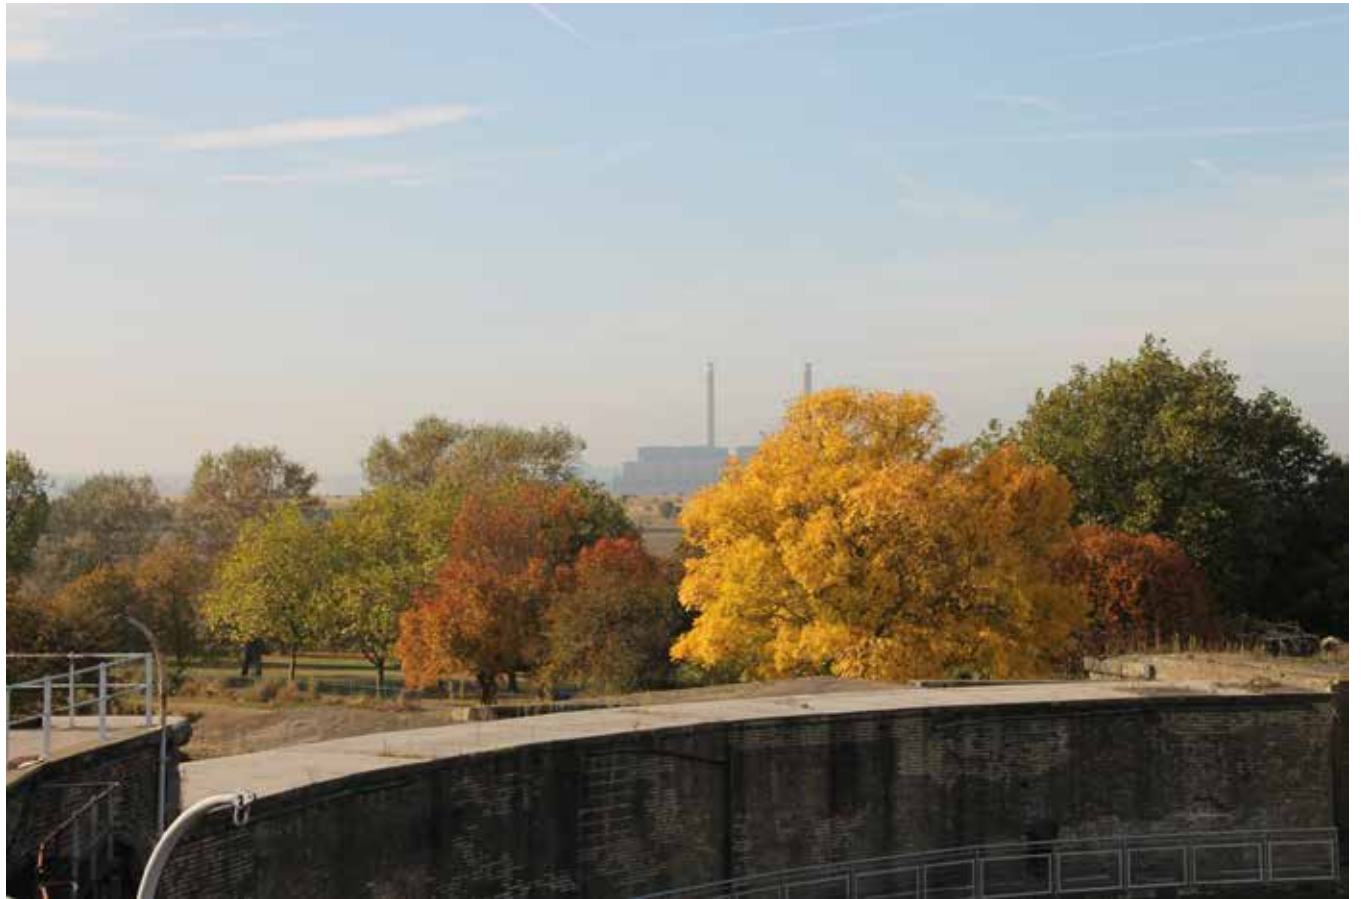
View 3: Looking west towards Tilbury Fort, here the original view is blocked by Tilbury Power Station and the trees

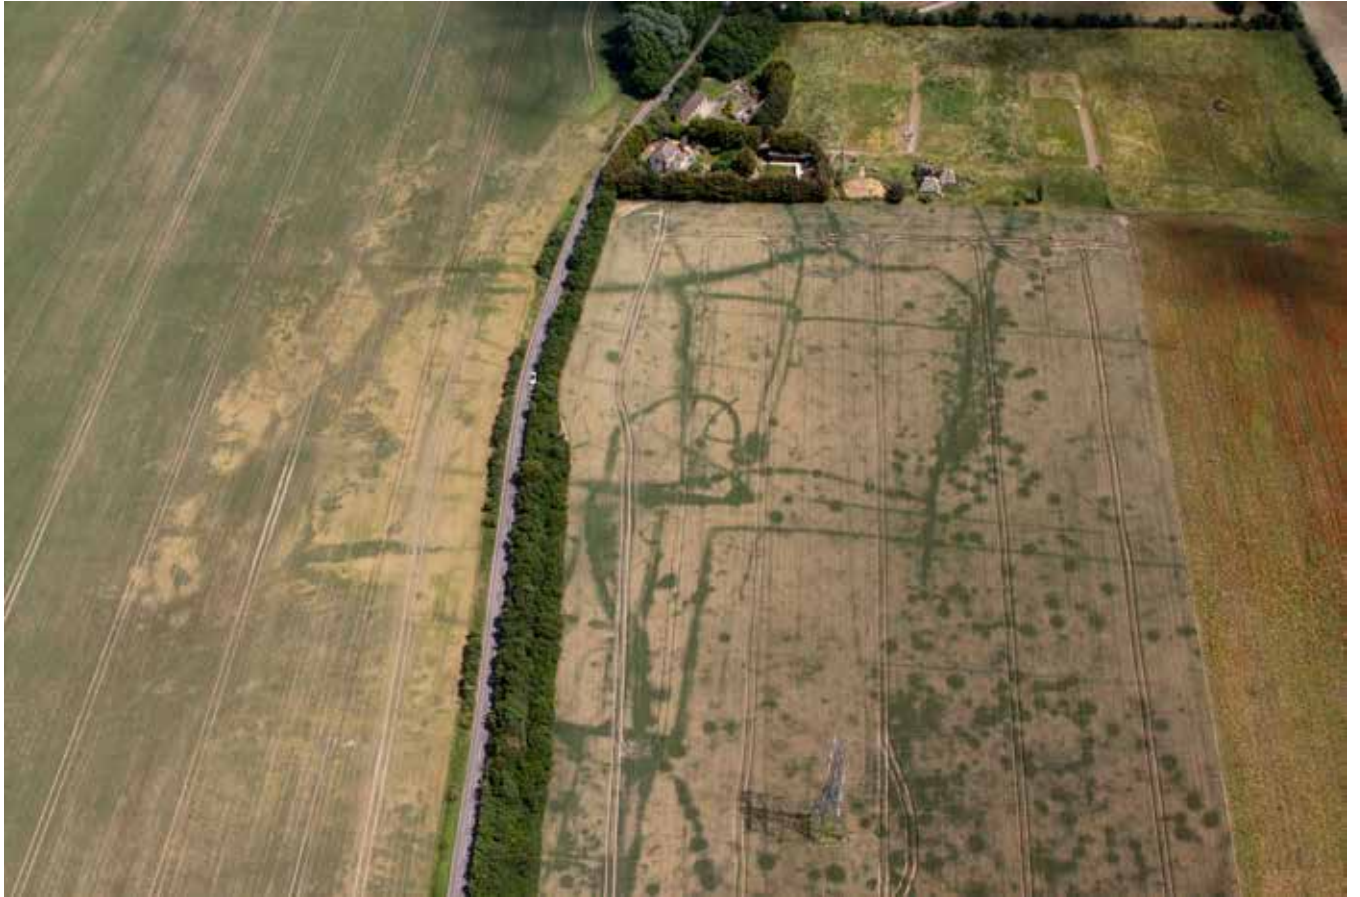
Figure 10 Aerial photograph of the cropmark complex, looking to the east. The cropmarks are visible as darker stripes in the ripening wheat; the A13 is located on the right-hand side of the photo (EX18/03/003, ©ECC)

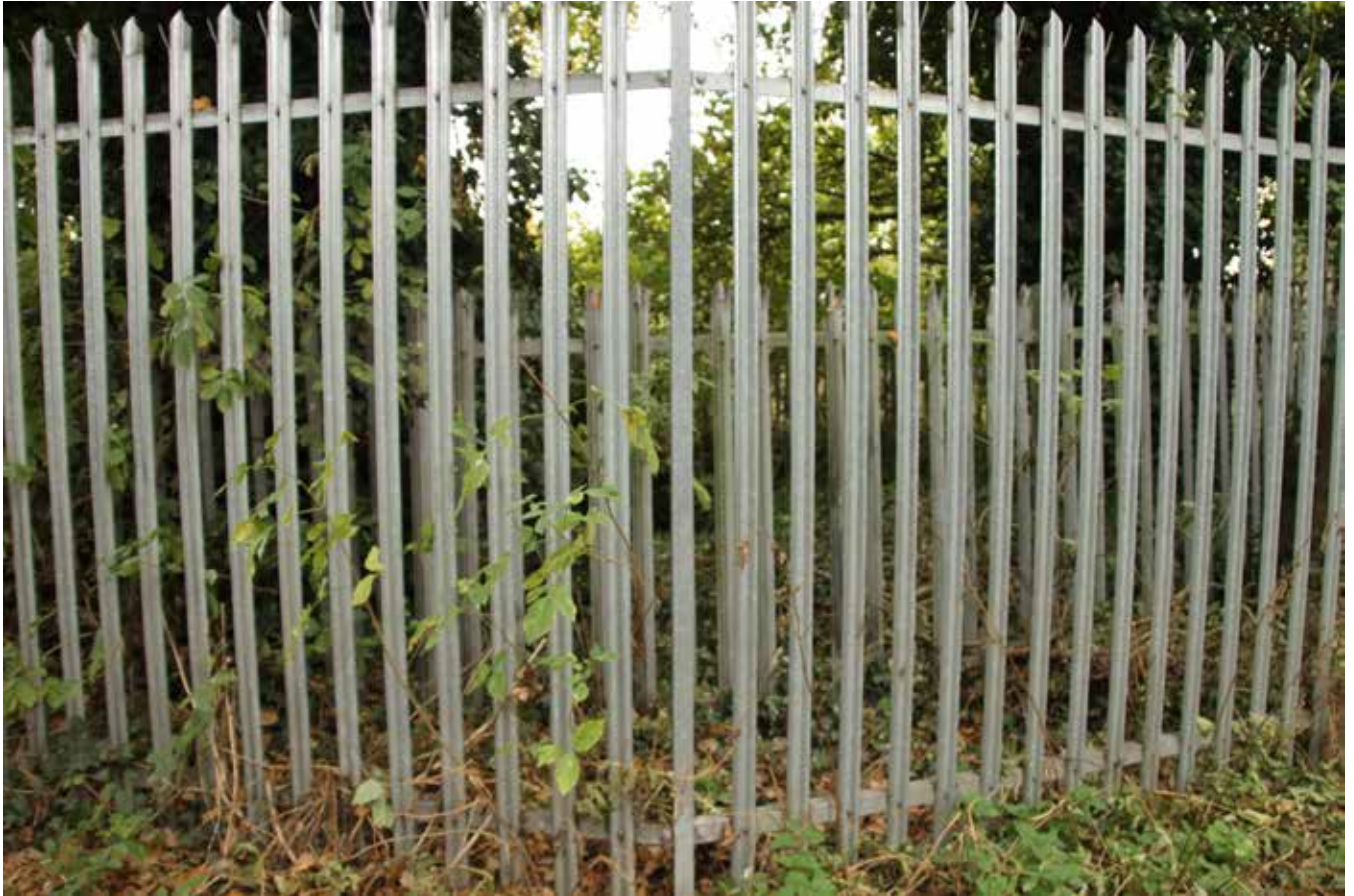
(Right) Figure 12 View into the northernmost fenced dene hole showing the top of the shaft.

Wood but all except 5 were blocked and could only be identified by depressions on the surface. The club entered and examined 15 shafts and associated chambers, mainly by cutting tunnels through from one set of chambers to the next. The Field Club carried out further investigation of the site in the 1950s and early 1960s. It is thought that there may be as many as 72 shafts, or dene holes, on this site. At the present time it is thought that only two shafts are open but these are securely gated and underground access is prohibited. The shafts are of geological interest as they show the section from the Thames terrace gravels, through the Thanet Sands and into the Chalk with its bands of flints visible in the chamber walls. The site is also designated a SSSI, as the dene holes are important for hibernating and roosting bats, and the woodland is important as habitat.

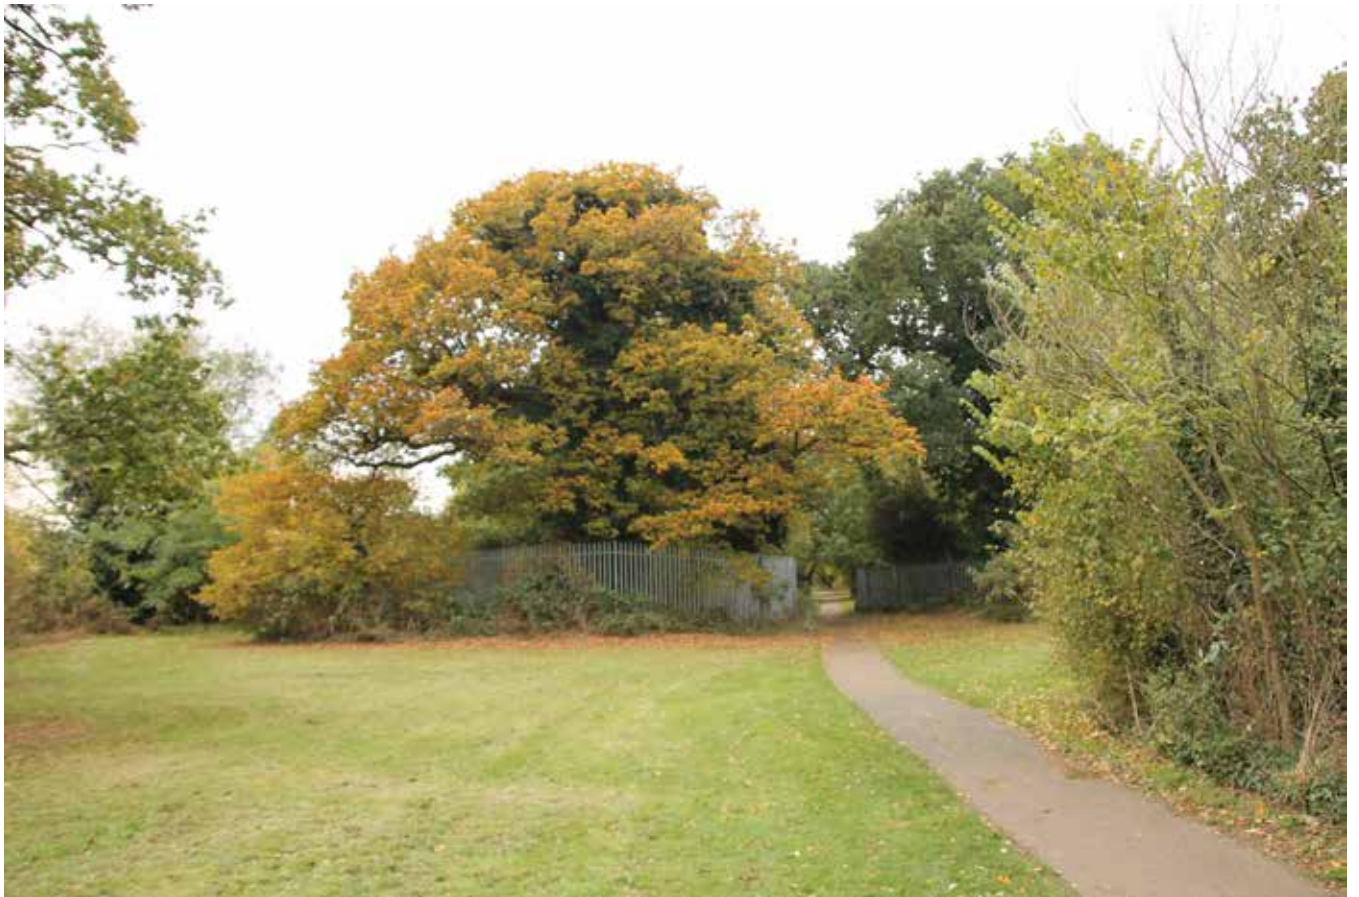
View 1: View looking west to two of the open dene holes (behind grey security fencing), located on either side of the main foot-path. The rear boundary of the properties fronting Parkside is on the left and shrubby growth and trees are to the right.

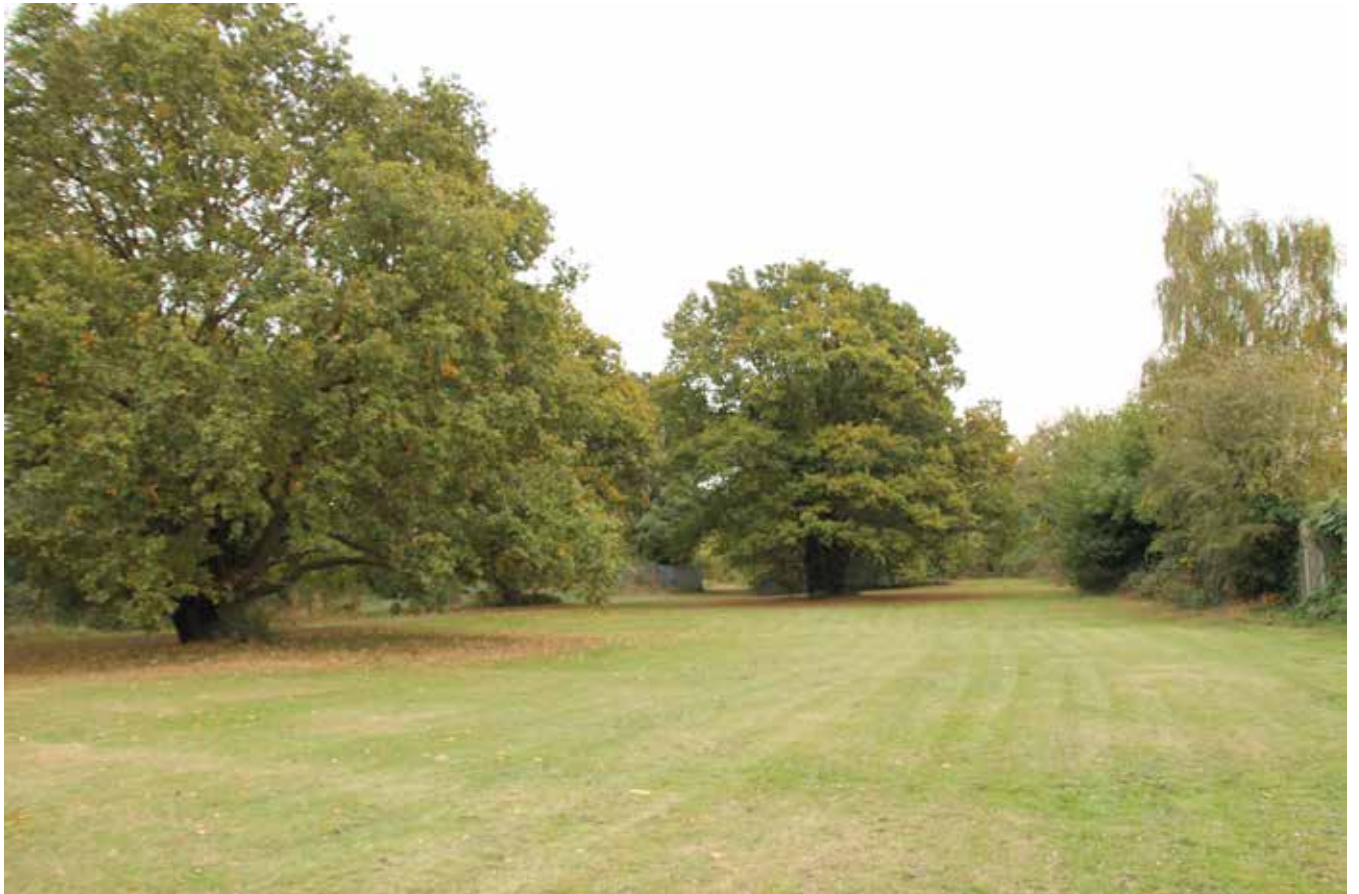
View 2: View looking east to the open dene holes (behind grey security fencing), partially hidden behind the mature trees in the foreground. The rear boundary of the properties fronting Parkside is on the right and The wooded areas of Hangman's Wood to the left.

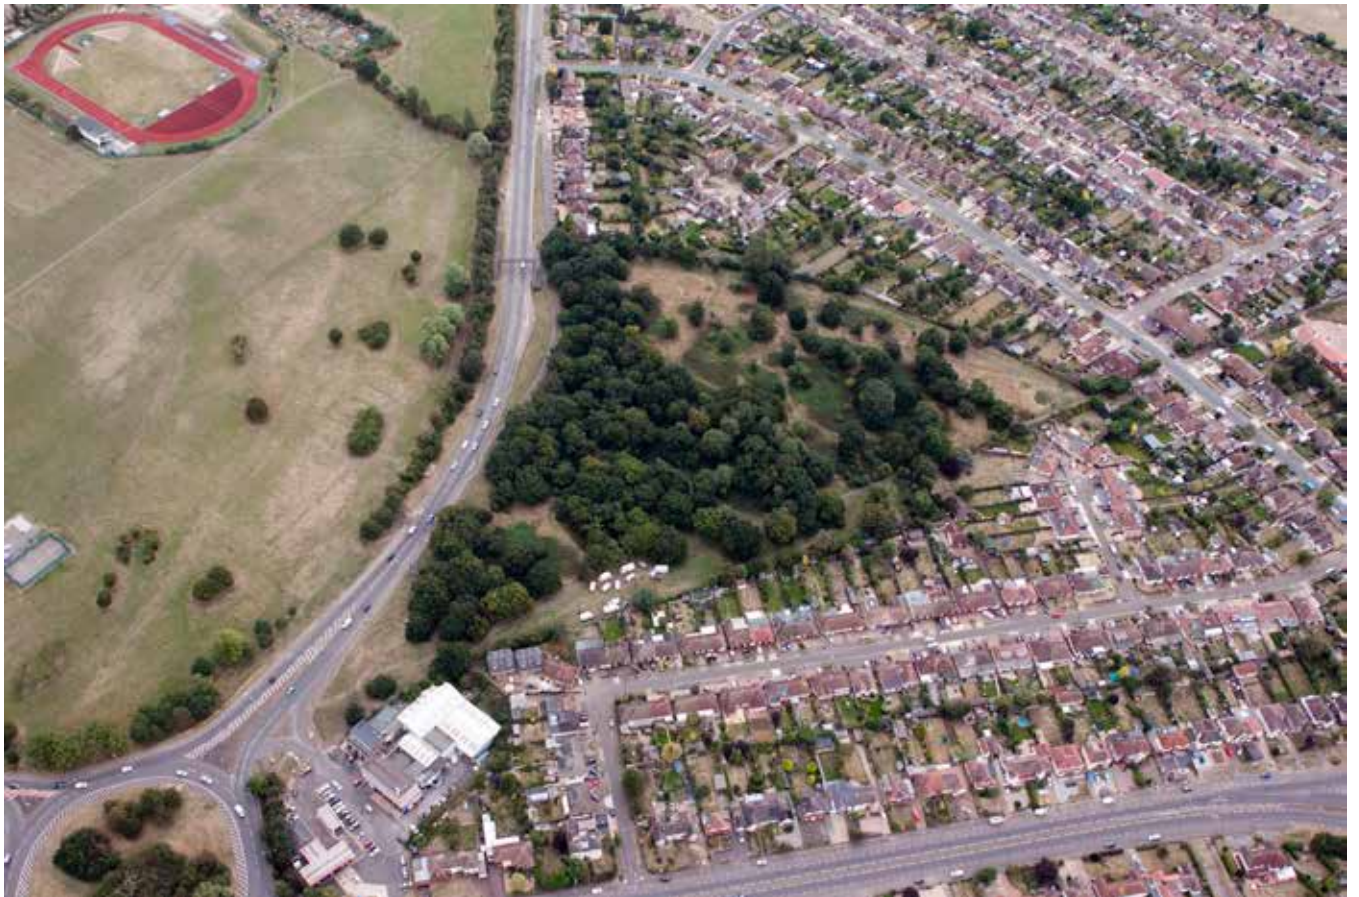
Figure 13 Hangman's Wood in its immediate setting. Some of the darker vegetation in the mown grass may indicate other dene hole sites.

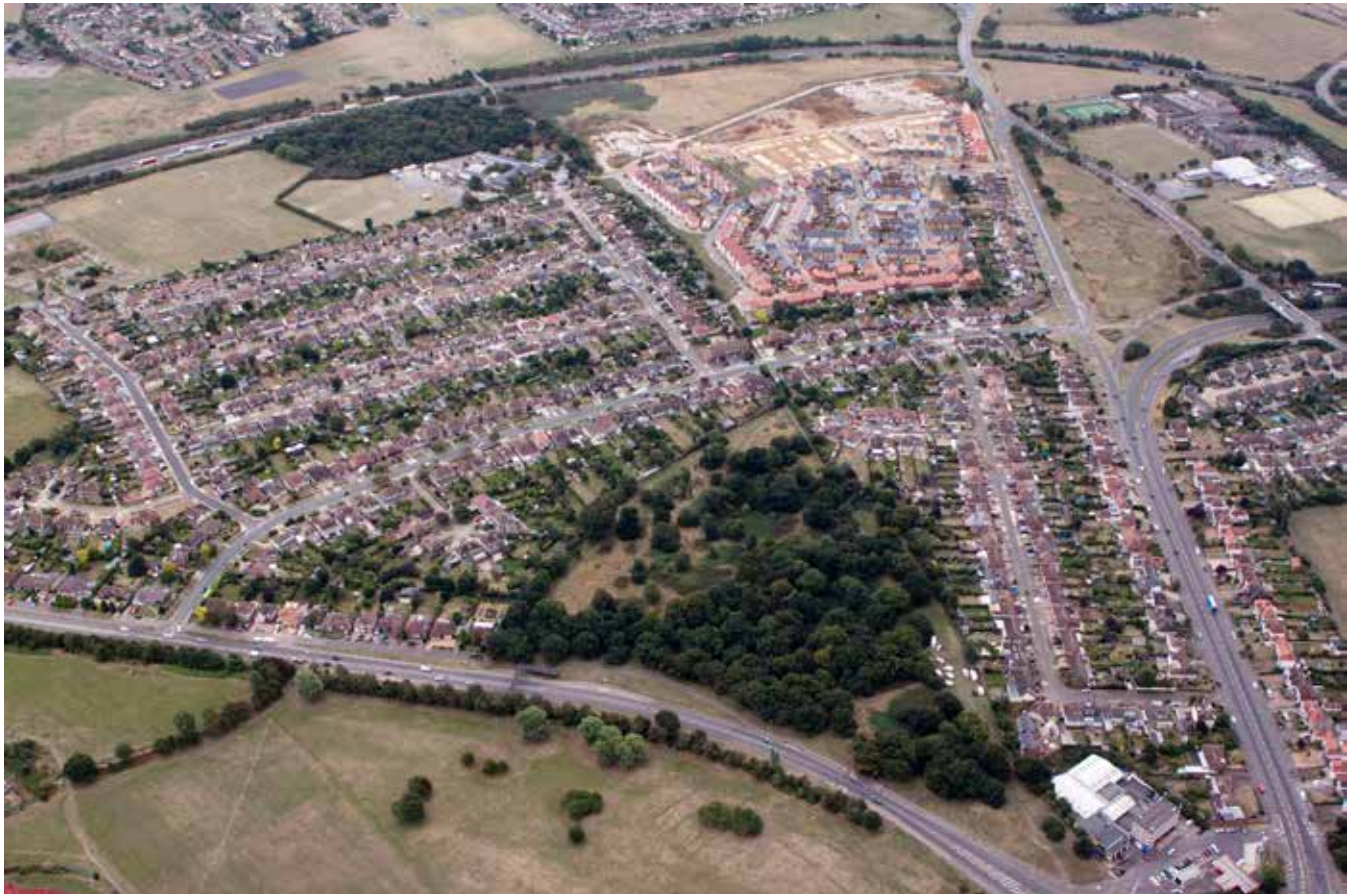
Figure 14 Hangman's Wood in its wider setting, with Tyrells Heath behind and Orsett Heath beyond. The former heathland character of the area is visible in places

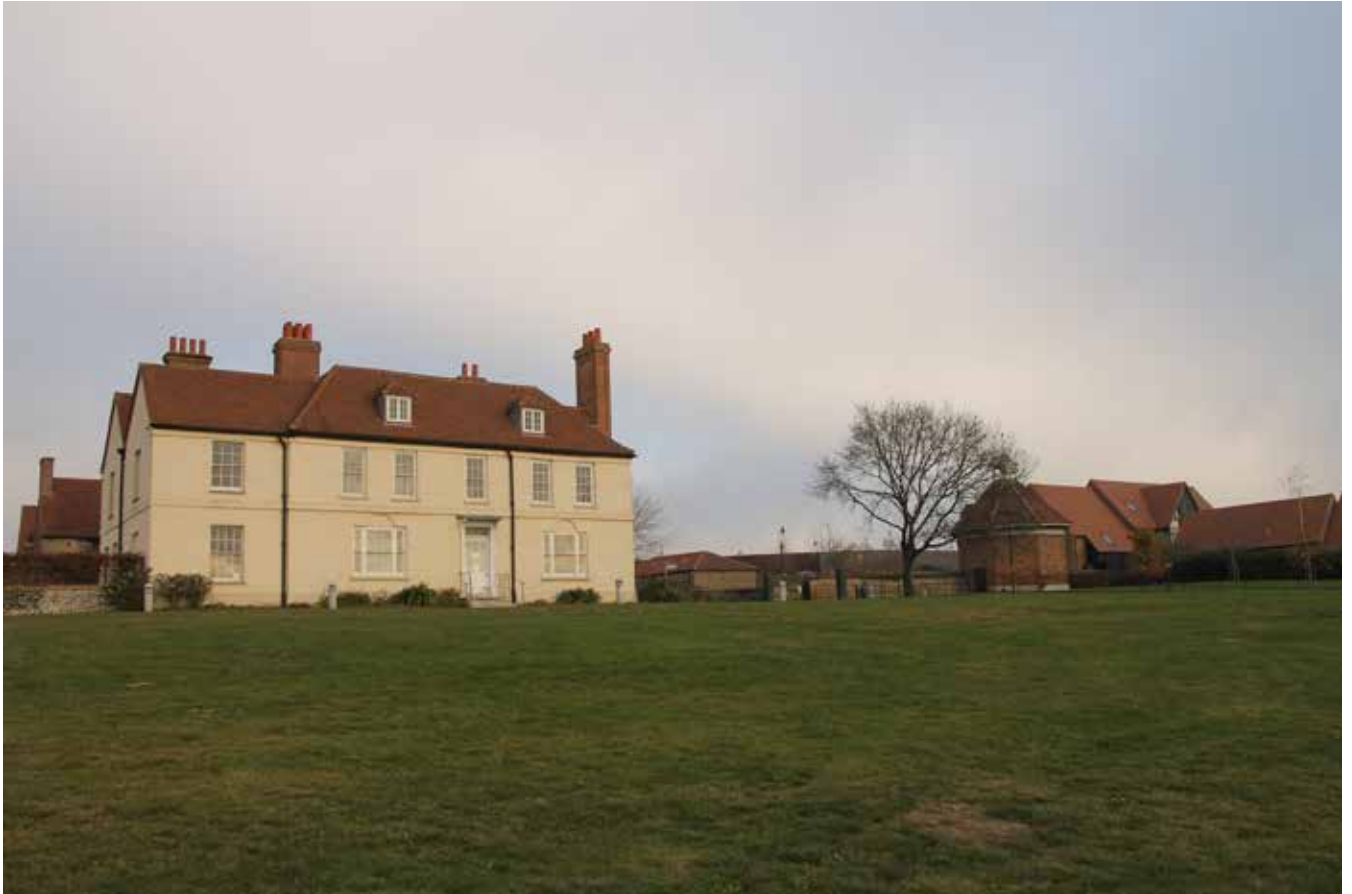
(Right) View 1: High House farmhouse and the dovecote looking north-west, with the farm buildings behind and the modern development to the east of the dovecote.

The dovecote also retains its two armed wooden potence complete with ladder, (a rotating structure designed to provide access to the nest boxes), which is supported upon a circular brick table (cemented over) some 1.25m in diameter.

The main beam of the potence is housed in the intersection of two alighting beams which also carry the framework of the louver. The internal roof timbers are to some extent restored but retain a fair number of the original timbers.

Following a national review of this class of monument in 1998, the High House dovecote is now thought to be one of only a small number of exceptional survivals in Essex, and it is especially notable for the survival of the potence and nest box array. The dovecote thus retains substantial evidence for the manner of its use and serves to illustrate part of the economy and lifestyle of the inhabitants of the associated manor since the 17th century. The very unusual development of the entrance is also of particular interest, reflecting the

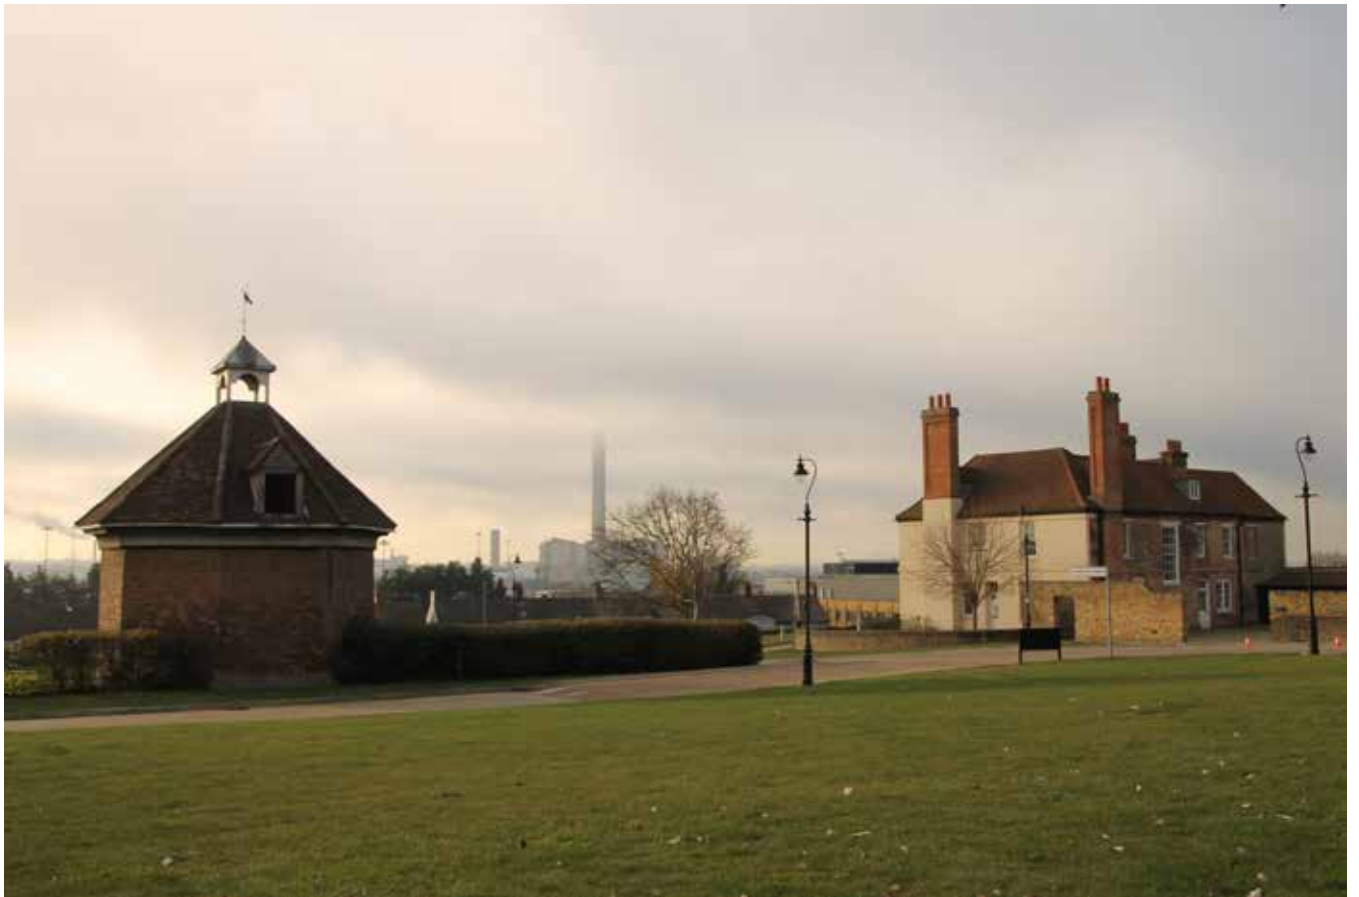
View 2: View south-eastwards showing the dovecote and farmhouse with the backdrop of industry along the Thames.

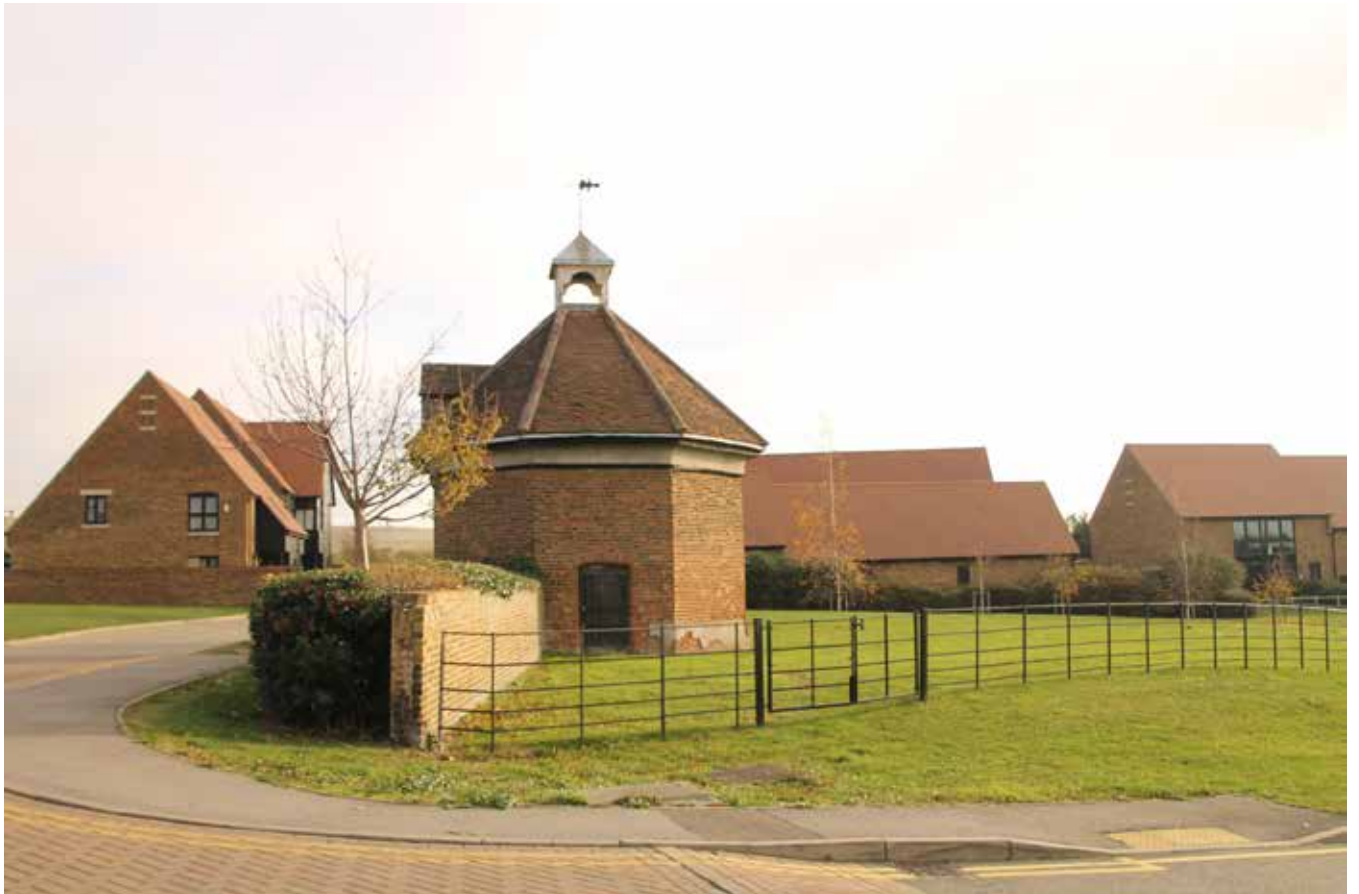
View 3: View of the dovecote from the west, with the modern housing development behind.

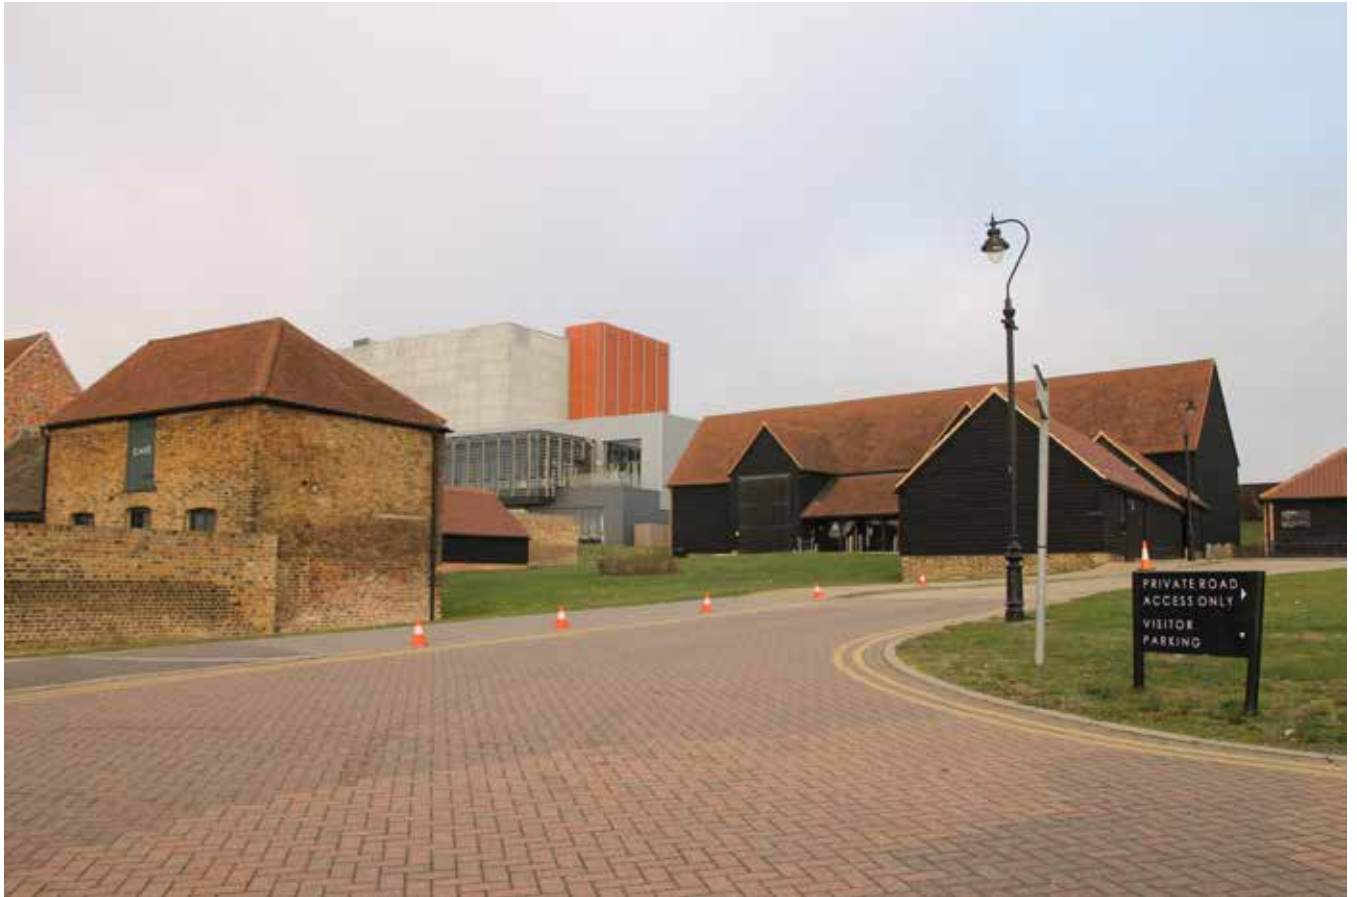
View 4: View of the farm buildings from the dovecote, with modern commercial development behind.

In the immediate vicinity, the heritage asset is surrounded by amenity grassland, car parking and the converted farm buildings. 20th-century housing developments surround the farm complex on the east, south and west, but at a distance. The railway line forms the north-east boundary of the farm complex. The more modern developments to the north-west, being on higher ground appear dominant in the landscape. Although part of the original curtilage of the farm has survived, the dominance of the commercial developments makes a moderate negative contribution to the setting of the heritage asset.

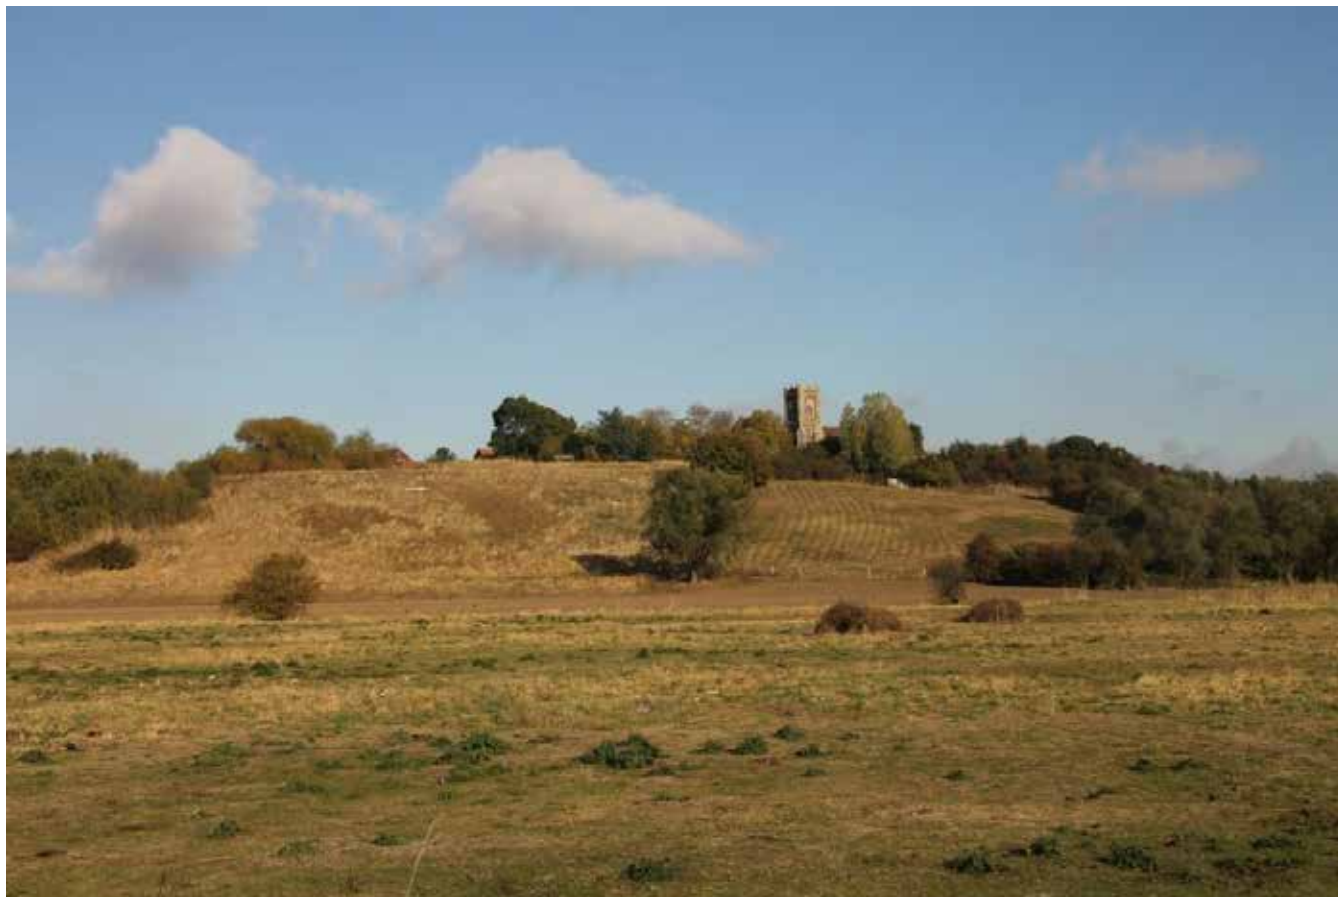
(Left) Figure 16 Location plan showing the principal views to and from the monument (other significant views are indicated by the smaller view-point symbols)

(Right) View 1: View looking northwards from Cooper Shaw Road up the escarpment to the monument with the Church and Hall complex behind
