Assessment of Settings

Thurrock Scheduled Ancient Monuments

April 2023

Authored by Historic Environment Team,
Place Services, Essex County Council

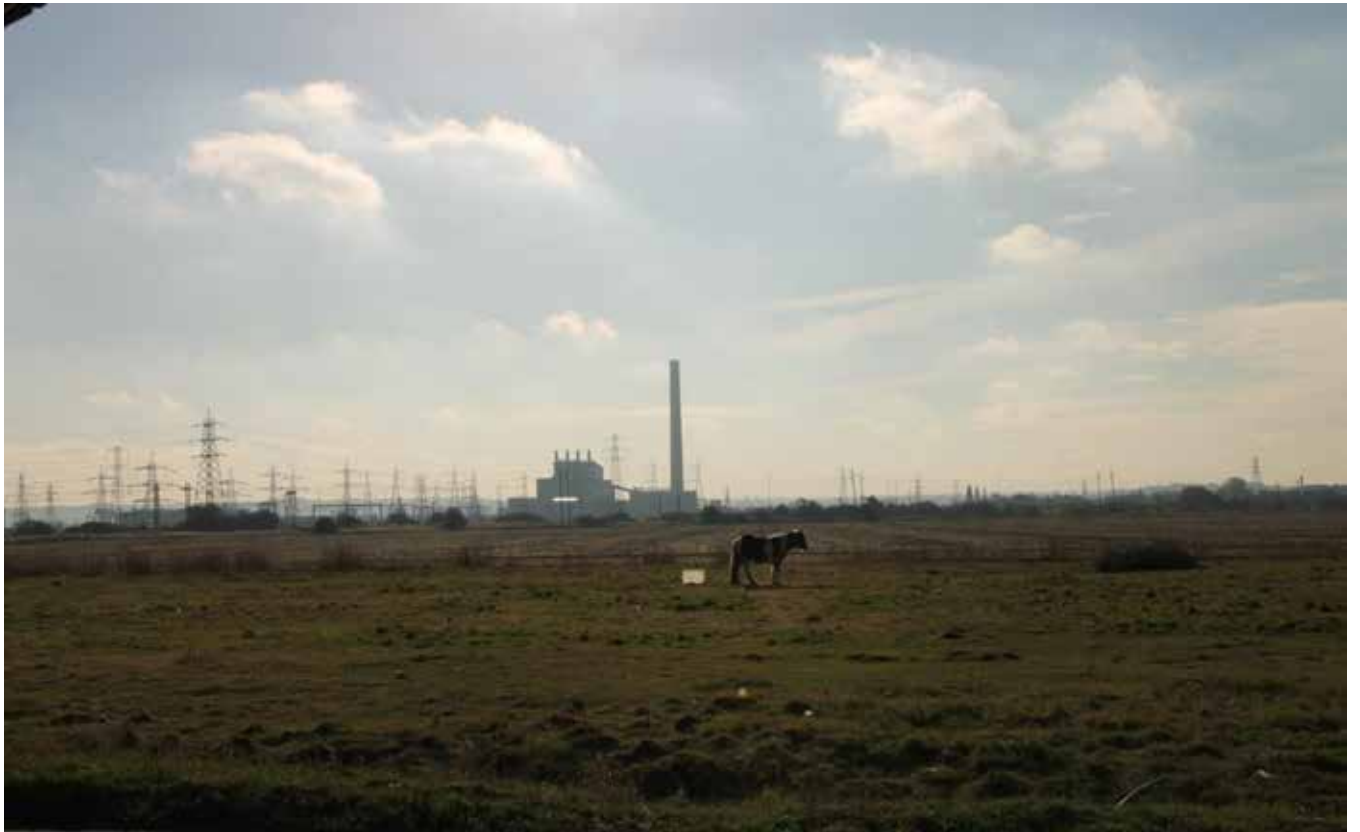
View 4: Looking south-west from the marsh edge towards Tilbury Power Station

monument in the past, but whether this took place during the period when the monument was in use or after it was abandoned is not known. The immediate setting of the site in relation to the Church and Hall, which are thought to be contemporaneous, remains largely unchanged. The escarpment location and open marshland setting remain much as they were throughout the presumed life of the monument, albeit with the addition of landfill sites, Tilbury Power Station and electricity pylons in the far distance.

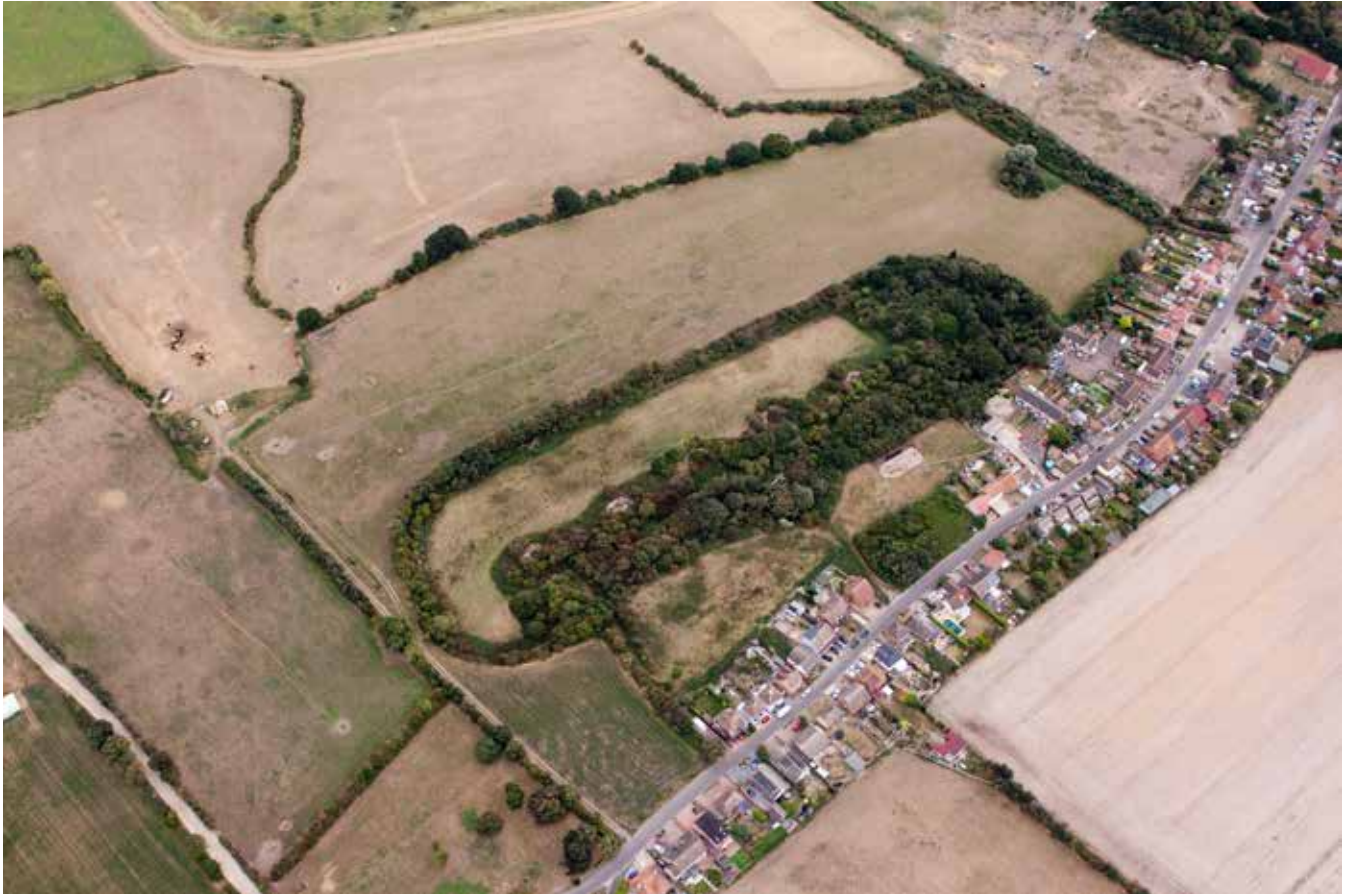
Figure 17 Plan showing the battery and the principal views in and out of the monument (other significant views are indicated by the smaller view-point symbols)

Figure 18 This aerial view shows some of the gun emplacements, but other structures are obscured by the vegetation. This also shows the former marshland (upper half of photo), now agricultural land between the battery and sea wall. East Tilbury is located to the rear of the battery.

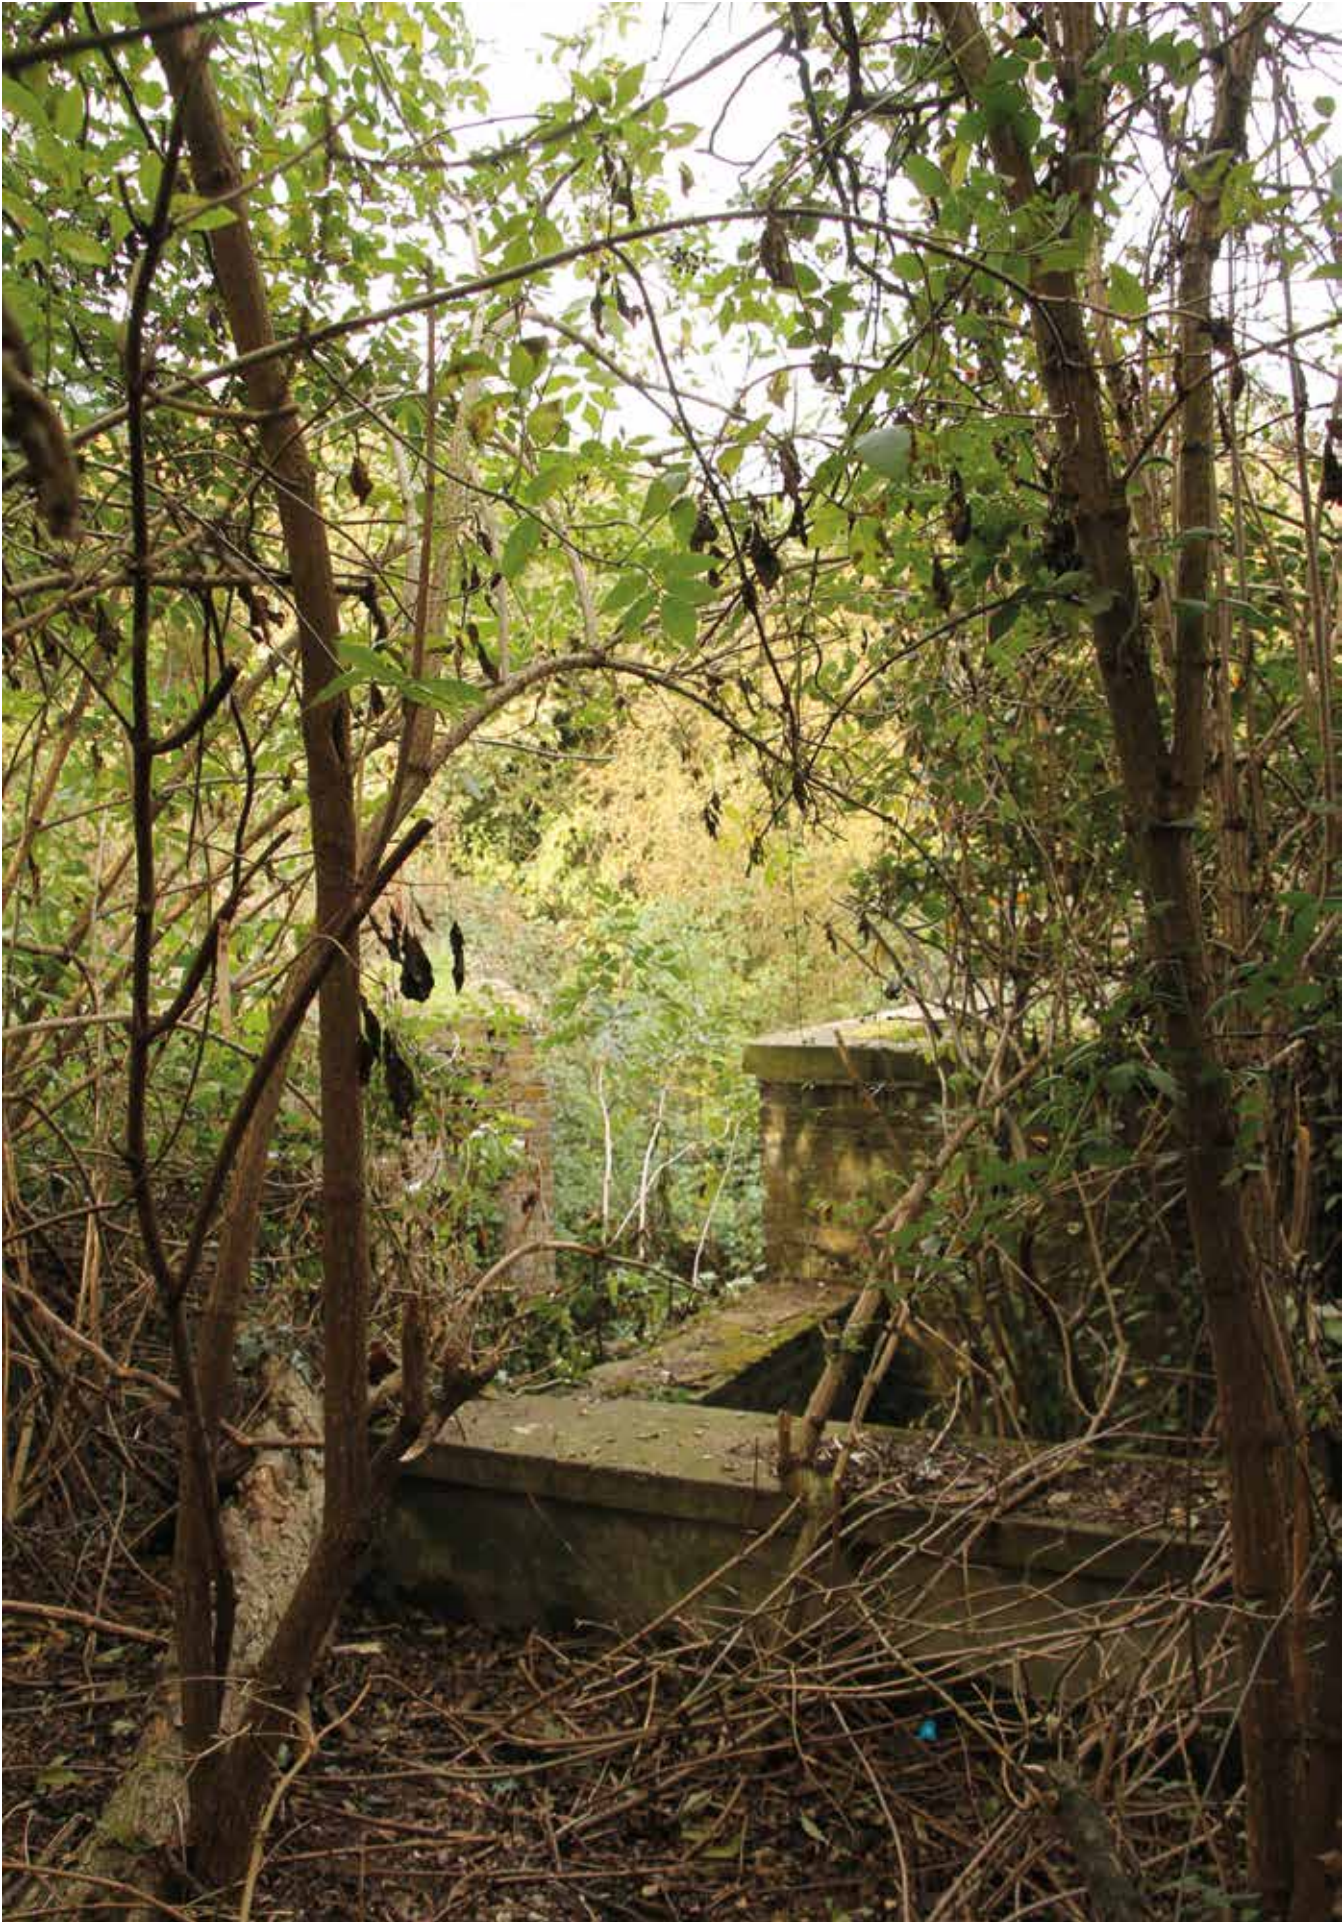
View 1: Part of the battery structure showing the undergrowth which has grown up around it.

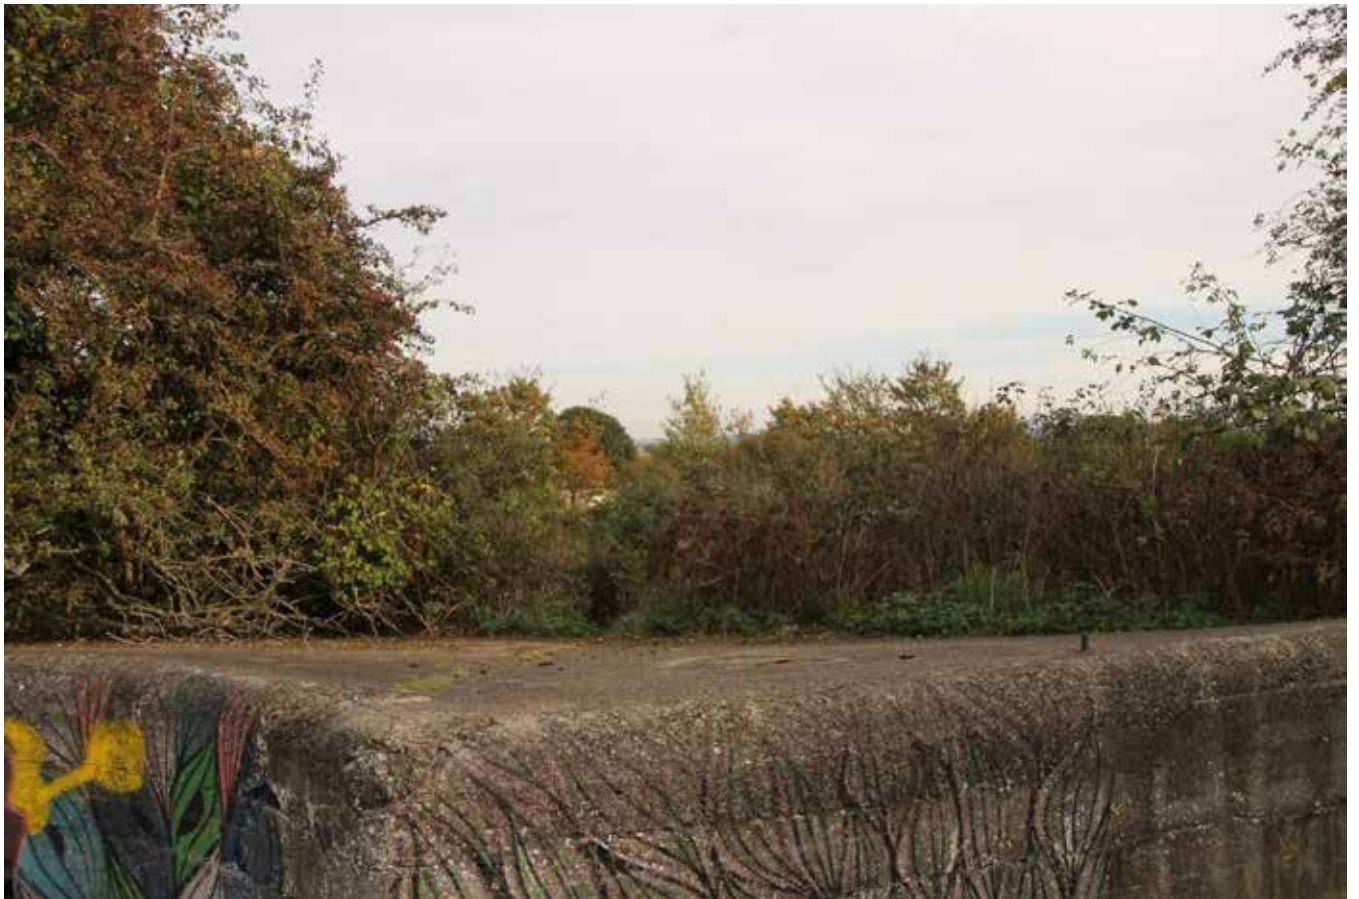
View 2: View eastwards from one of the gun positions towards the marsh and river, which are no longer visible.

The battery was constructed with a clear view across the marshes and sea wall to the Thames. The nature of the marshes has changed, with improvement around the edges of the marsh by drainage and some enclosure of individual fields. There are now mature hedge lines blocking that view across the marsh. The battery went out of use before the First World War and the guns removed. The rest of the structure survives very well with what appears to be little damage, apart from graffiti and some rubbish dumping. The battery is now covered by tree growth, which may lead to structural damage. It is also impossible to see an overall view of the battery.

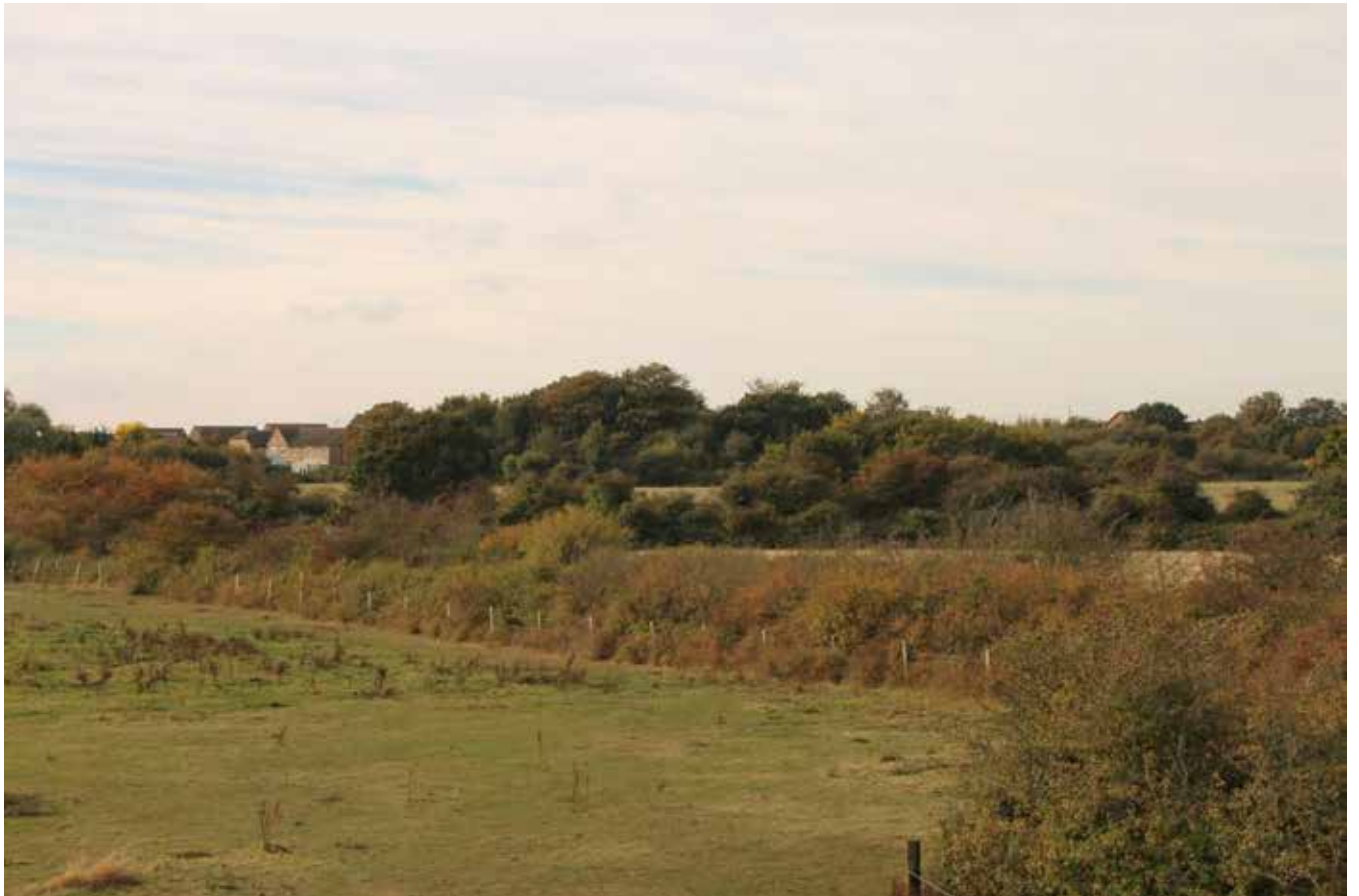
View 3: View of the battery from the east on the seawall, showing the tree and shrub growth on the scheduled monument.

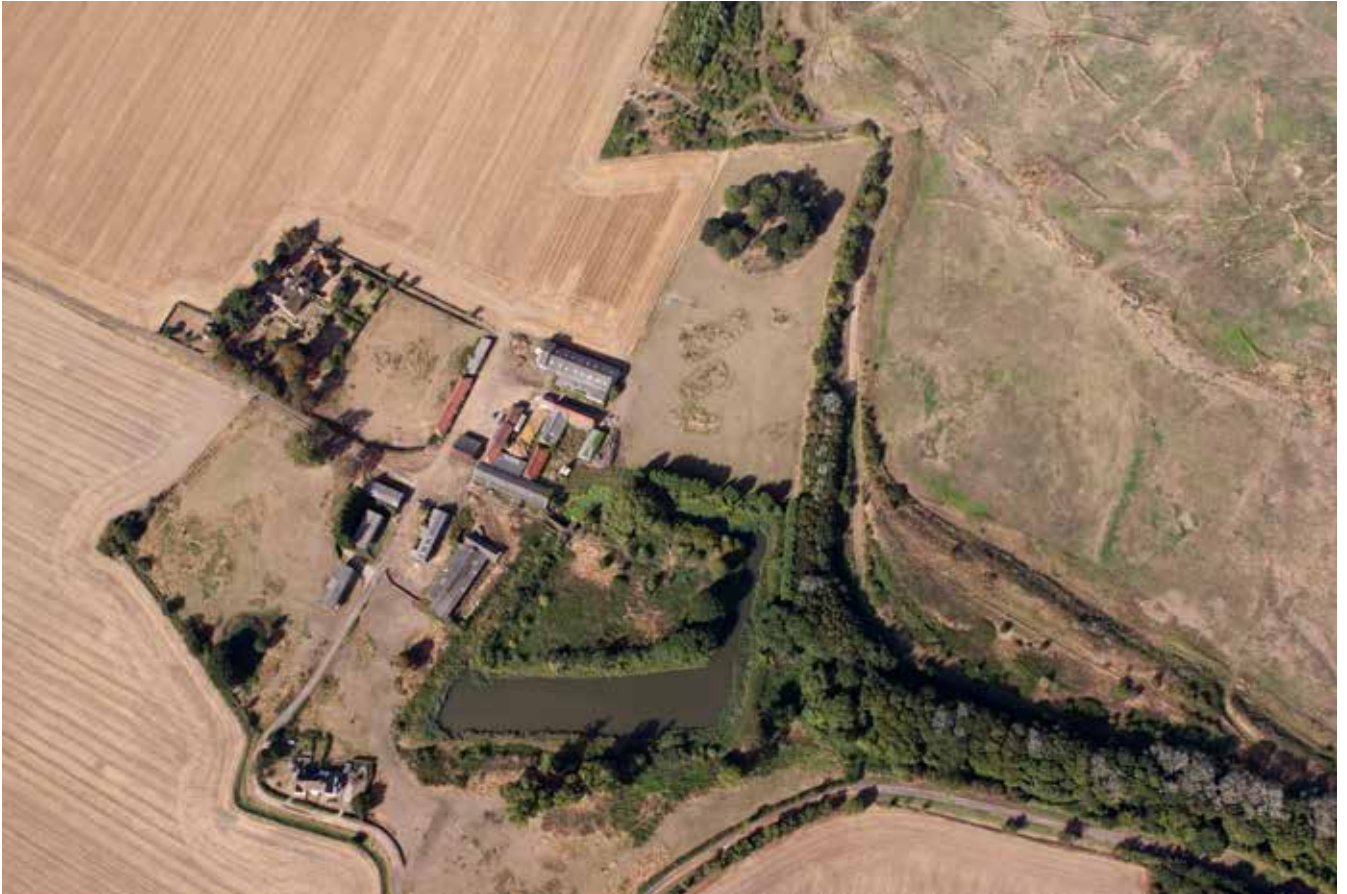
Figure 19 Location plan showing the principal views to and from the monument (other significant views are indicated by the smaller view-point symbols)

Figure 20 Aerial photograph of both the Scheduled moat and of the Roman barrow to the north, together with the associated farm complex. The clay-pit is located on the right-hand side of the photo

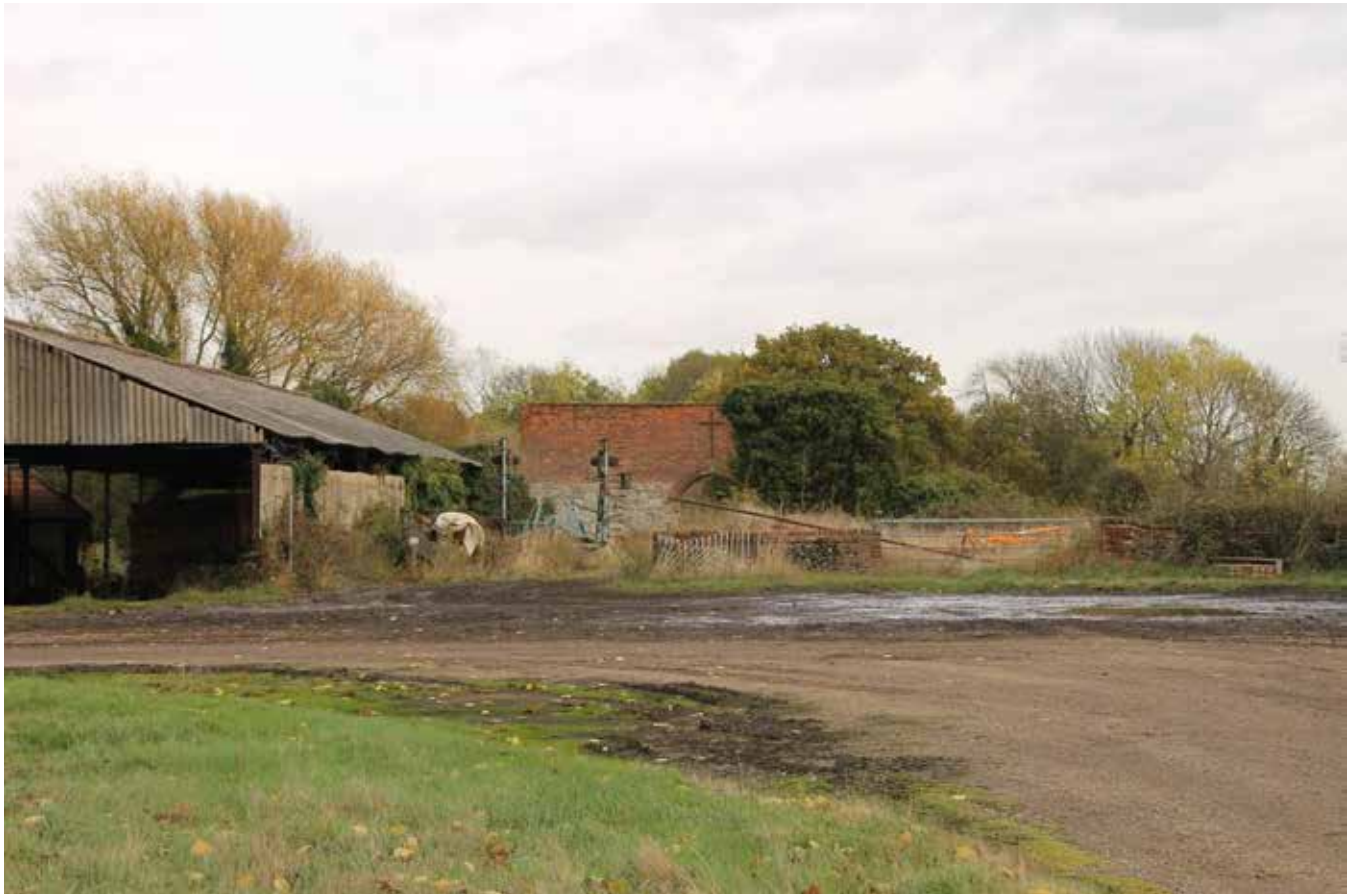
View 2: Looking from the farmyard access road to the gatehouse, the moated site is under the vegetation to the rear of the gatehouse.

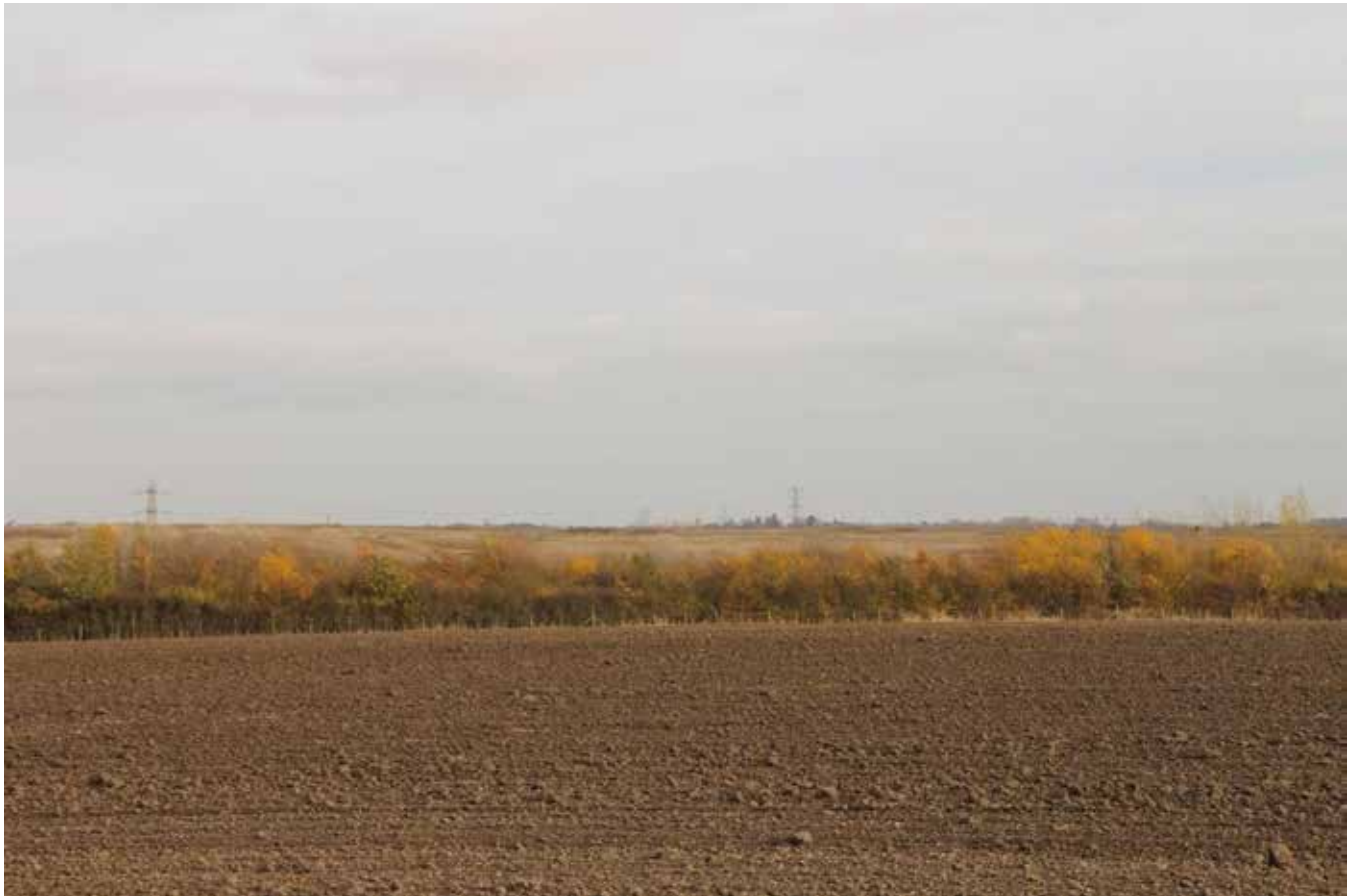
View 6: Looking from the footpath to the south-east, showing the raised levels relating to the reinstated quarries, the cranes of the London Gateway port are visible on the horizon

Moated sites are the typical monument of the Essex medieval landscape, with some 933 recorded on the Historic Environment Record, of which 109 are Scheduled, and many more are of Schedulable quality. South Ockenden Old Hall is unusual both in the size and quality of its moat and the survival of the gatehouse, evidence that it represented a higher-status monument than many of its contemporaries. Many of the Essex moated sites, including that of South Ockenden, are still located within their original rural setting. There has been extensive quarrying to the east, which has been largely reinstated, albeit not to the original ground levels.

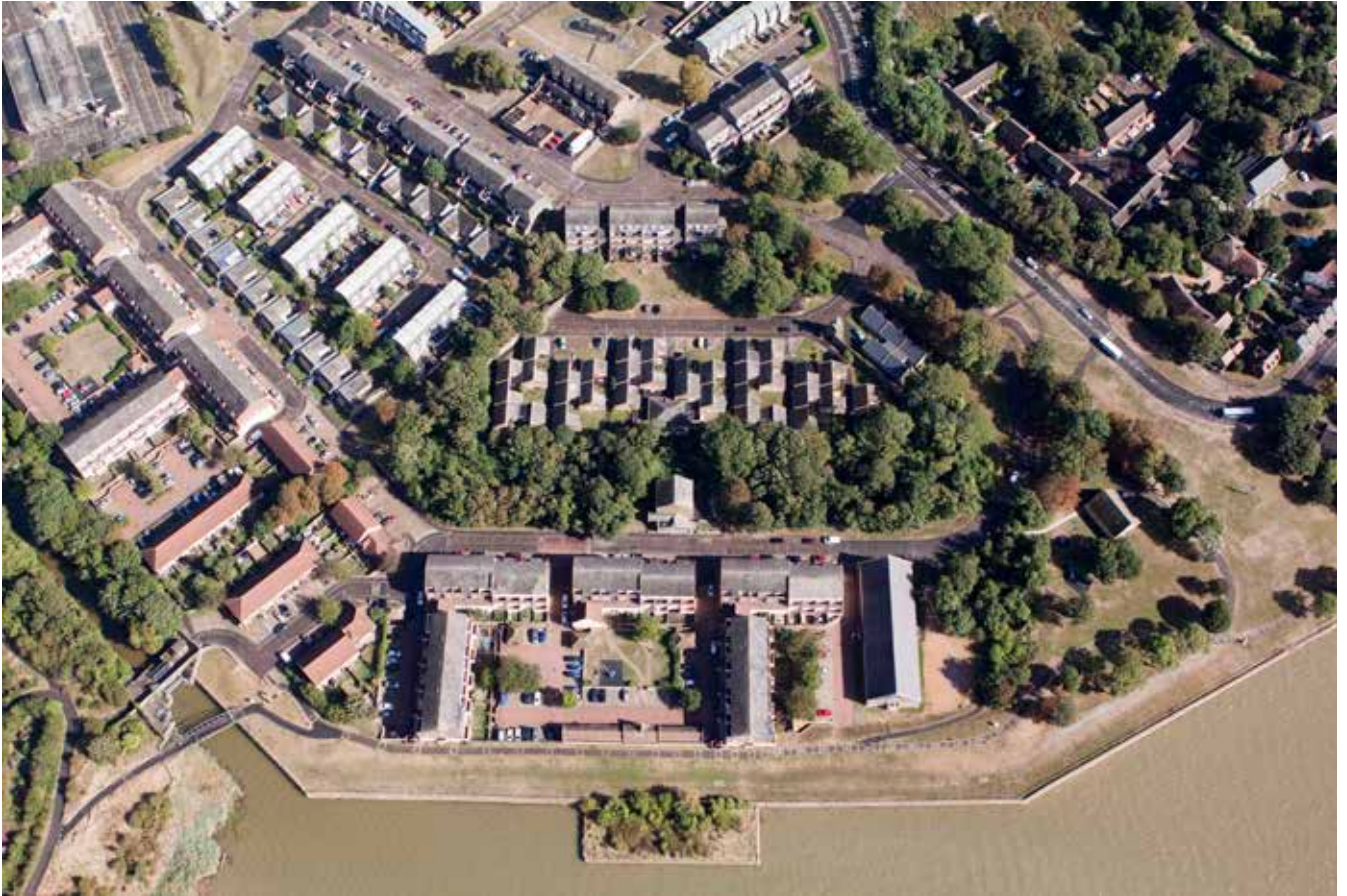
Figure 21 Location plan showing the principal views to and from the monument

Figure 22 Aerial view of Purfleet Magazine looking north, showing its Thameside setting.

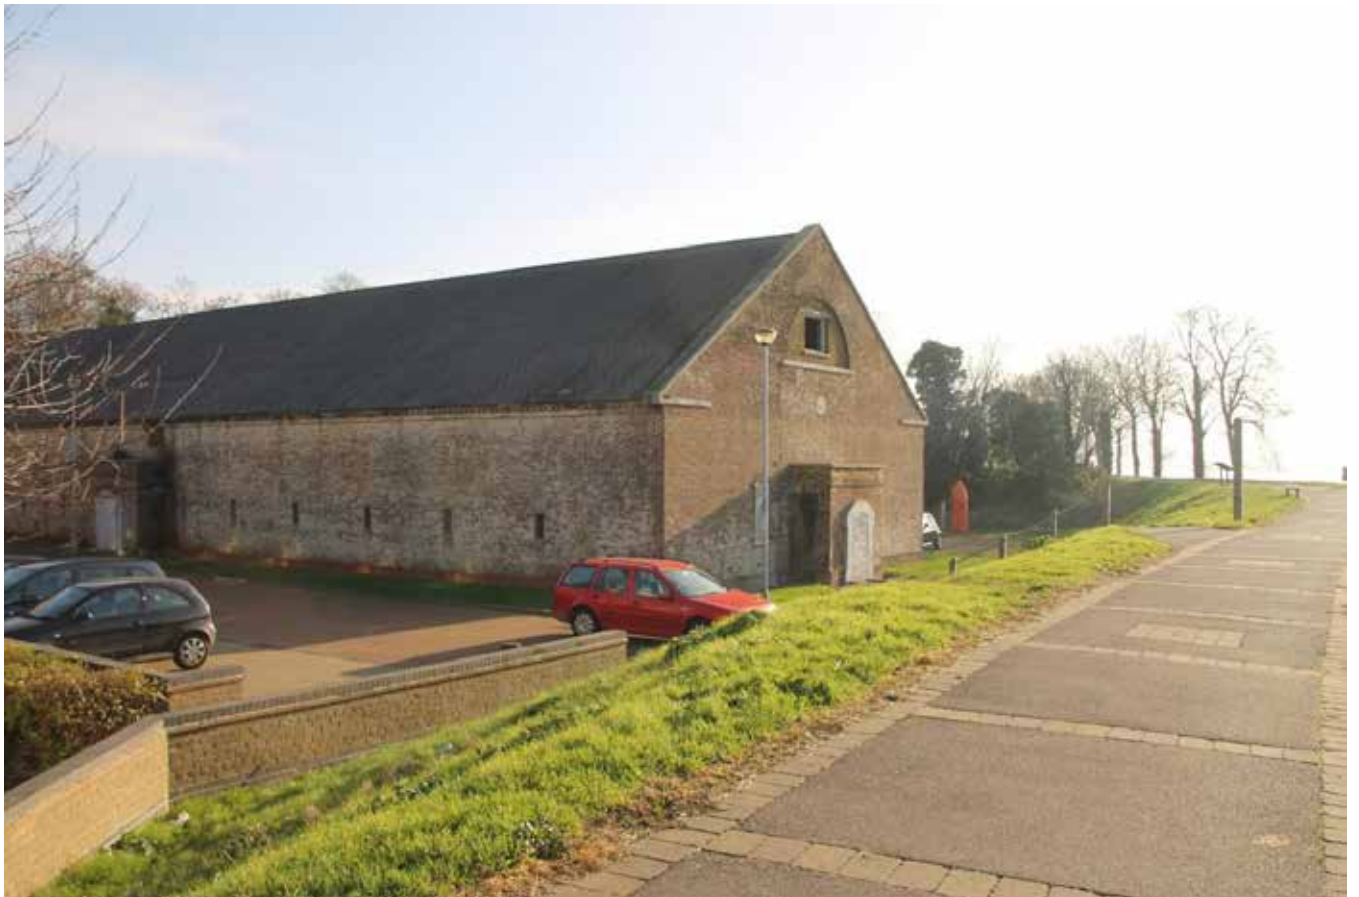
View 1: View looking southwards along the seawall to the Magazine building and beyond to the corner of the park and the Thames

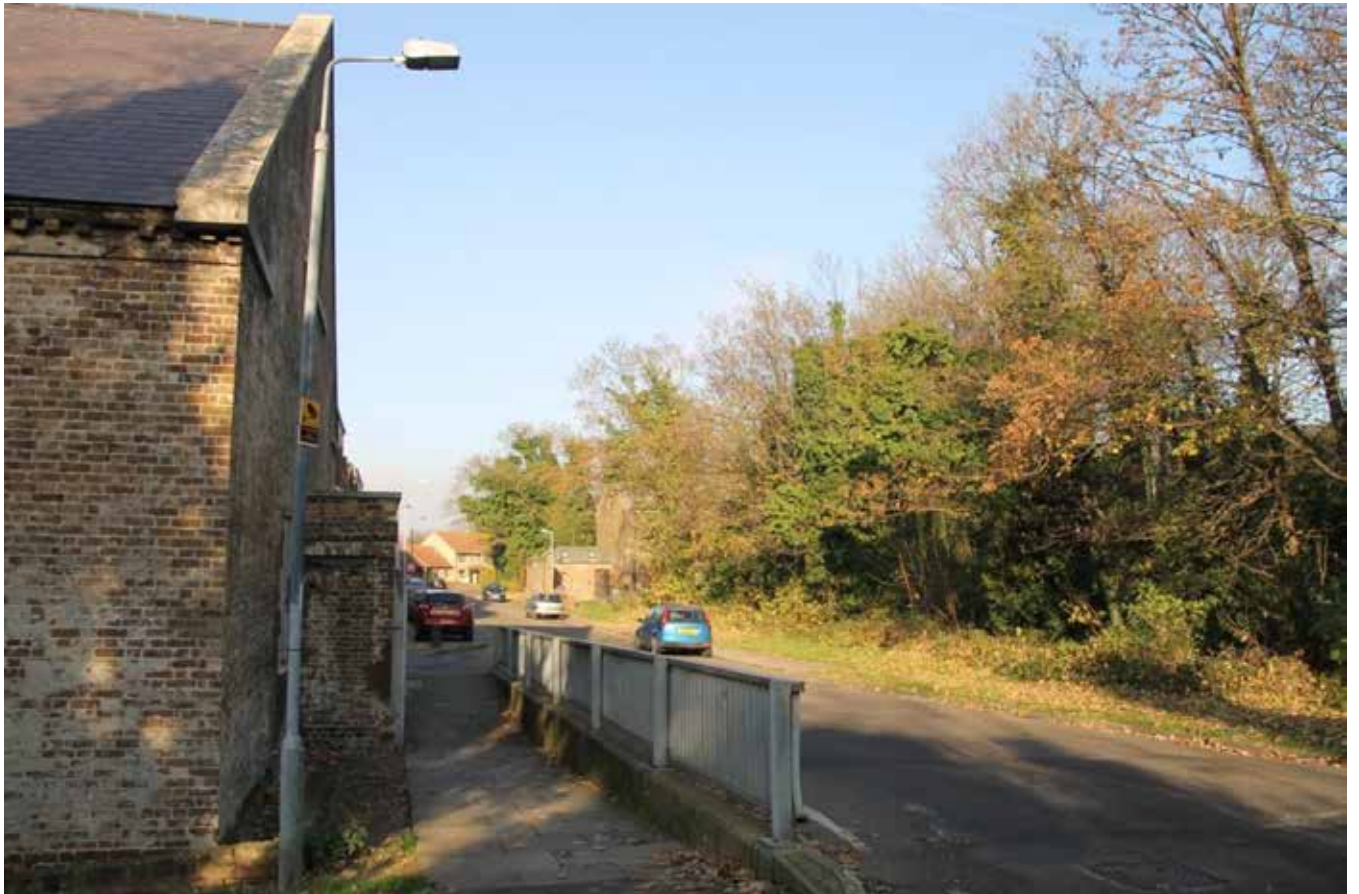
View 2: View looking northwards from the Magazine to the Proof House, showing the natural slope of the edge of the escarpment

with a hot iron on a glass, porcelain or copper plate: the (altered) interior was originally provided with a gallery. This function of testing powder took place against the background of scientific development in eighteenth century France and Britain and Britain's attempts to standardise and improve the quality of powder available to the army and navy. It also relates to a critical period in Britain's growth as a naval power in the decades after the Seven Years War. This scientific testing was to ramify greatly and have a decisive effect on the development of explosives sites and military ordnance yards in the 19th century. The only other proof house to have survived is the early nineteenth century example at the Marsh Works in Faversham, Kent. The plan and form of this building - the gallery being repeated in Sir Frederick Abel's laboratory of the 1860s at Woolwich's Royal Arsenal (grade II) - also clearly relates to its function as an eighteenth century laboratory building, one that now represents a very rare, possibly unique, example of such a structure.

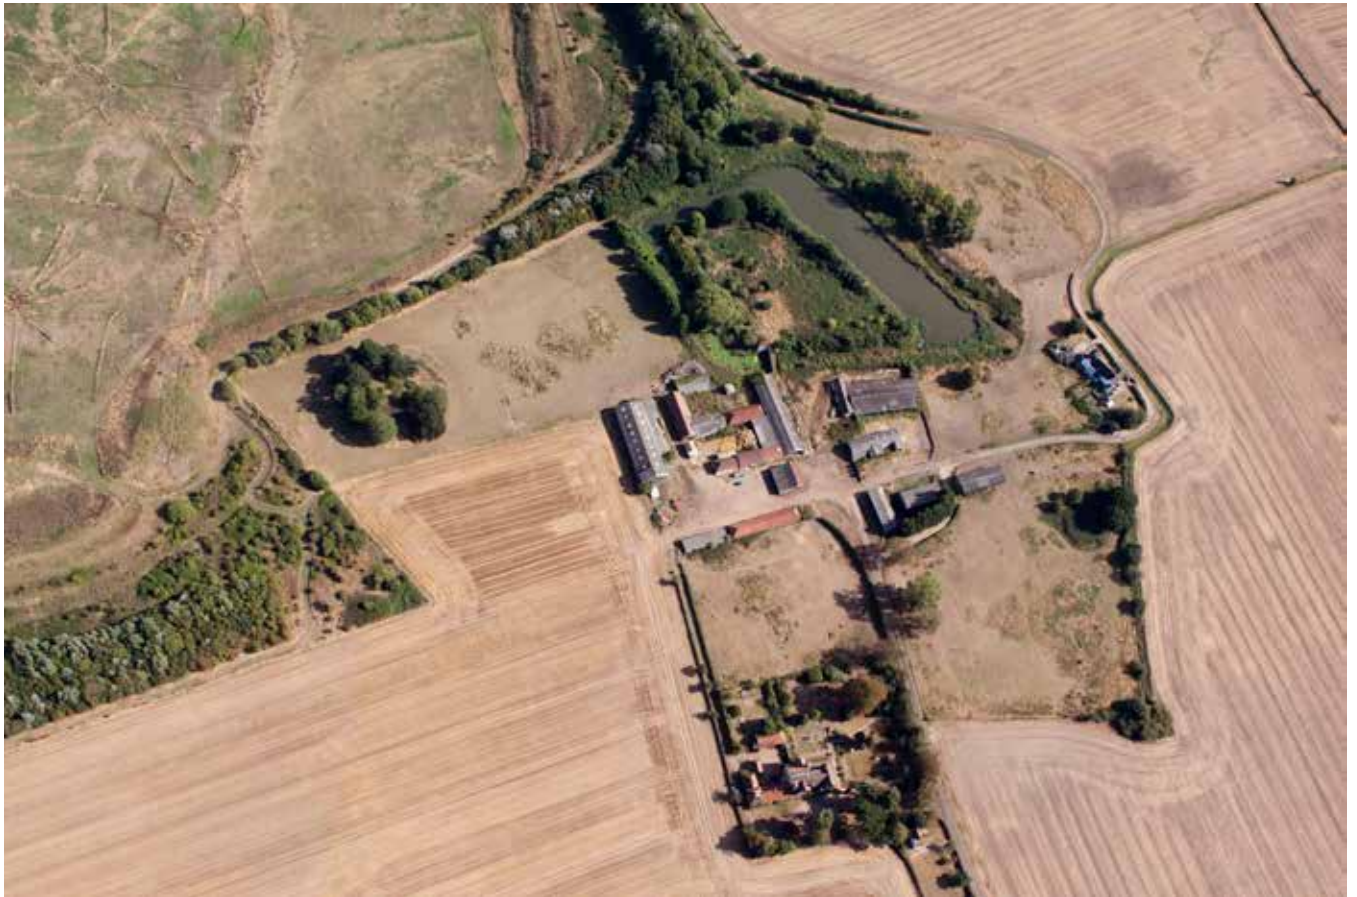
Figure 24 Aerial photograph looking east across the Roman barrow showing the inter-relationship between it and the Scheduled moat and associated farm complex to the right of it. The cropmark of the second barrow is just visible in the top right-hand corner of the photo. The clay-pit occupies the top left-hand side of the photo.

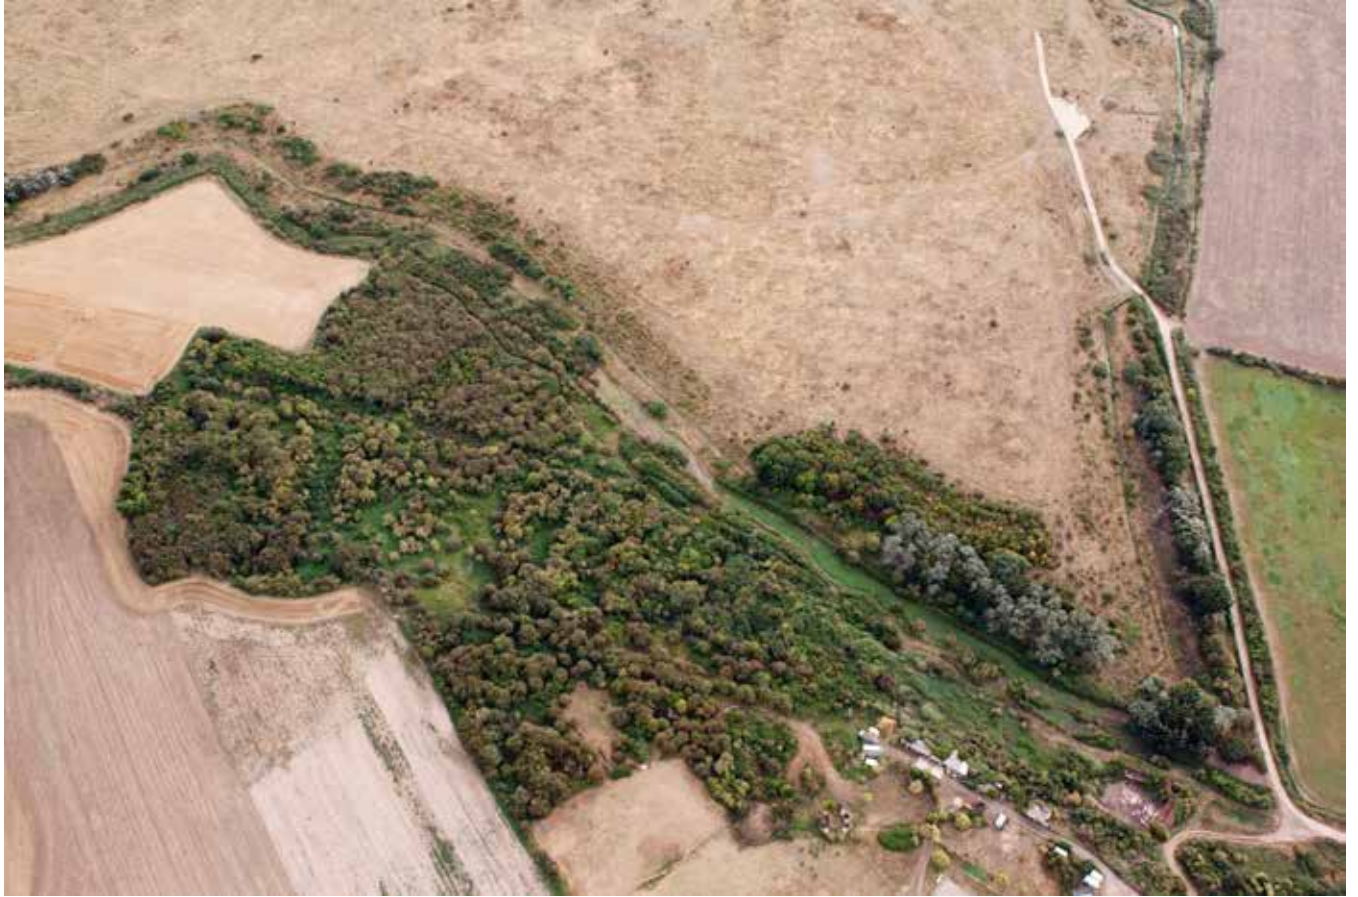
Figure 26 Aerial view of the anti-aircraft battery from the north. Some of the structures are showing at the bottom of the photo.

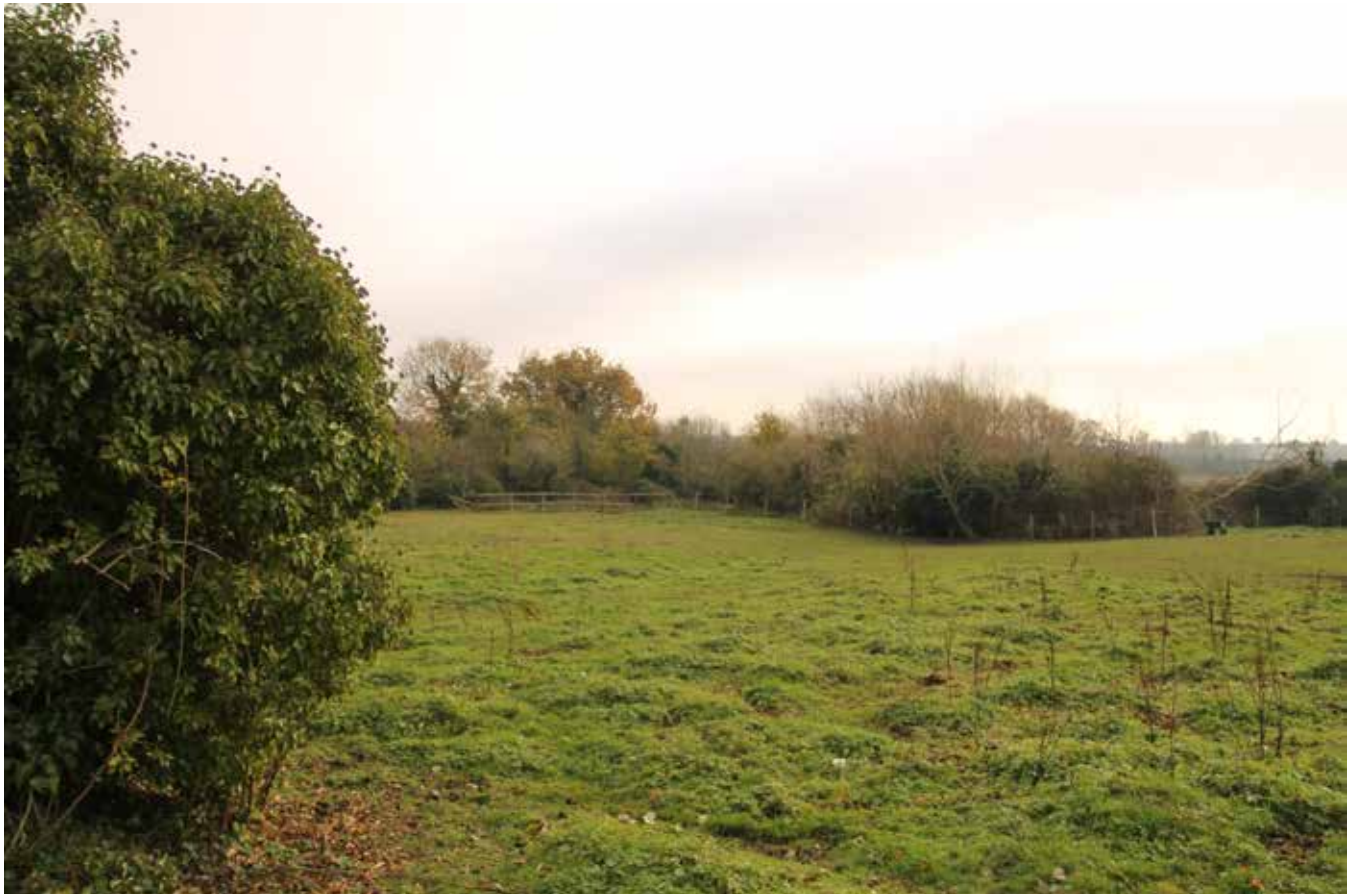
View 2: Looking south-east from the churchyard boundary across the Scheduled area, the western arm of the moat is just visible as a depression running across the centre of the photograph. The remainder of the site is under the scrub. The fields to the south can just be glimpsed over the hedge.

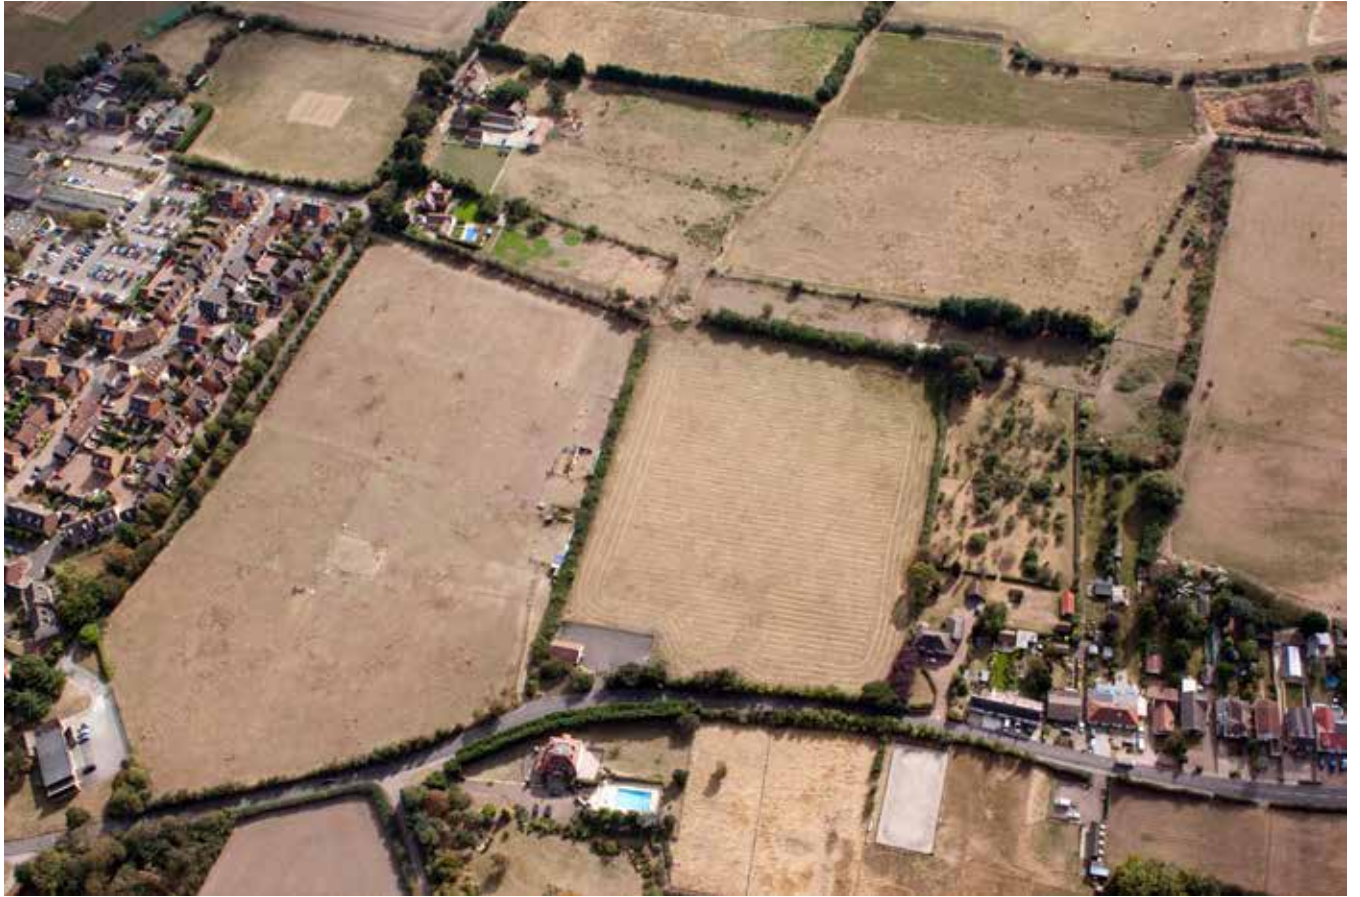
Figure 30 Aerial photograph Looking south over the heritage asset, showing the immediate rural setting (EX16_03_001, ©ECC)

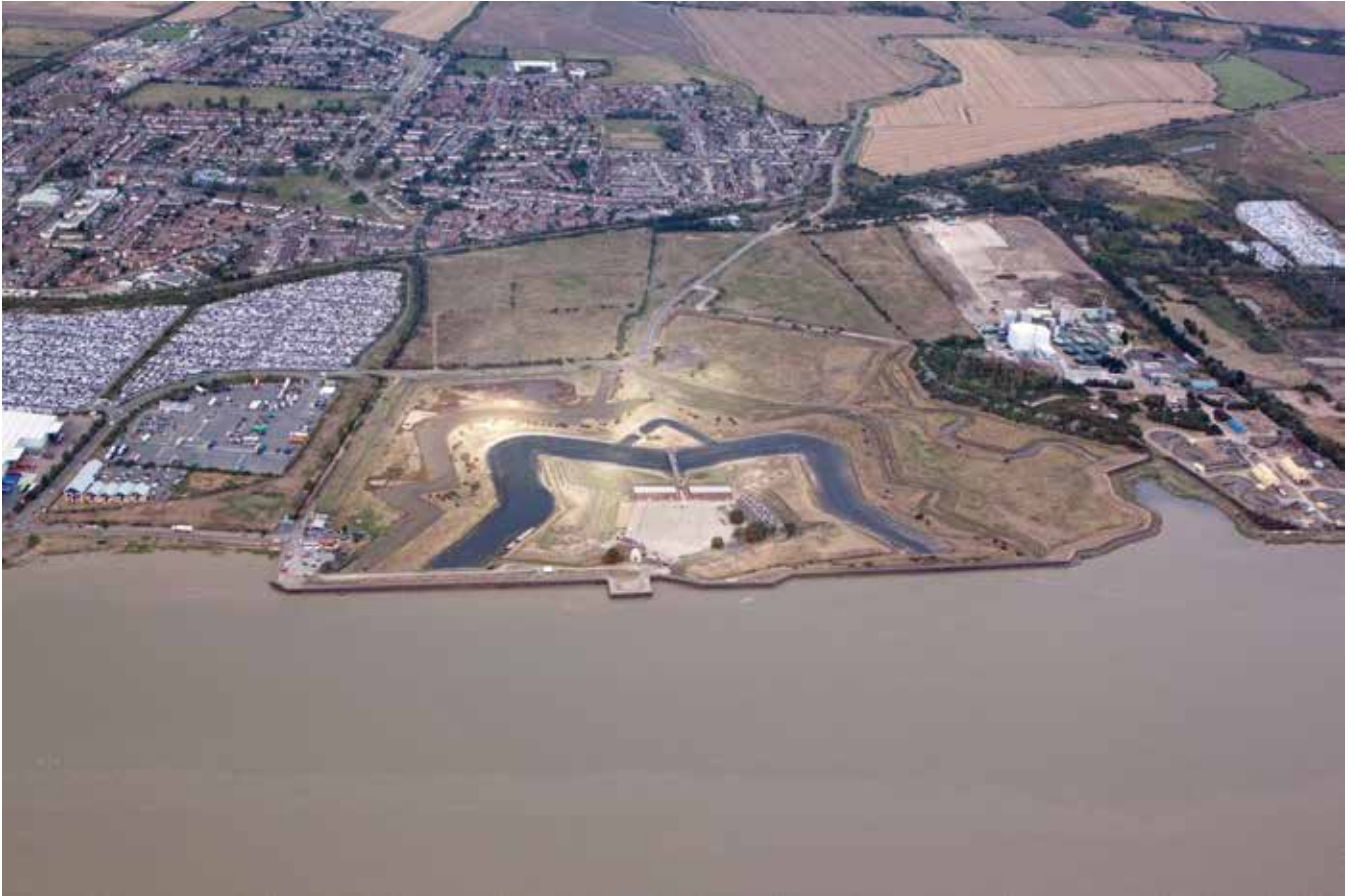
View 6: Aerial photograph of Tilbury Fort, looking northwards, showing the extent of the historic marshland, and the location of modern development in relation to the heritage asset.
