Assessment of Settings

Thurrock Scheduled Ancient Monuments

April 2023

Authored by Historic Environment Team,
Place Services, Essex County Council

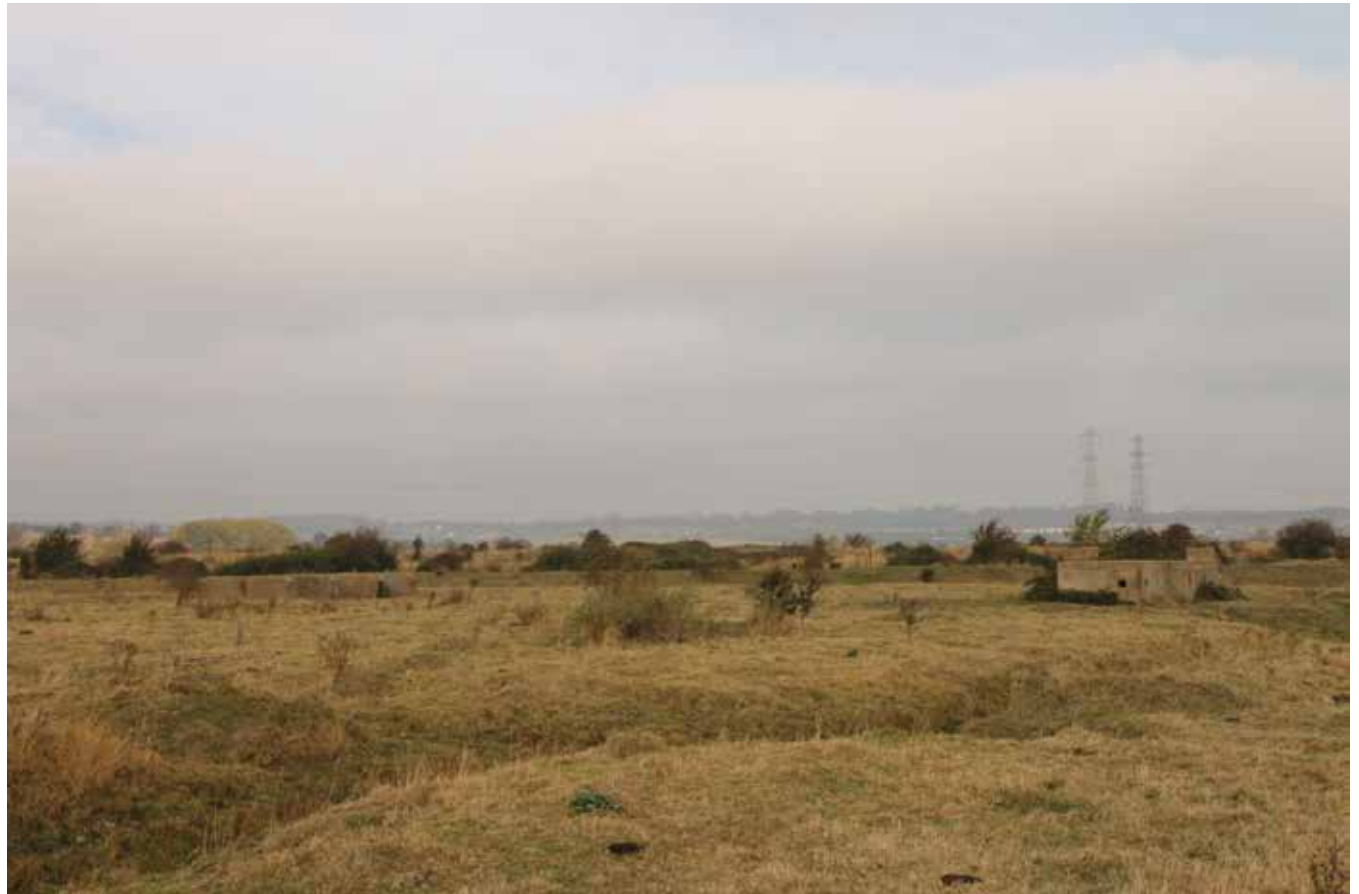
View 2: View looking northwards through the bombing decoy site (storage bays to left and night-shelter to right), across the marsh and the Fobbing Creek sea-wall to the higher ground at Vange. Some of the earthworks in the foreground relate to the historic farmstead of Great Ilfords.

The night shelter is built of concrete; it is 6m long by 3.2m wide, aligned north-south and has a single sloping entrance on its northern side. Inside are two rooms: the southernmost is the Operations Room, with the smaller Engine Room to its north. Approximately 17m to the west of the night shelter, on heavy concrete foundations, are four parallel walls each 7m long by 1.3m high, aligned east-west. With railway sleepers formerly bridging the gaps, these walls are thought to have functioned as six storage bays for the drums of oil necessary for the operation of the site.

Approximately 17m to the west of the night shelter, on heavy concrete foundations, are four parallel walls each 7m long by 1.3m high, aligned east-west. With railway sleepers formerly bridging the gaps, these walls are thought to have functioned as six storage bays for the drums of oil necessary for the operation of the site.

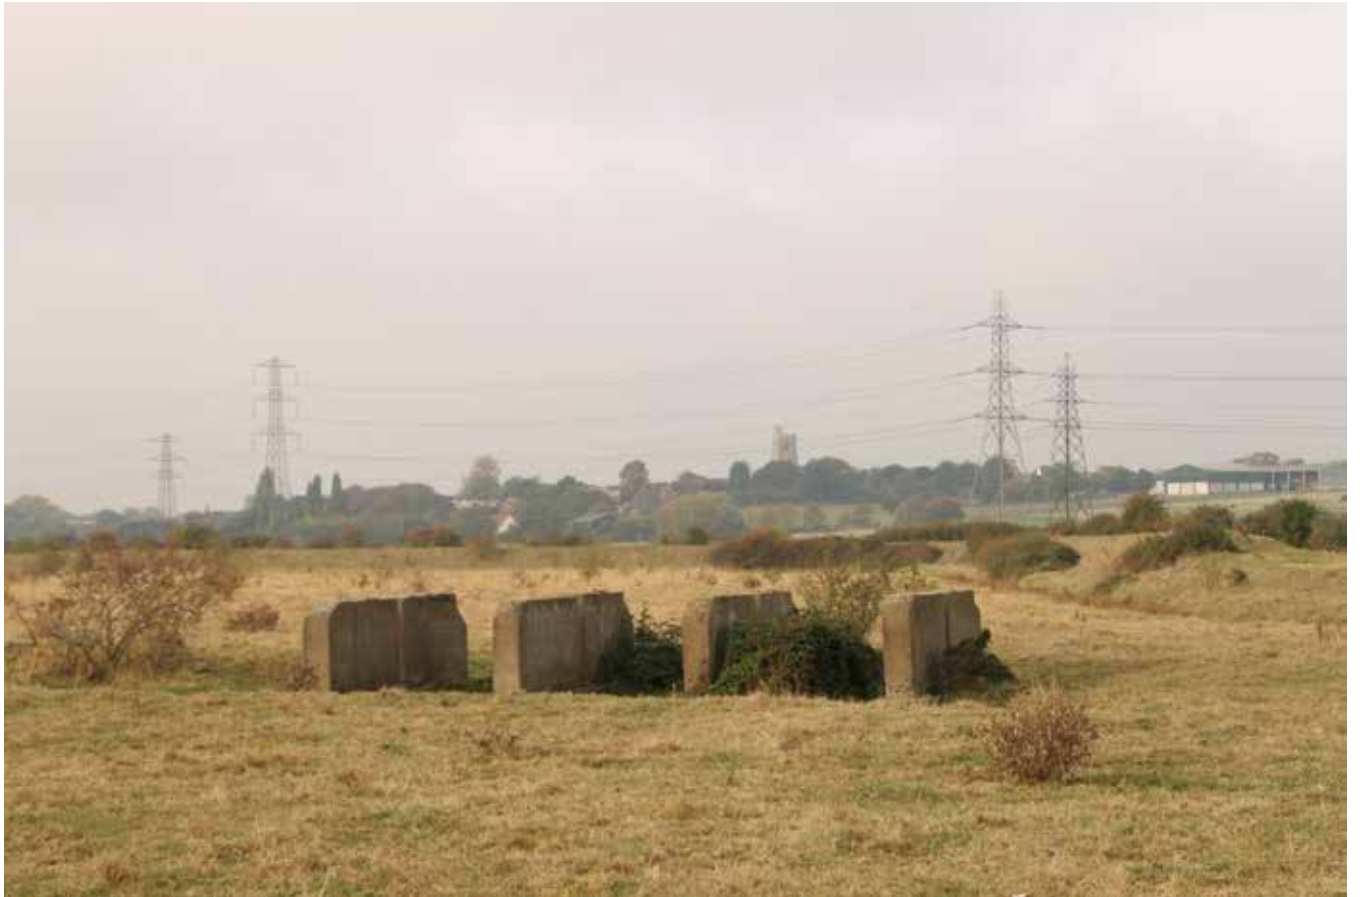
View 3: Looking eastwards across the storage bays to the historic settlement of Fobbing on the spur of higher ground, Fobbing church- tower is clearly visible above the tree line.

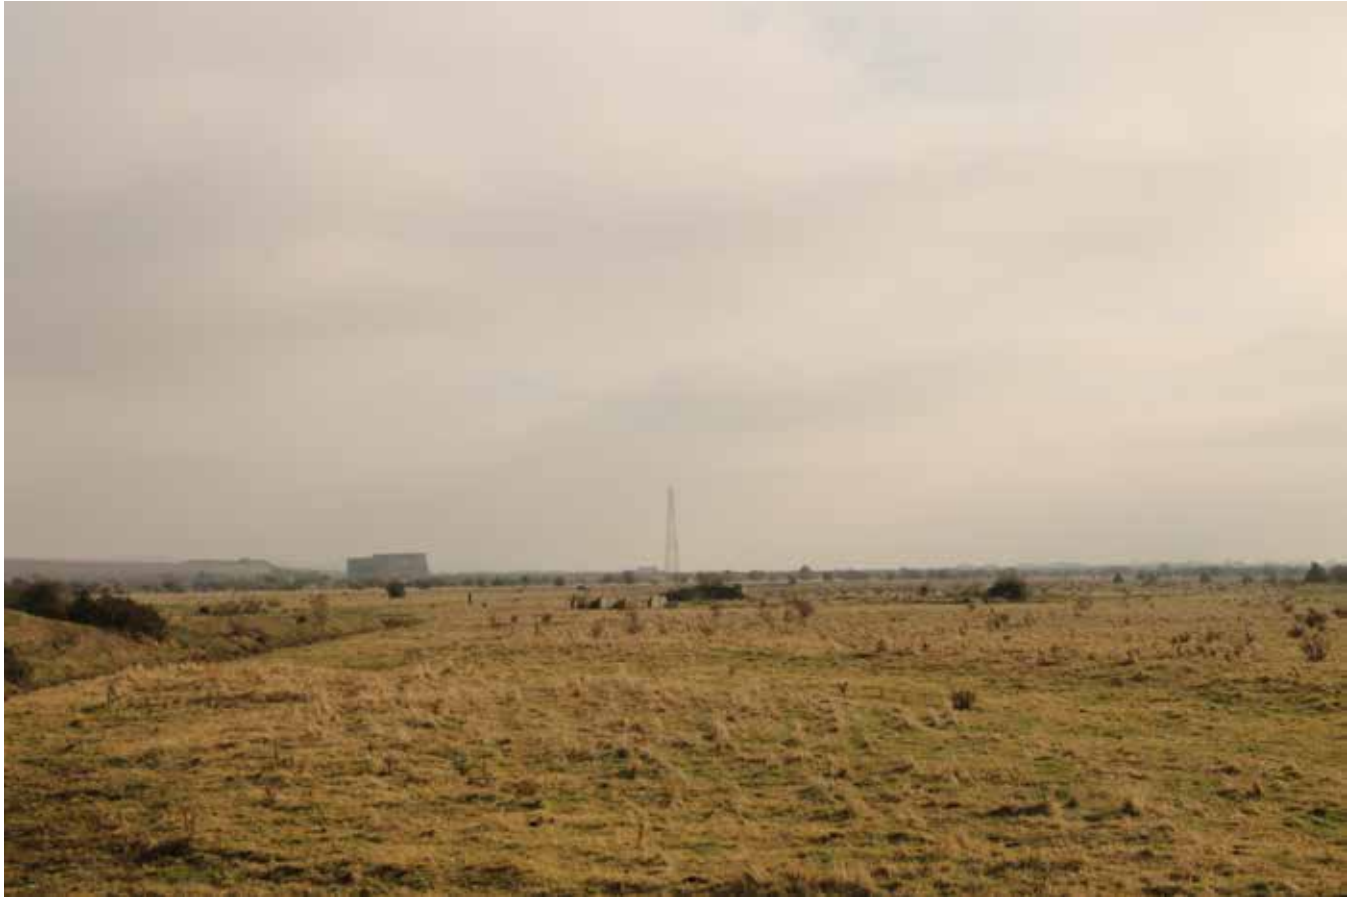
View 4: View to the east from the night-shelter to Canvey Island showing the open aspect of the marshland in this direction. The structure in the middle distance is the flood barrier on Holehaven Creek. The raised ground to the left of this is the Canvey Island land-fill site
