Assessment of Settings

Thurrock Scheduled Ancient Monuments

April 2023

Authored by Historic Environment Team,
Place Services, Essex County Council

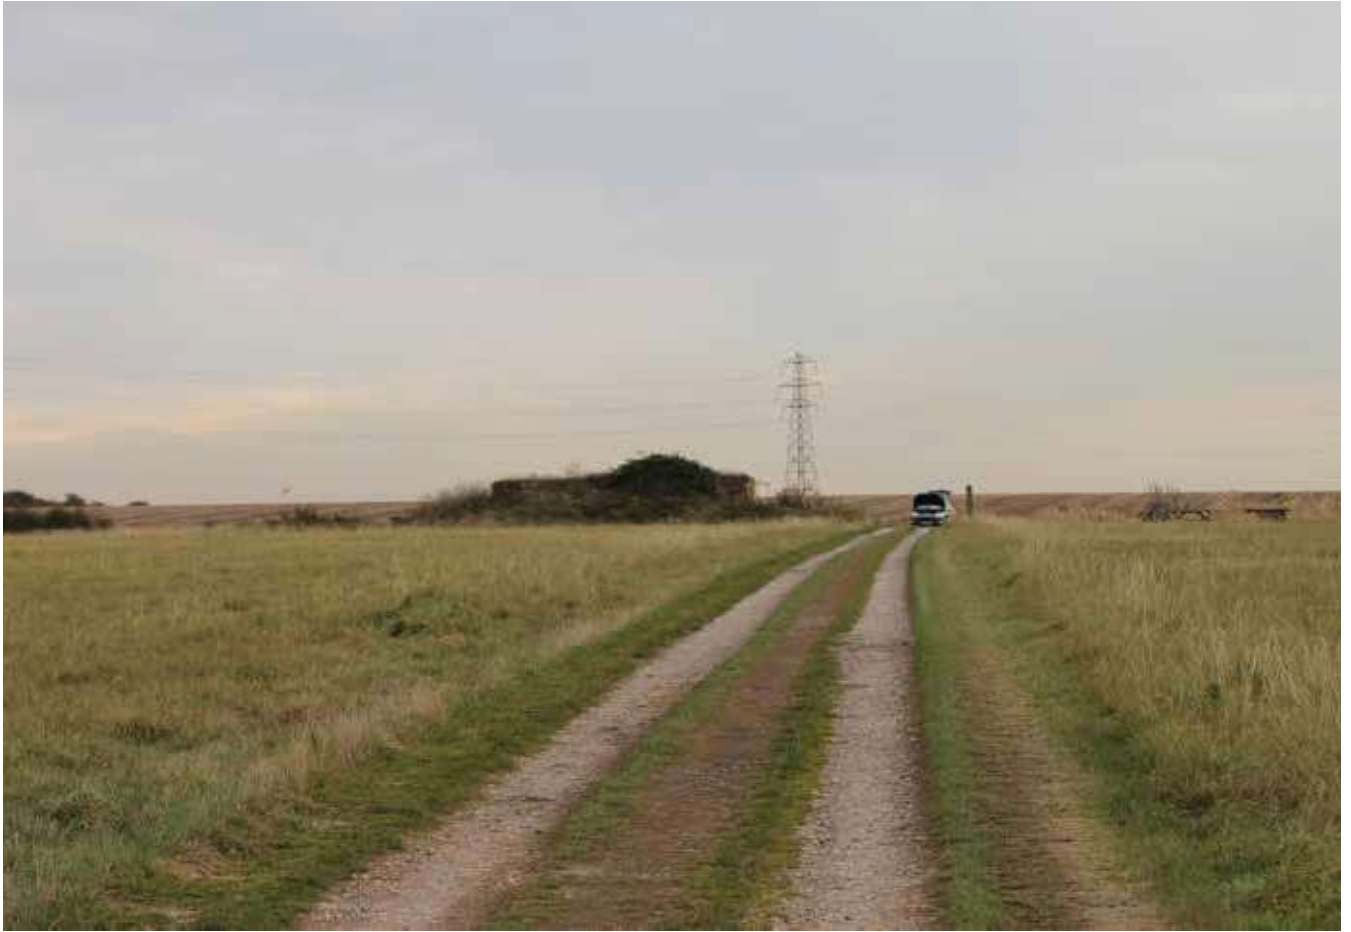
View 1: View looking south across the night-shelters (above-ground in the centre and the top of the below-ground on the right), also showing the modern pylon and the wind sock to the left.

The first night shelter to be built was constructed below ground level. Of concrete construction it had two entrances, one with steps halfway along the southern face and one taking the form of an escape hatch with vertical steel ladder (the former is now in-filled). These gave access to at least two

underground rooms. The only part of this shelter visible above-ground is the escape hatch and a steel chimney pipe. This structure was found to be prone to flooding and was replaced by an above-ground night shelter, located to the east, during the course of the war.

The monument is largely in good repair, with the above ground shelter currently being used as the club house for a model aeroplane club. The below ground shelter is difficult to access and there was some standing-water on the floor. It is known that there has been some dumping of waste materials into this part of the structure.

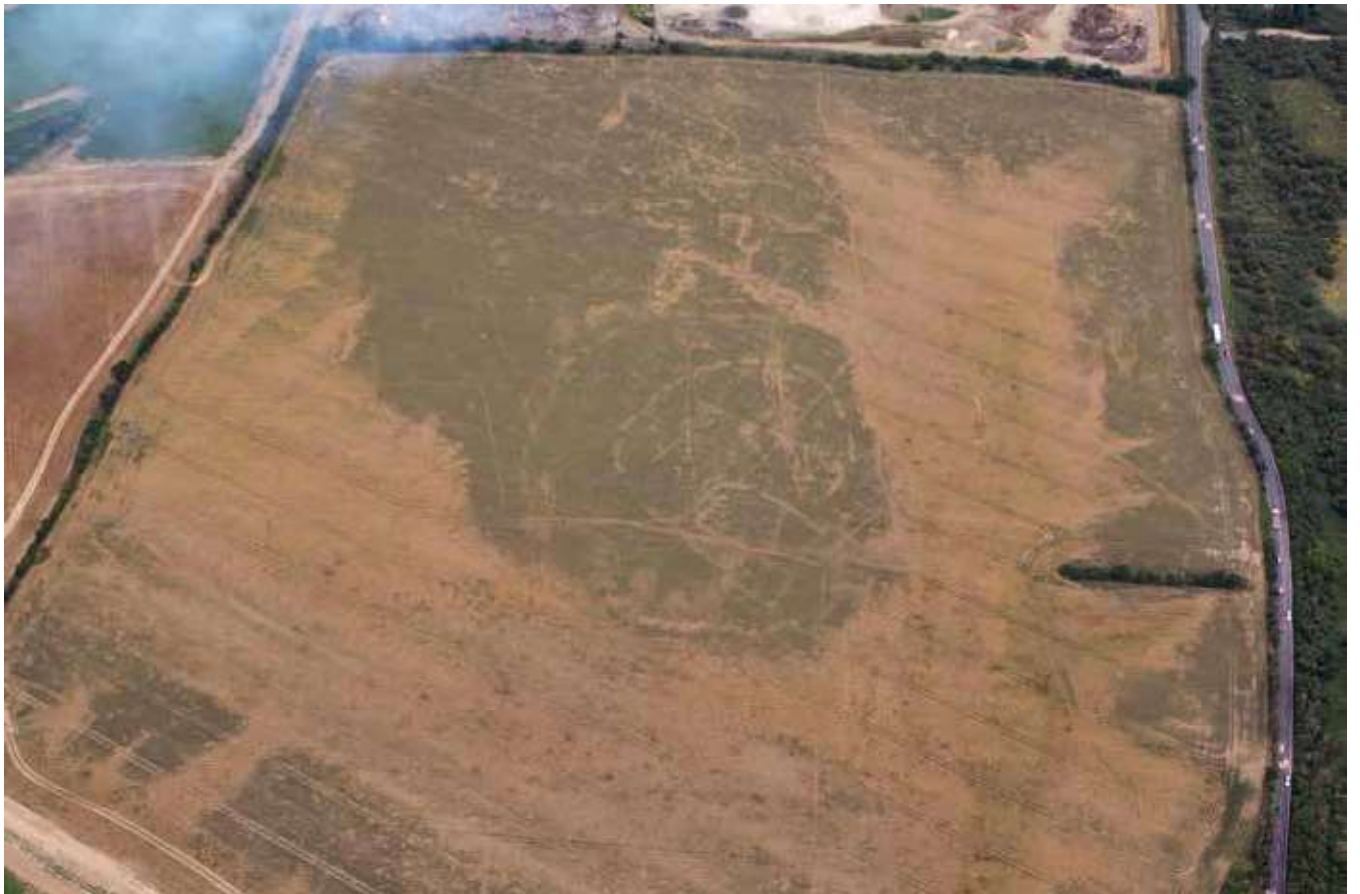
Figure 6 Aerial view of the cropmarks, looking north, the causewayed enclosure is visible in the centre of the photographs as the lighter dashed lines forming two concentric circles. (EX11_04_048 ©ECC)

The monument comprises a Neolithic causewayed enclosure, Iron Age settlement and an Anglo-Saxon round barrow cemetery situated on a natural platform on the Thames terraces. Although there are no visible earthworks at ground level the monument survives as buried features which have been identified as cropmarks from aerial photographs. These include three roughly

circular concentric interrupted ditches (i.e. they are not continuous but are crossed by causeways at irregular intervals), enclosing an area at least 160m in diameter.

In 1975 trial trenching and small scale excavation took place in order to verify the interpretation of the monument. Parts of the ditches and palisade slot were excavated which confirmed their Neolithic date. A continuous bank was found to have been originally constructed on the berm between the two outer ditches, the material for which was quarried from the interrupted ditches. The palisade was an additional, contemporary, defensive feature inside the middle ditch. Within the enclosed area various pits and post holes were investigated. A number of the features identified during excavation were shown to be Iron Age in date. A period of Early Iron Age settlement was followed in the Middle Iron Age by an enclosed settlement within a rectilinear ditched enclosure, which lies within the southern part of the monument. In addition, two of the five ring ditches were fully excavated and were found to represent round barrows containing Saxon inhumation burials in wooden coffins.

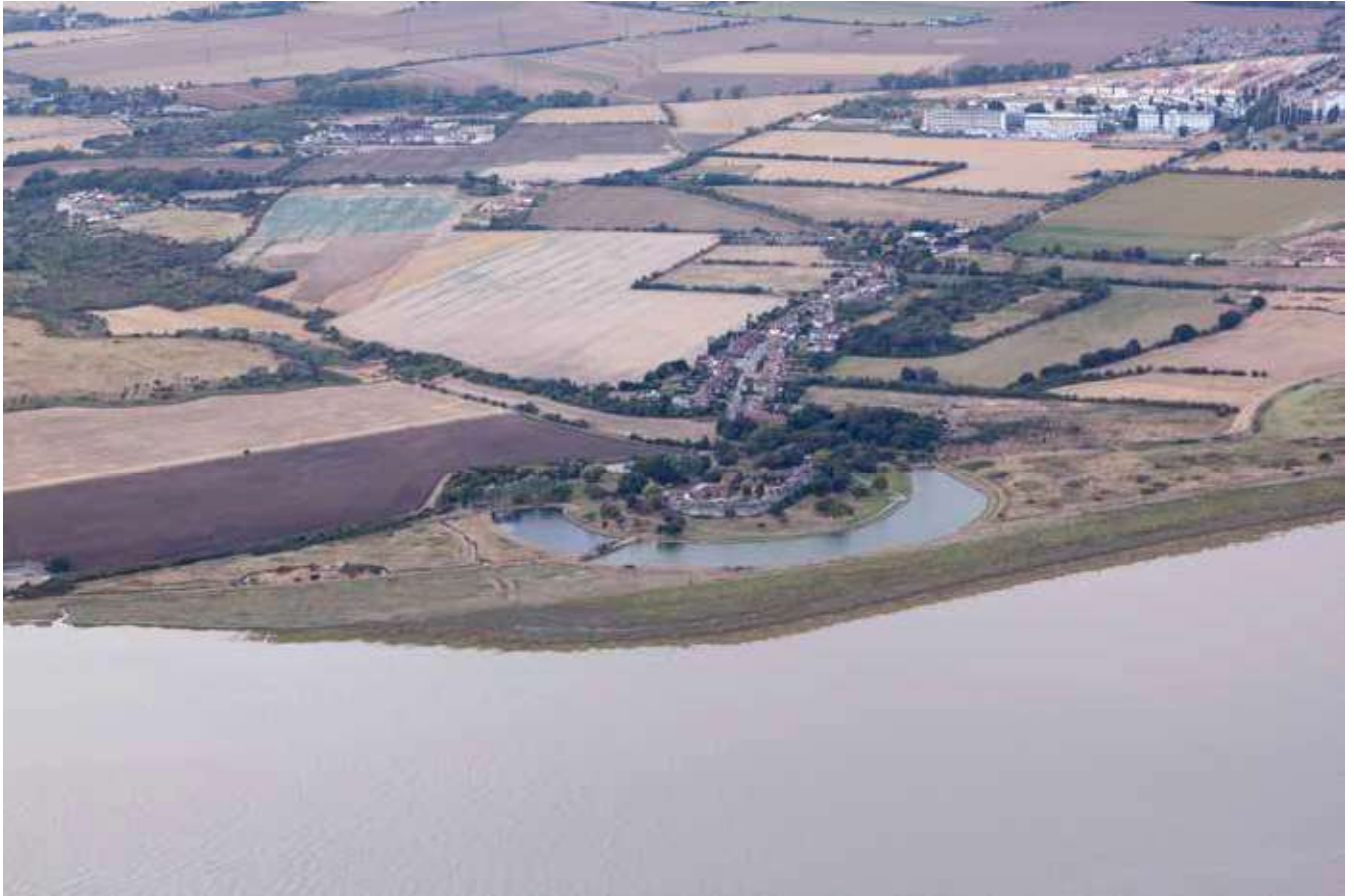
Figure 8: Aerial view of Coalhouse Fort showing its marshland setting. The East Tilbury battery is located in the small area of woodland beside East Tilbury to the rear of the Fort, whilst the Bowaters farm anti-aircraft battery is in the woodland on the left-hand edge of the photo.

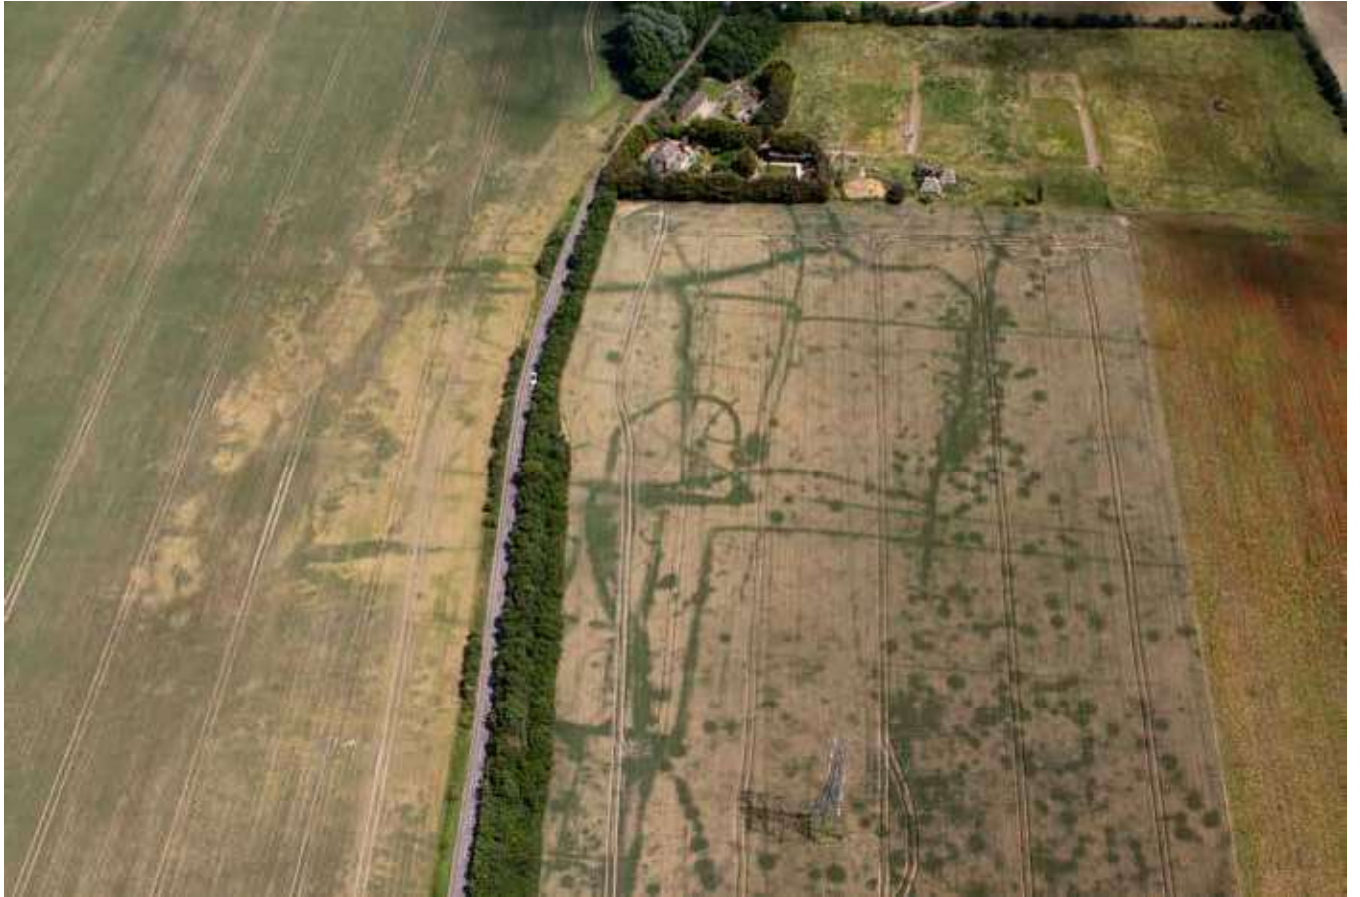
Figure 10: Aerial photograph of the cropmark complex, looking to the east. The cropmarks are visible as darker stripes in the ripening wheat; the A13 is located on the right-hand side of the photo (EX18/03/003, ©ECC)

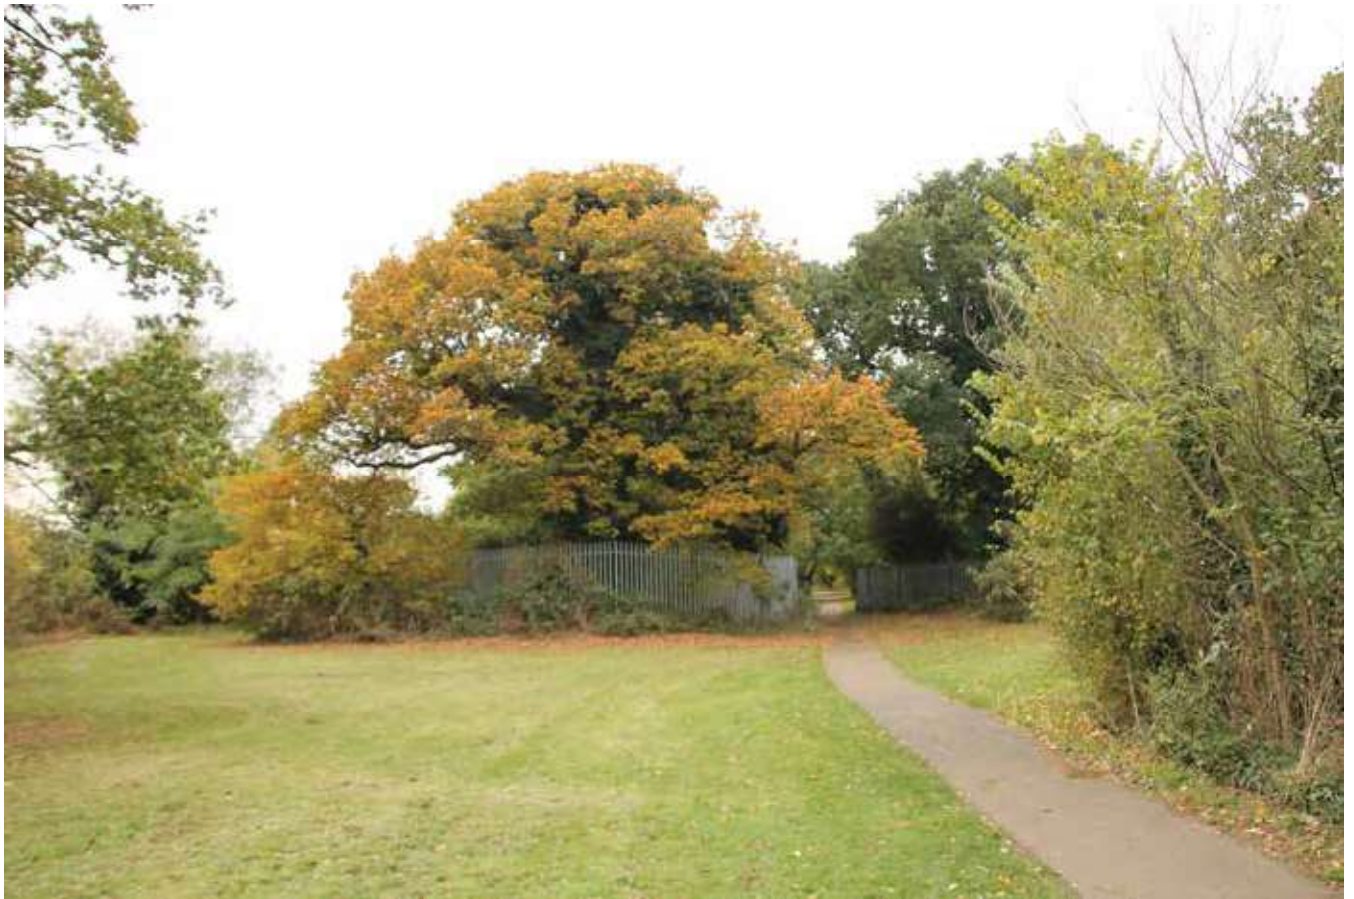
View 1: View looking west to two of the open dene holes (behind grey security fencing), located on either side of the main footpath. The rear boundary of the properties fronting Parkside is on the left and shrubby growth and trees are to the right.

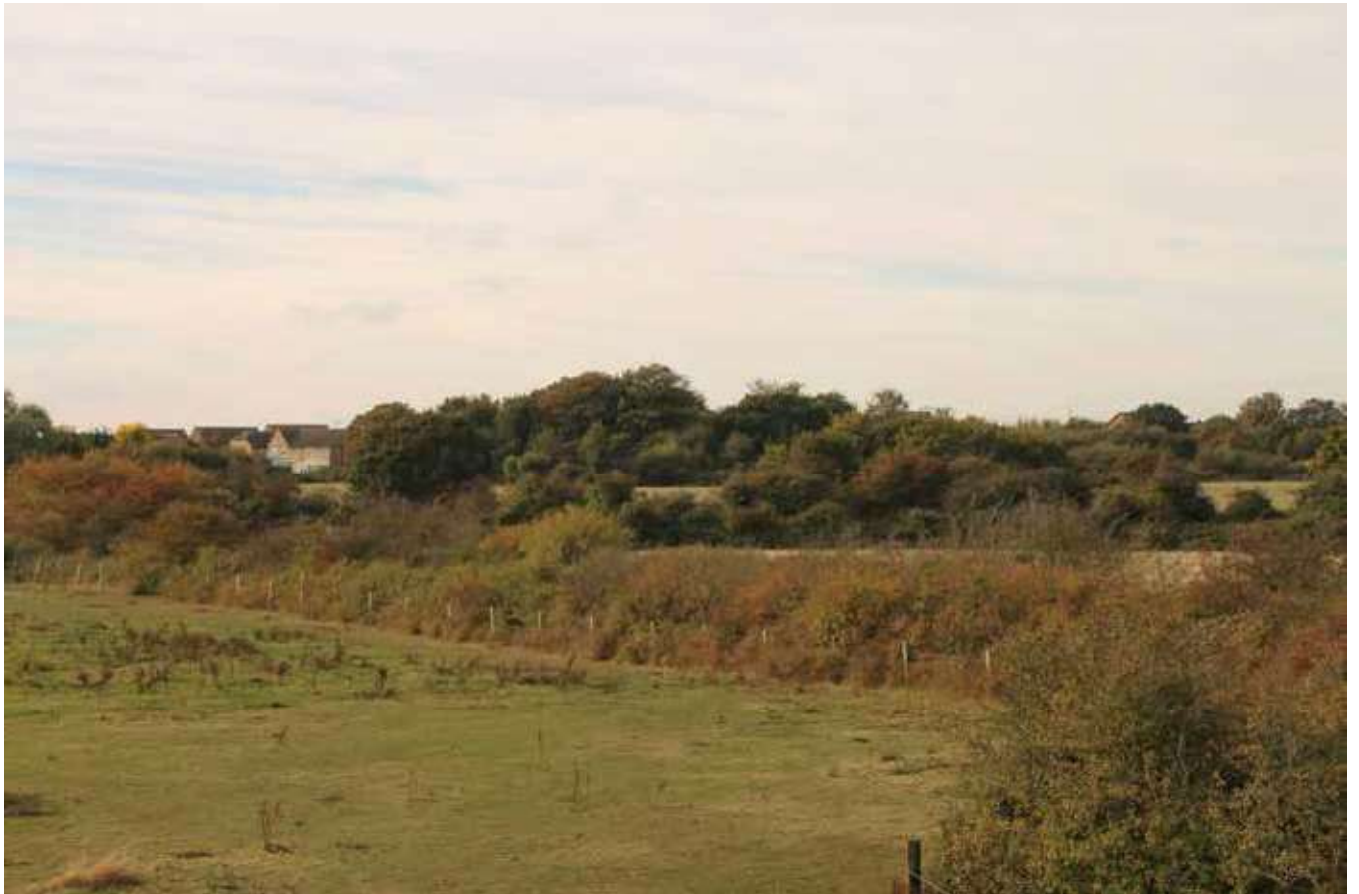
View 3: View of the battery from the east on the seawall, showing the tree and shrub growth on the scheduled monument.

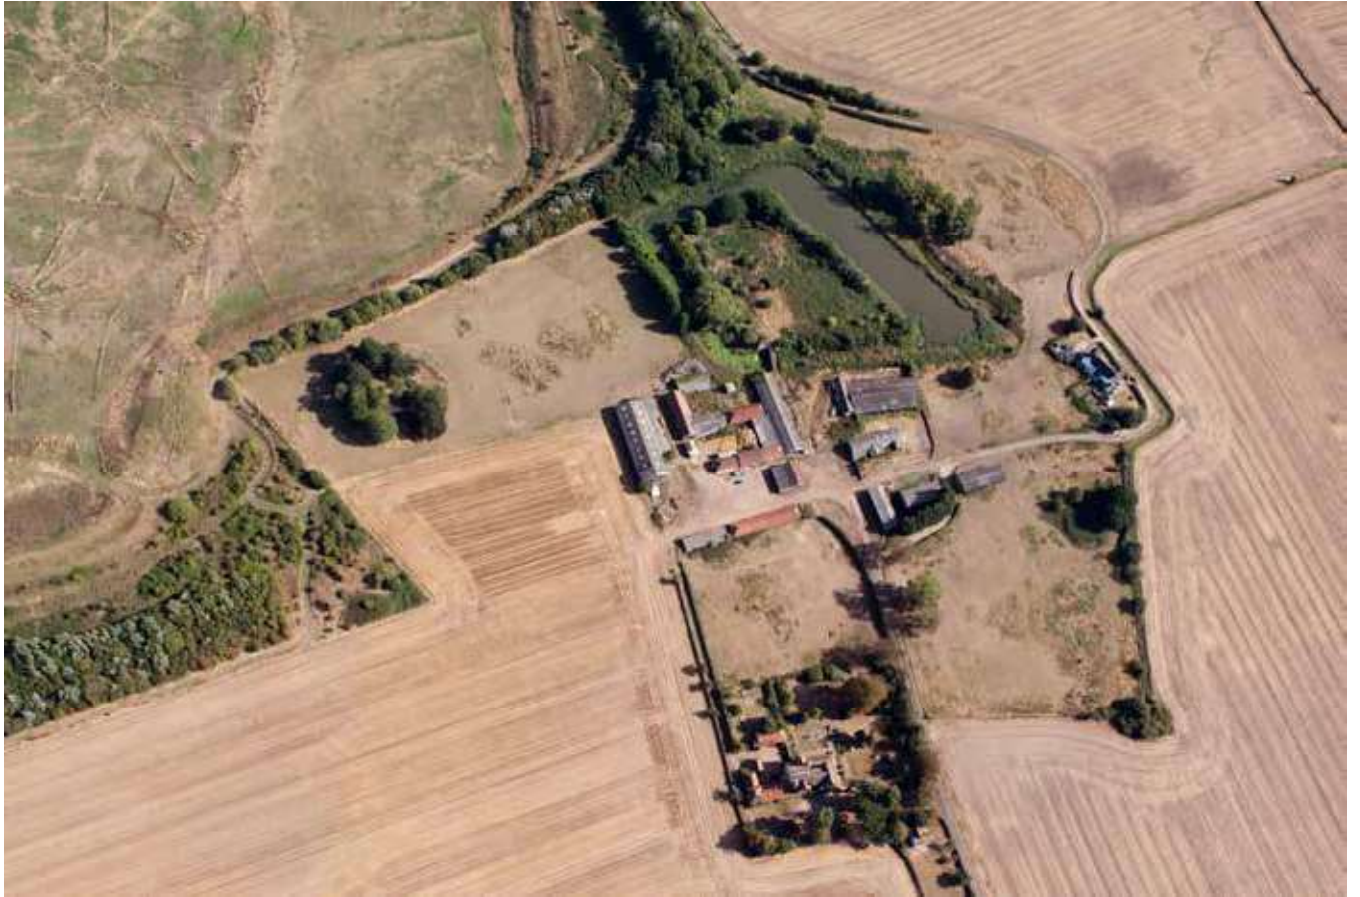
Figure 24: Aerial photograph looking east across the Roman barrow showing the inter-relationship between it and the Scheduled moat and associated farm complex to the right of it. The cropmark of the second barrow is just visible in the top right-hand corner of the photo. The clay-pit occupies the top left-hand side of the photo.

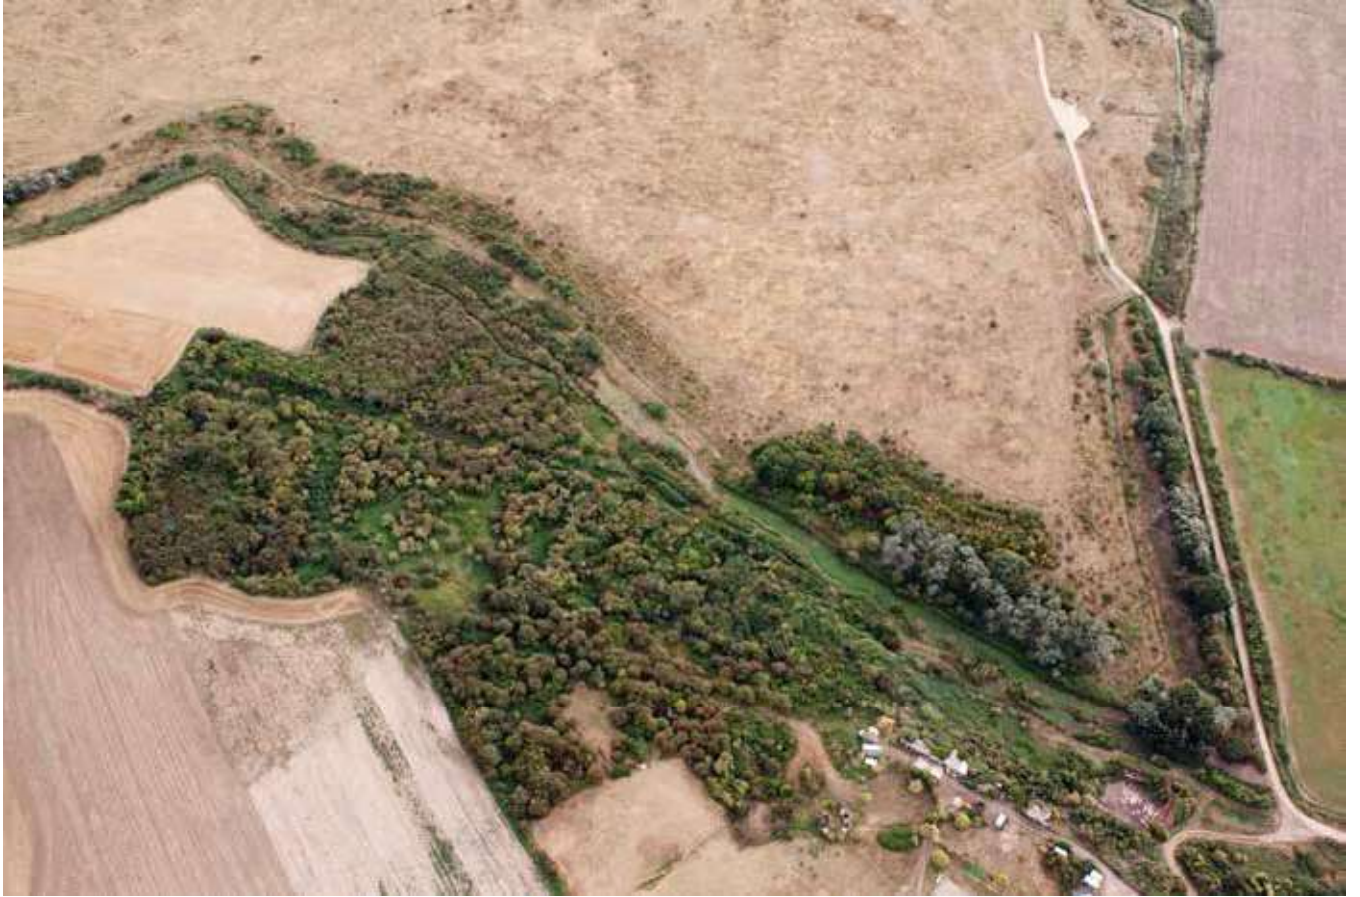
Figure 26: Aerial view of the anti-aircraft battery from the north. Some of the structures are showing at the bottom of the photo.

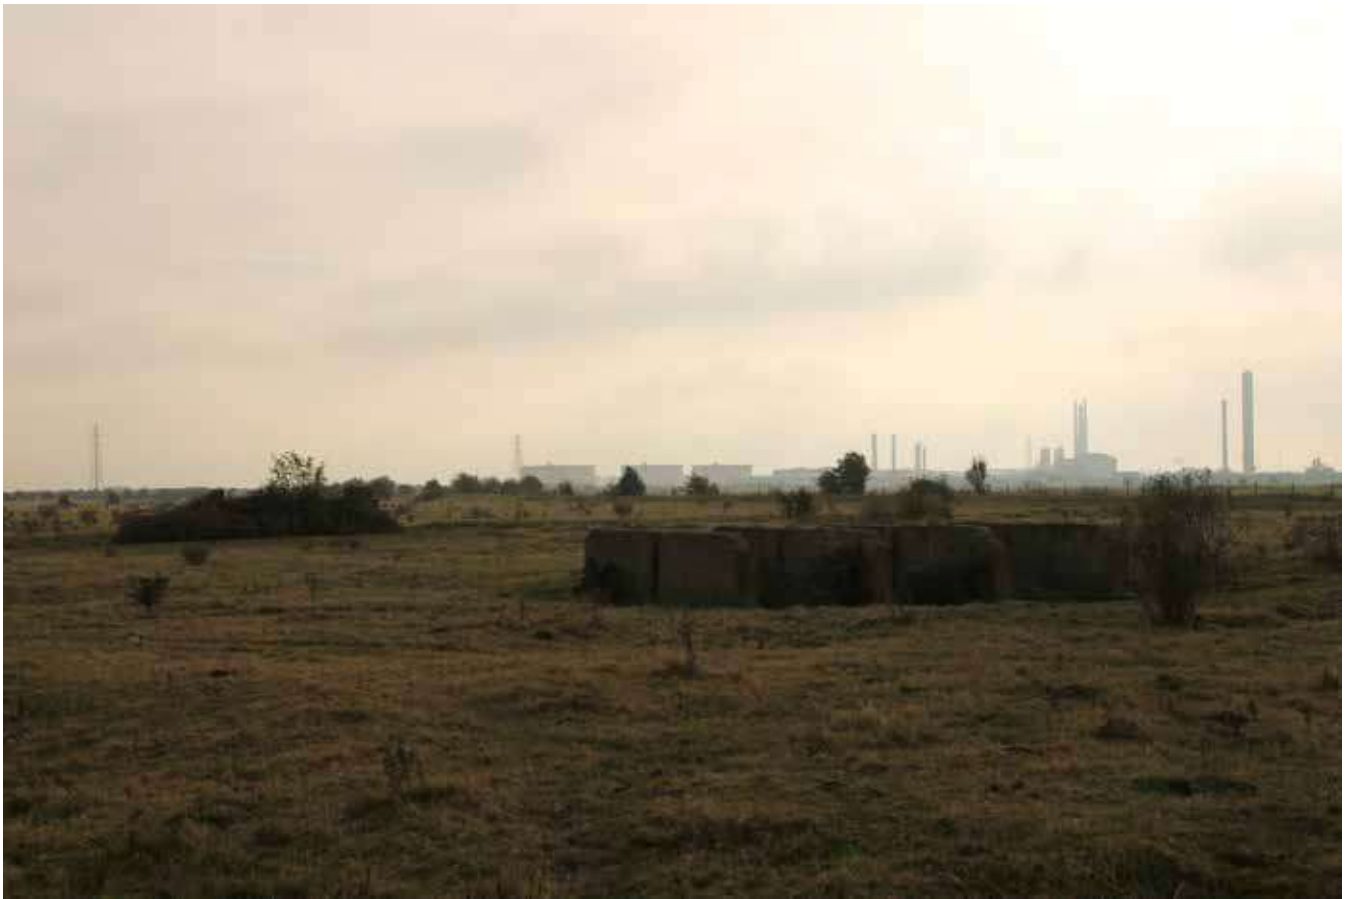
View 1: View looking south-east across the storage bays (in the foreground) and the night-shelter (on the left) towards the Shell Haven/Coryton oil refinery in the distance
